FINAL REPORT

**INCIDENT OF SRILANKAN AIRLINES
FLIGHT UL121 AIRBUS A330, 4R-ALC
ON 13TH OCTOBER 2008
AT CHENNAI INTERNATIONAL AIRPORT
INDIA**

**AIRCRAFT INCIDENT REPORT****SYNOPSIS:**

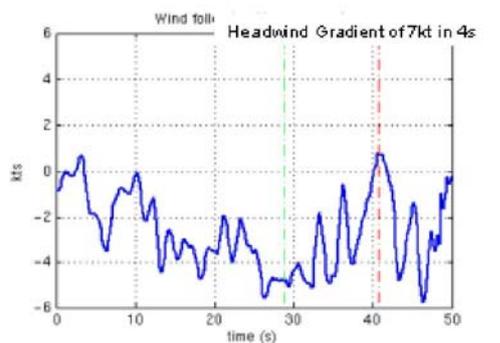
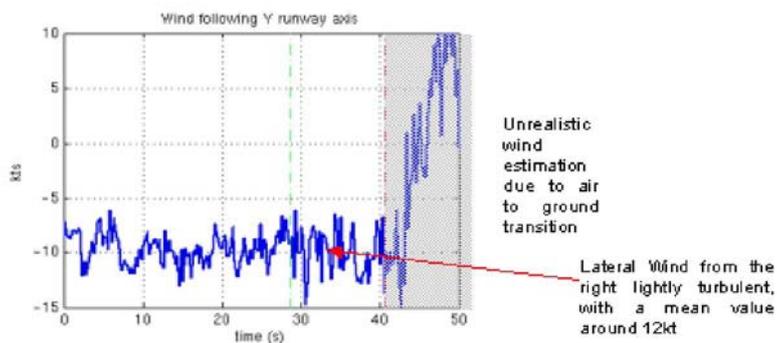
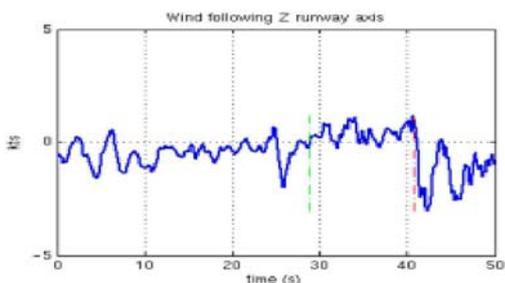
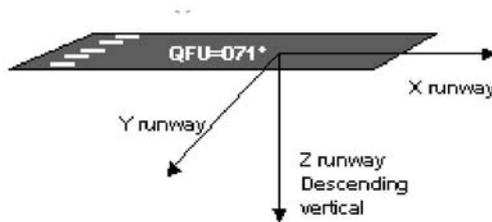
Wind reconstruction: Runway axis

140 degrees < wind direction < 180 degrees (mean wind direction = 160 degrees)
 09 kts < wind speed < 12 kts (mean wind speed = 10 kts)
 72 degrees < aircraft heading < 76 degrees (for runway QFU: 071 degrees)

Above wind information coming from DFDR raw data show that A330-200 MSN 311 experienced during approach a moderate crosswind coming from the right.

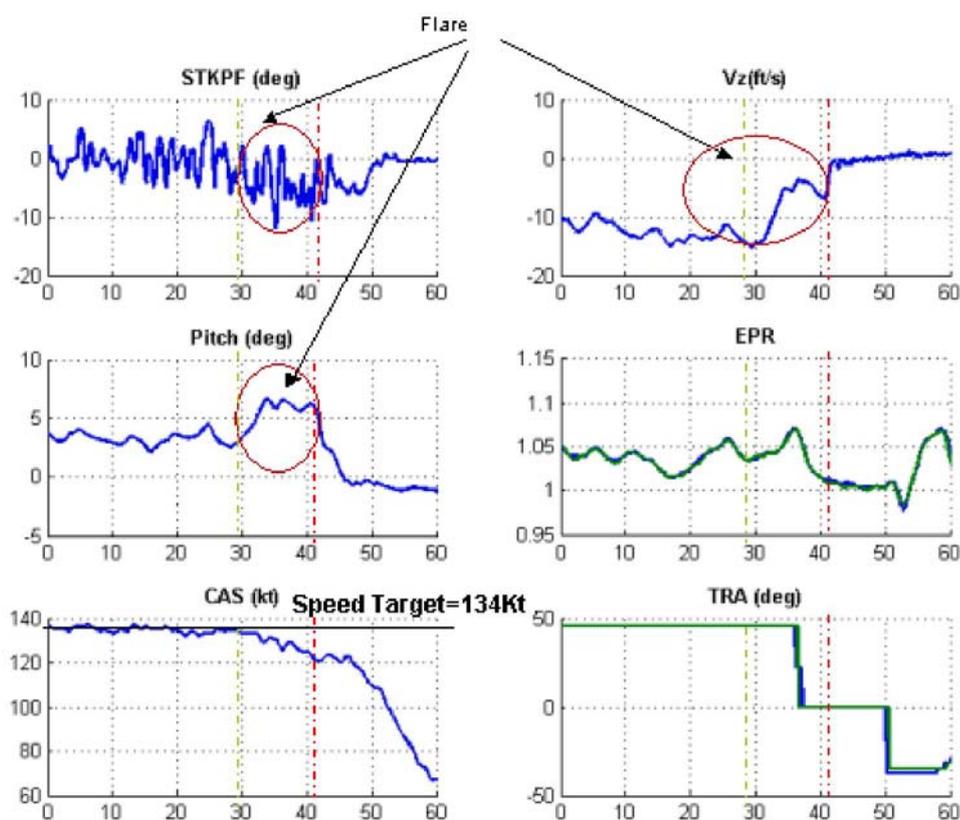
- ◆ Above simulations show a strong longitudinal activity on side stick during approach.
- ◆ The flare is performed at 75 feet RA through several nose up orders which led to:
 - Aircraft pitch increase
 - Aircraft vertical speed decrease
 - Aircraft CAS decrease
 - Thrust increase to compensate CAS decrease before thrust levers set on “IDLE” notch

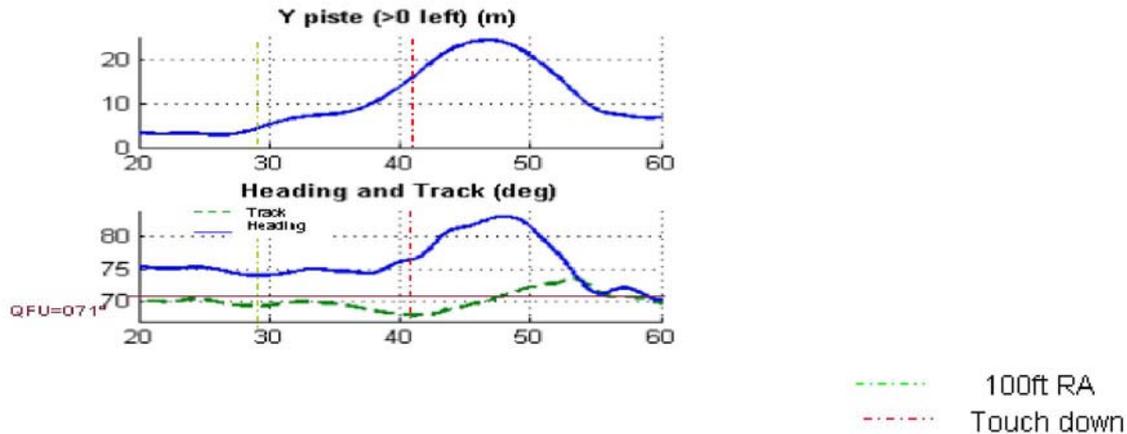
Note: The lateral trajectory has been computed thanks to integration of inertial parameters. According to this trajectory, fewer than 100 feet RA aircraft approached on runway 07 with a divergent trajectory to the left.

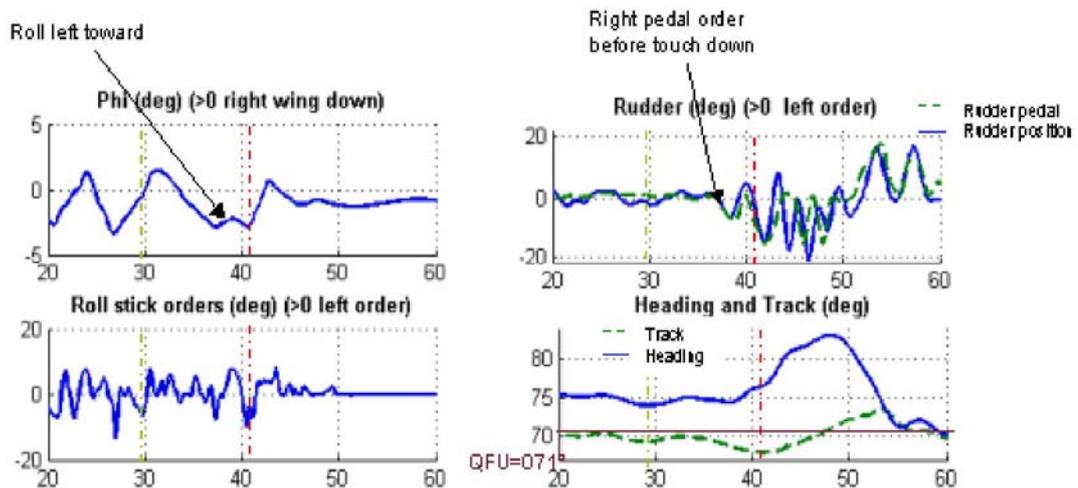
- ◆ Above simulations show a strong lateral activity on side stick during approach
- ◆ Under 60 feet RA, aircraft rolls to the left and combined with a right pedal order led to a heading increase to the right creating sideslip => aircraft nose moves to the center line but the track was still divergent at time of touchdown.

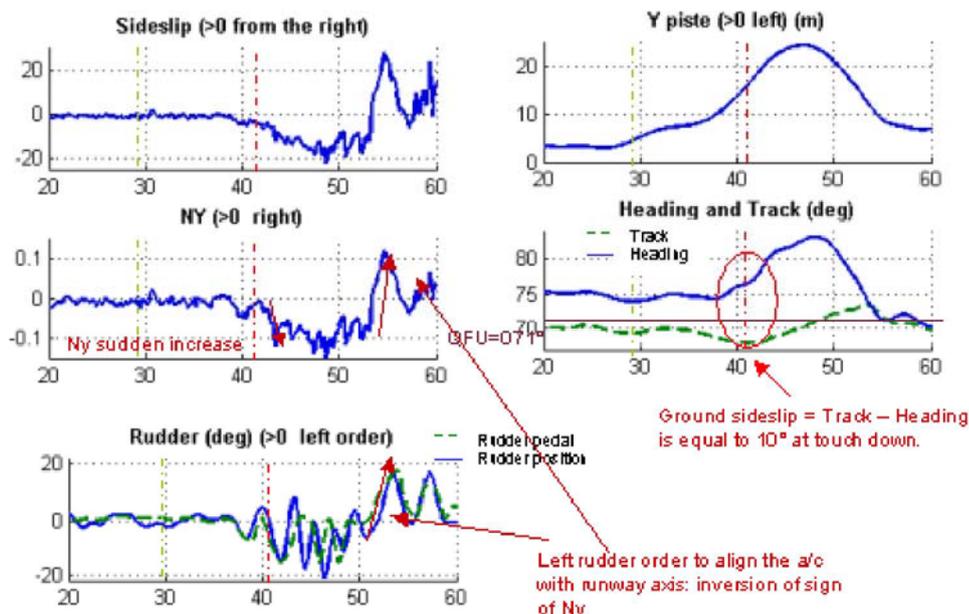
- ◆ After touchdown, aircraft heading increases suddenly (aircraft nose moves to the right) until sudden lateral load factors (N_y) increase.
- ◆ Aircraft slides on the runway after touchdown. Subject aircraft sliding is characterized by the fact that lateral load factor is weak initially after touchdown (aircraft sliding) and then increase suddenly (ground adherence recovery).
- ◆ Aircraft sliding is due to the ground sideslip before touchdown associated with a wet runway.
- ◆ The inversion of sign of the lateral load factor corresponds to the left rudder order and the nose wheel steering to align the aircraft on the runway axis.

Touch down occurs with -1.5 degree of left roll angle Aircraft pitch attitude is $+6$ degrees with -8 degrees of drift angle Estimated vertical speed at touchdown is -4 ft/s (± 2 ft/s) Vertical acceleration is $+1.2g$ Lateral acceleration is $-0.04g$

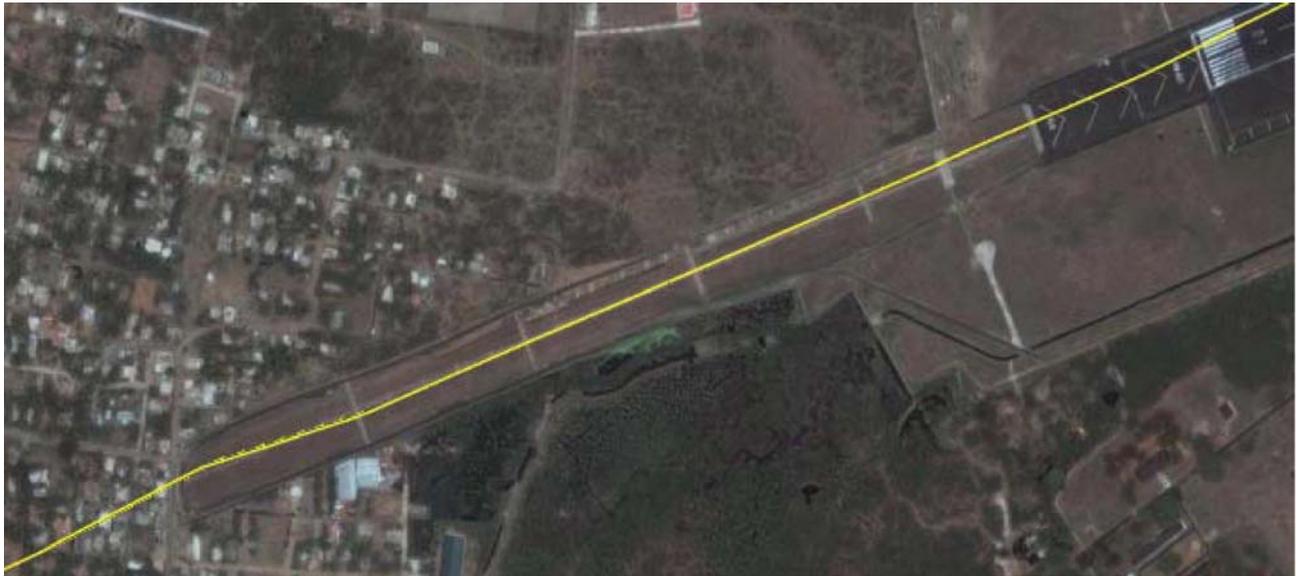
AIRCRAFT TRAJECTORY DURING SHORT FINAL

- ◆ Under 100 feet RA, aircraft trajectory began to diverge to the left of runway axis. Indeed, instead of maintaining right roll orders to counter the right crosswind, the pilot flying:

- Let the aircraft rolled to the left leading to an increase of aircraft deviation to the left of the runway axis
 - Performed a right ruder pedal leading to an aircraft nose movement to the right, which created an aircraft sideslip. As a consequence, subject action corrected the aircraft heading but not the aircraft track => Aircraft trajectory was not centered on the runway centerline at time of touchdown

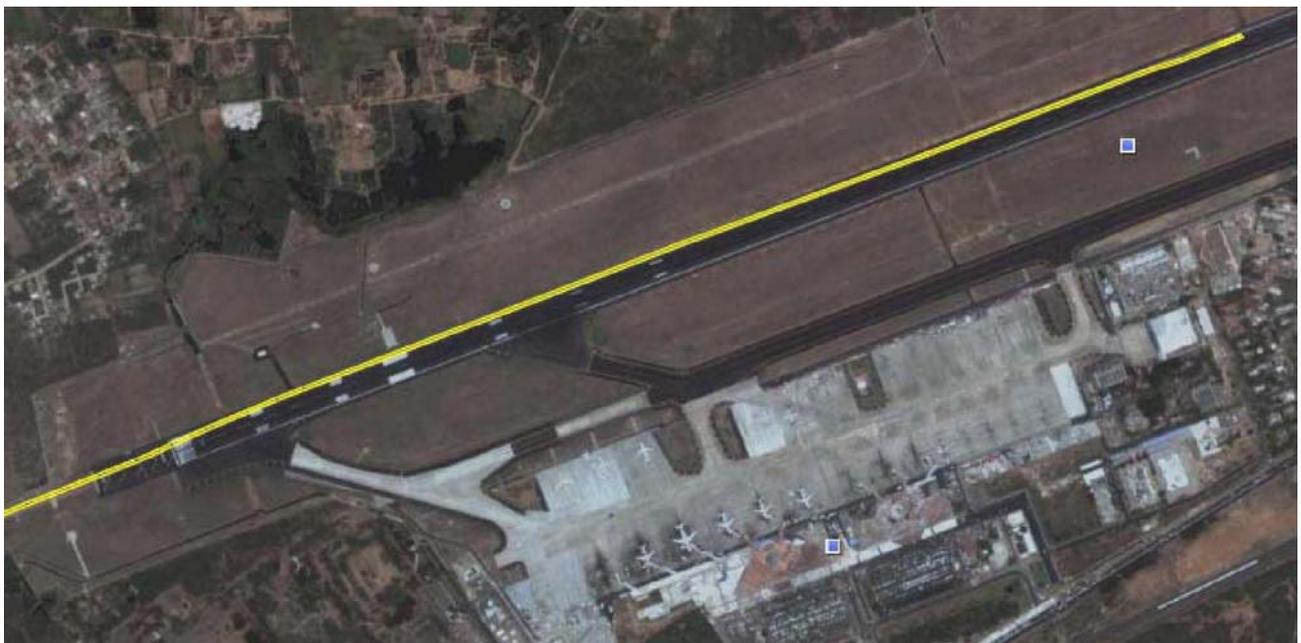
TRAJECTORY OF LEFT MAIN LANDING GEAR ON THE RUNWAY 07

- ◆ After touchdown, aircraft slid □ subject sliding is due to the difference between the track and the heading at time of touchdown associated with a wet runway.
