FINAL REPORT

**INCIDENT OF EXPO AVIATION FLIGHT EXV 711
F-27, REGISTRATION 4R-MRA
ON 21ST FEBRUARY 2008
AT COLOMBO AIRPORT, RATMALANA – SRI LANKA**

Released by the Director General of Civil Aviation Sri Lanka

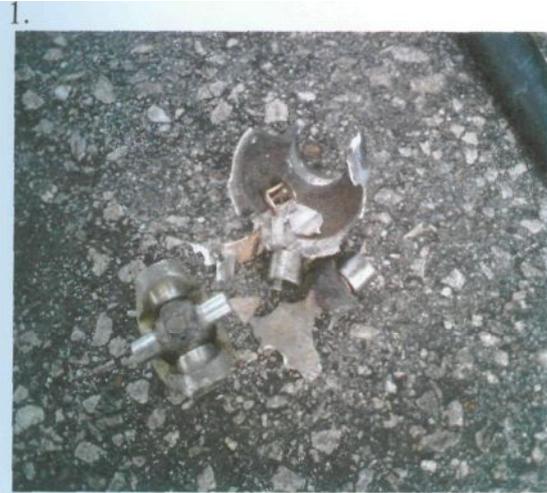
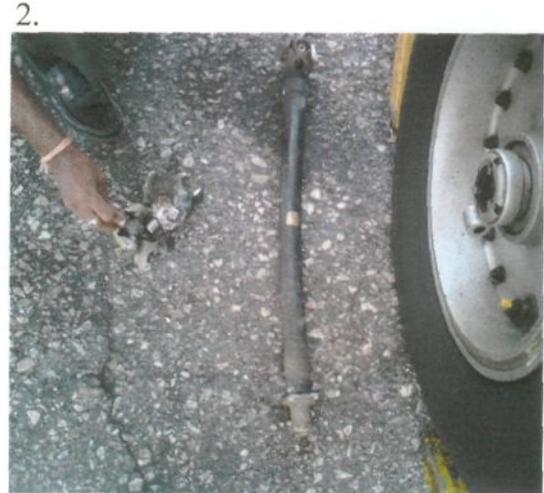
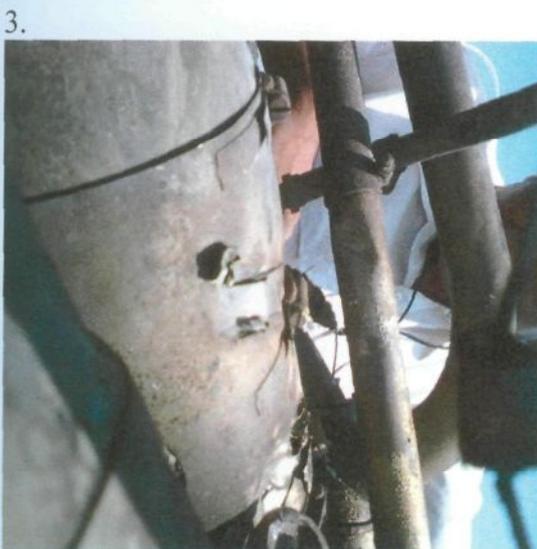
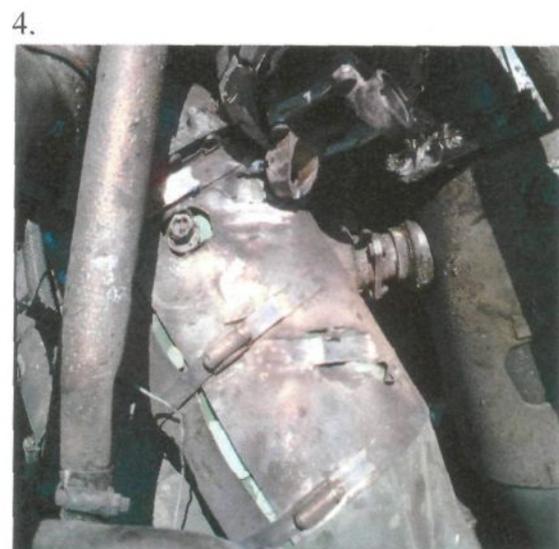
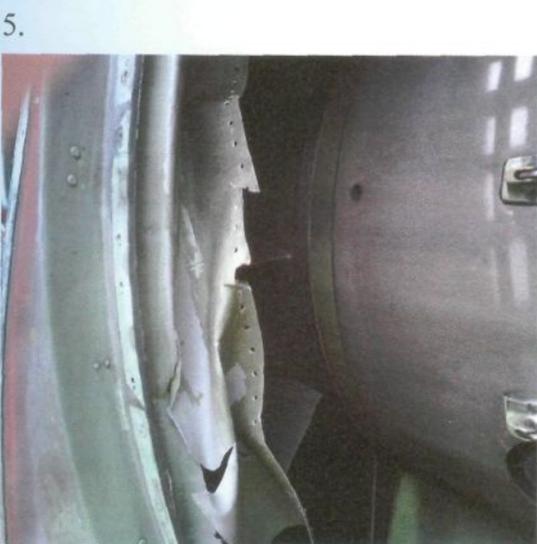
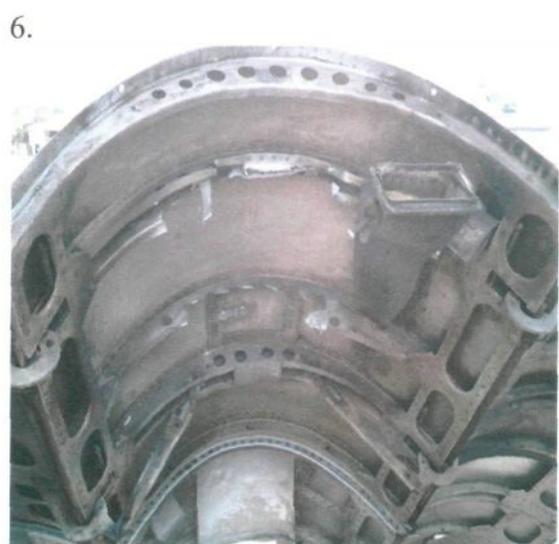
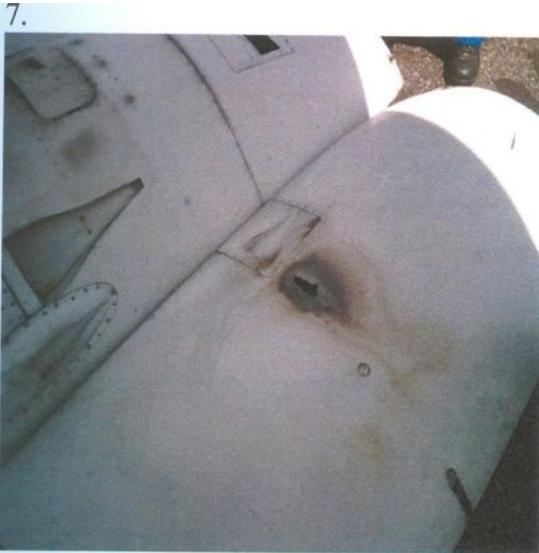
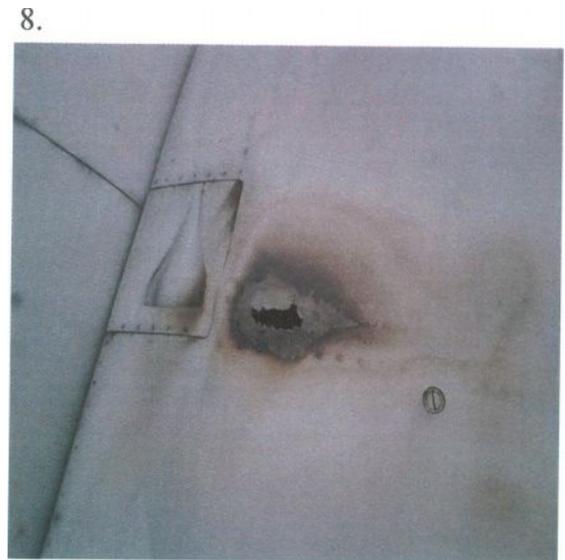
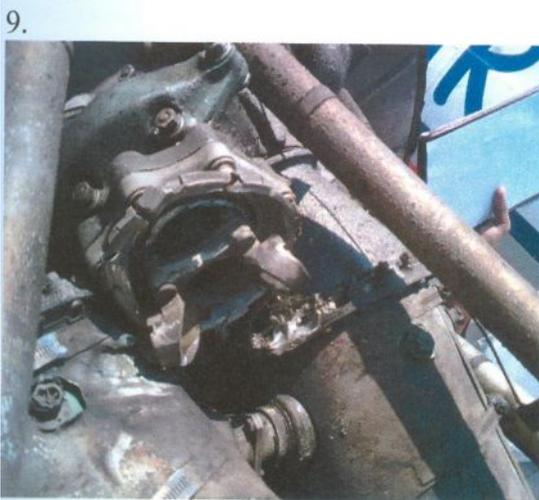
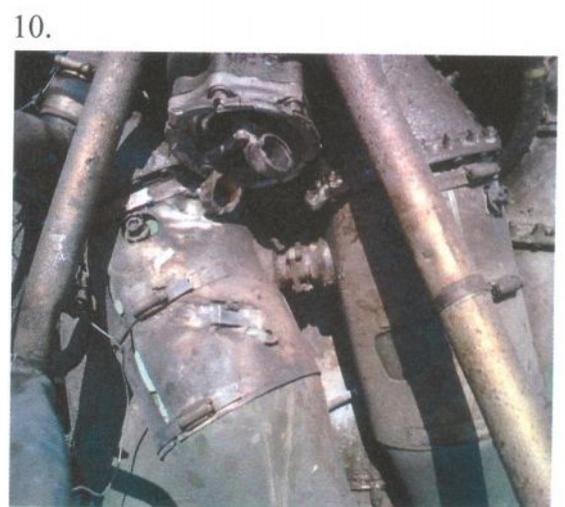
**APPENDIX - 3 - PHOTOGRAPHS TAKEN AT RATHMALANA ON 21ST
FEBRUARY 2008
FIRE ON NO. 1 ENGINE F-27 4R-MRA**

The AGB Drive Shaft	- Bent, discoloured and sheared From the coupling flange
Coupling flange	- Sheared
Cover of the Coupling shaft universal joint	- Completely broken
Combustion Chamber No: 1	- Damage to expansion chamber and Outer air casing flange Dents and cracks outer air casing
AGB drive coupling (engine End)	- Excessive play
Coupling Shaft Cove air seal	- Fretting wear
Gear Wheel (Driven AGB drive)	- Teeth Damaged
Cover Assembly (gear box end)	- Completely damaged
Engine mount assembly	- Dent on one strut
Engine cowling assembly	- LH inboard burnt hole
Engine cowling assembly	- LH top two nos. of reinforce frame damaged
Bracket cable guide gearbox drip tray	- Damaged
Gear box drip tray	- Damaged hole
Fire sense element	- Discoloured and broken

- 2.2 Drive Shaft** - At the inspection on ground it was observed that the AGB drive shaft of No. 1 engine had come out from the bearings of the universal joint assembly at the engine end. As a result of this, the shaft was rotating without coupling, hitting the combustion can No.1 causing impact damage on outer casing and expansion chamber. The flame tubes of combustion chambers have not suffered any impact damage. No evidence is there to reveal that the fire has come out from the damaged combustion can.

- 3.1.5 The cover of the coupling of AGB Drive shaft at engine end had broken as a result of this Drive shaft hitting on it. The broken pieces of this cover had become red hot due to hot air coming from the damaged combustion can had hit and punched the engine cowlings

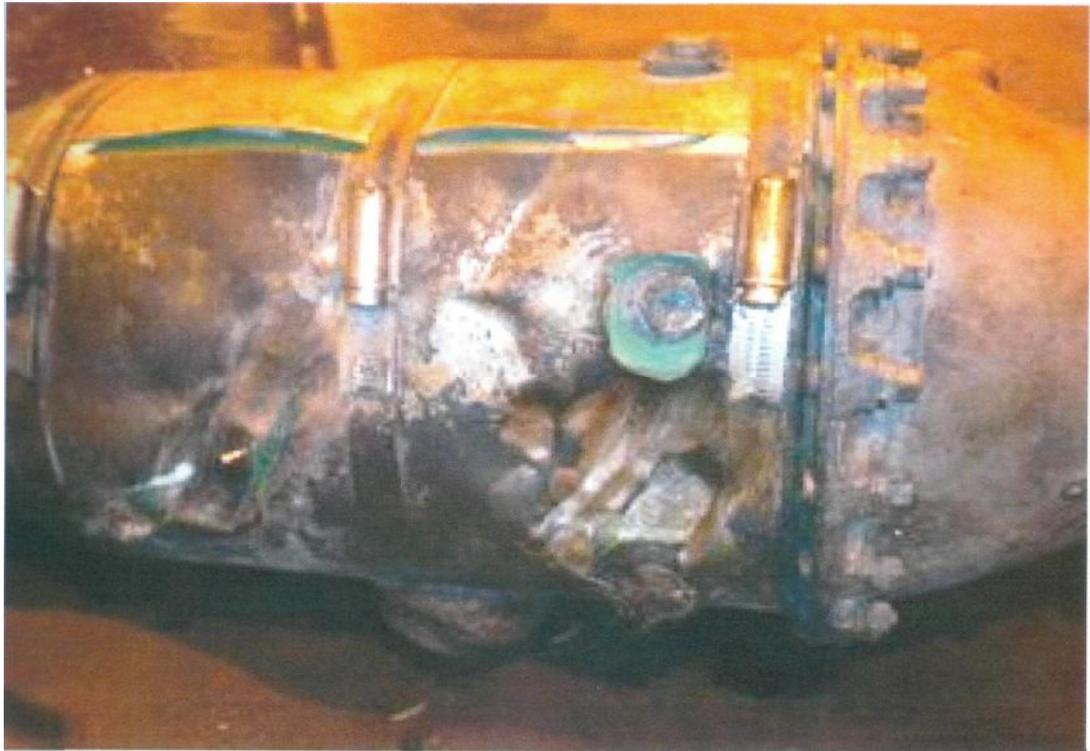
Photo #1: Combustion Chamber #2

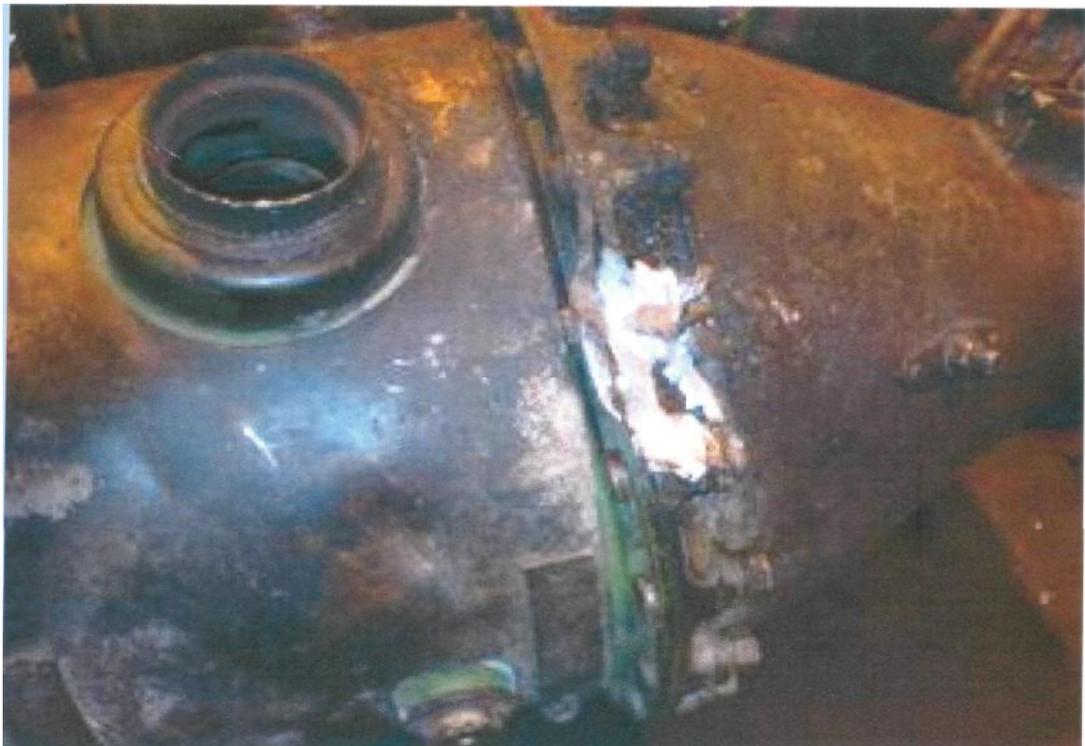
Photo #2: Combustion Chamber #1
