FINAL REPORT

Incident of Millennium Airlines
Cessna Aircraft, model 152, bearing
registration 4R-DJD
at Colombo Airport, Ratmalana - Sri Lanka
on 14th June 2014

**FAILURE ANALYSIS REPORT ON WHEEL DETACHMENT
OF A CESSNA 152 AIRCRAFT**

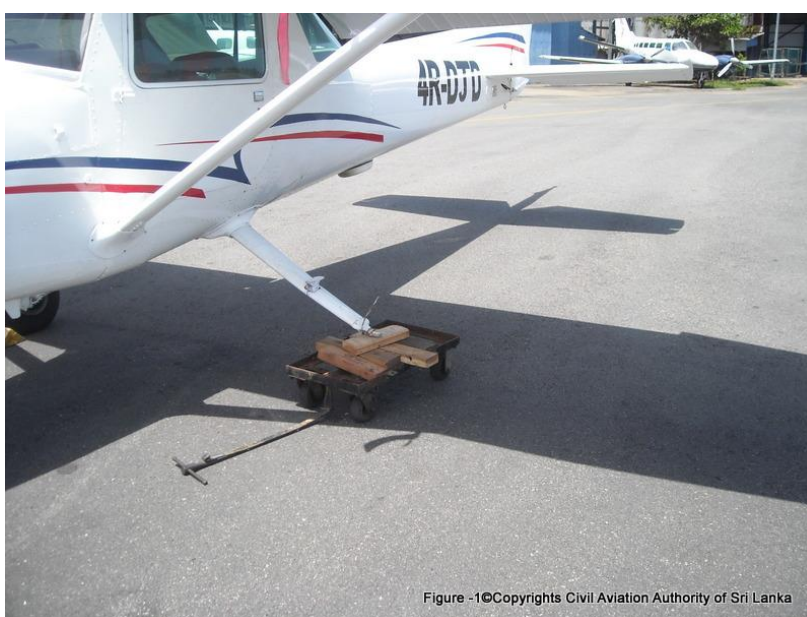
Figure 1: 4R-DJD without left wheel

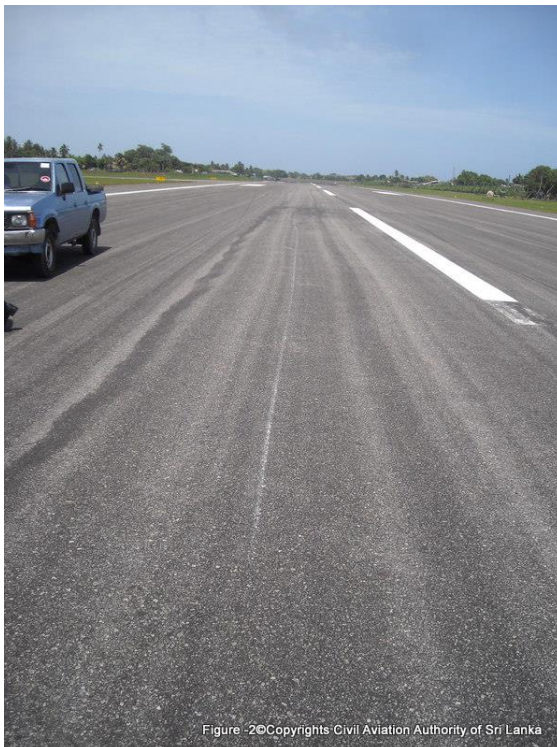
Aircraft, 4R-DJD landed without the port wheel on Runway 22, Colombo Airport, Ratmalana. The Runway was not damaged, but left with a scraped mark. See picture below.

Figure 2: Runway 22, Ratmalana Airport, Colombo, Sri Lanka

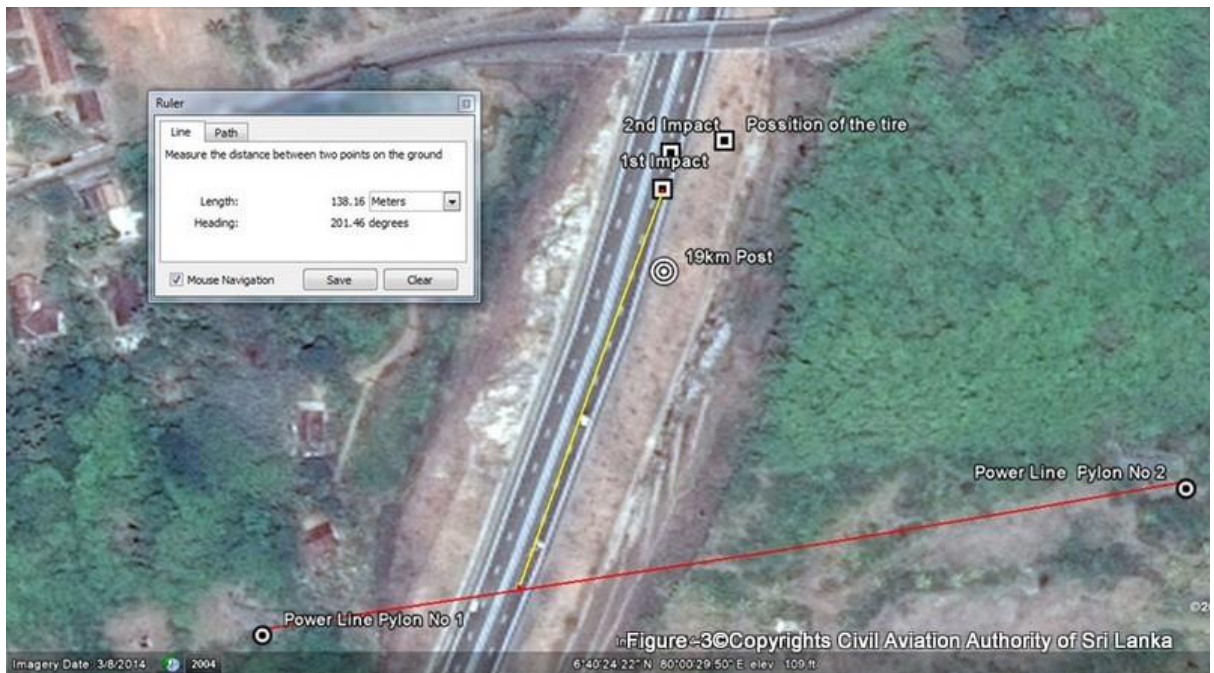
About 10NM south/south east of the Departure Airport, Ratmalana, the damaged wheel was found in Paragasthota area under Milleniya Police division, (approximate GPS coordination are $6^{\circ} 40' 26.26''$ N and $80^{\circ} 00' 22.28''$ E) on Southern expressway. At this location, there is a high tension power line over the southern expressway. The height of the power lines is approximately 115ft above the ground level and area elevation is approximately 100ft from mean sea level. According to the Milleniya Police, the first impact point of the wheel on the expressway is approximately 80m – 100m from the point where wires are crossing the highway (Shortest Distance). (Please refer Site Sketch at Appendix 02)

Figure 3: Site picture at Paragasthota, Milleniya on Southern Expressway

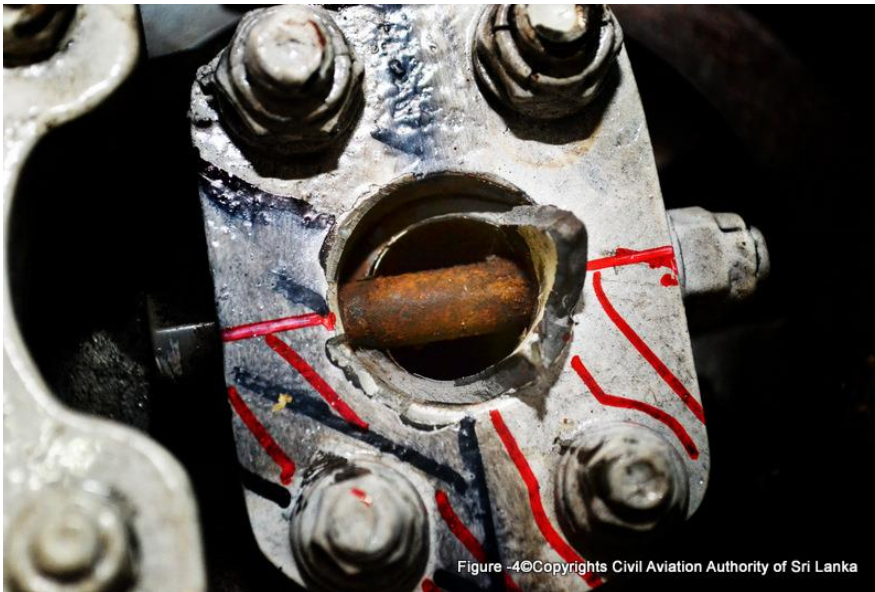
Figure 4: Damaged Strut

- 6.1.1. Investigation and examination on the detached wheel and the strut revealed cracks and corrosion in the affected area. As per the conclusions of the Report obtained from the University of Moratuwa, severe corrosion in the strut end as well as in the fixing bolt have contributed to a crack initiation. The Report further confirms that the root cause of the detachment of the wheel is due to a fatigue crack initiated from the bolt hole of the strut. The Failure Analysis Report on Wheel Detachment obtained from the University of Moratuwa is at Appendix 7.

7.1.2.1. It was found that there had been severe corrosion in the strut end as well as in the fixing bolt which led to a crack initiation in the bolt hole of the strut.

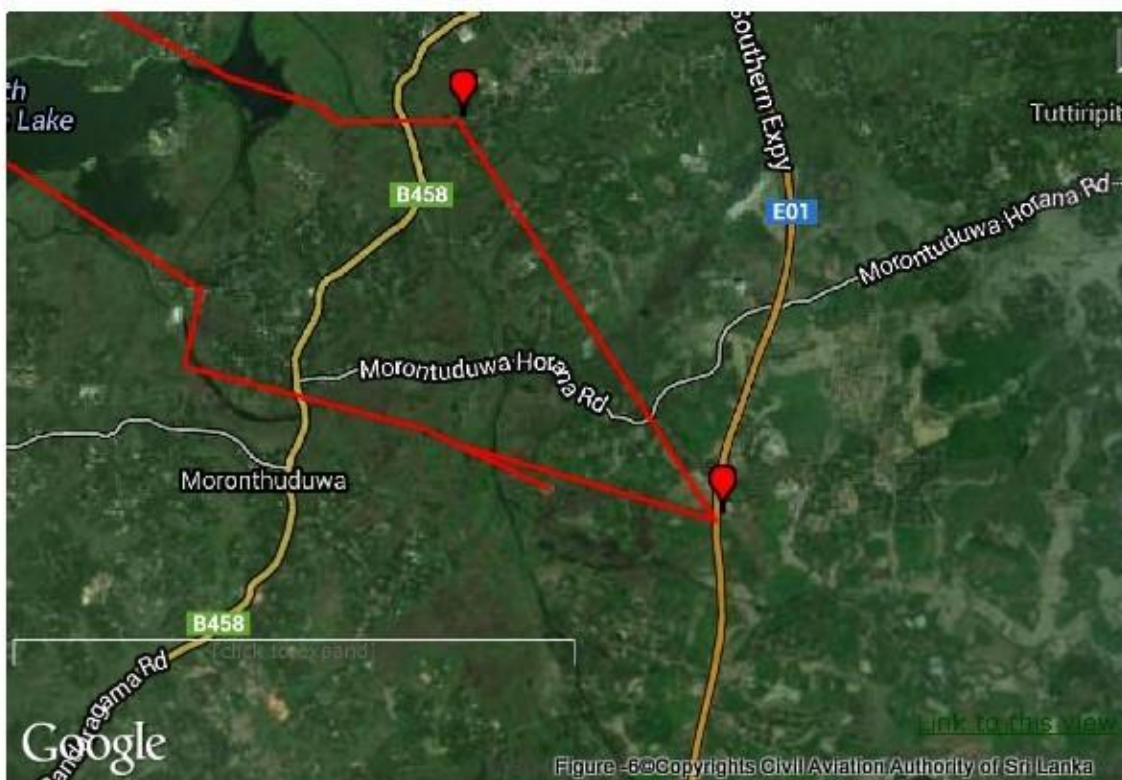
6.3.2. During the incident flight, the longest time gap (2 minutes 24 seconds) between two detected points was evident in the same area where the wheel was found. Accordingly there is a likelihood of a height reduction from the height it was operating. This possibly the lowest and longest height drop in the incident flight. (The Areal Track is at Appendix 05).

Figure 6: Indication of Radar on the area of operation

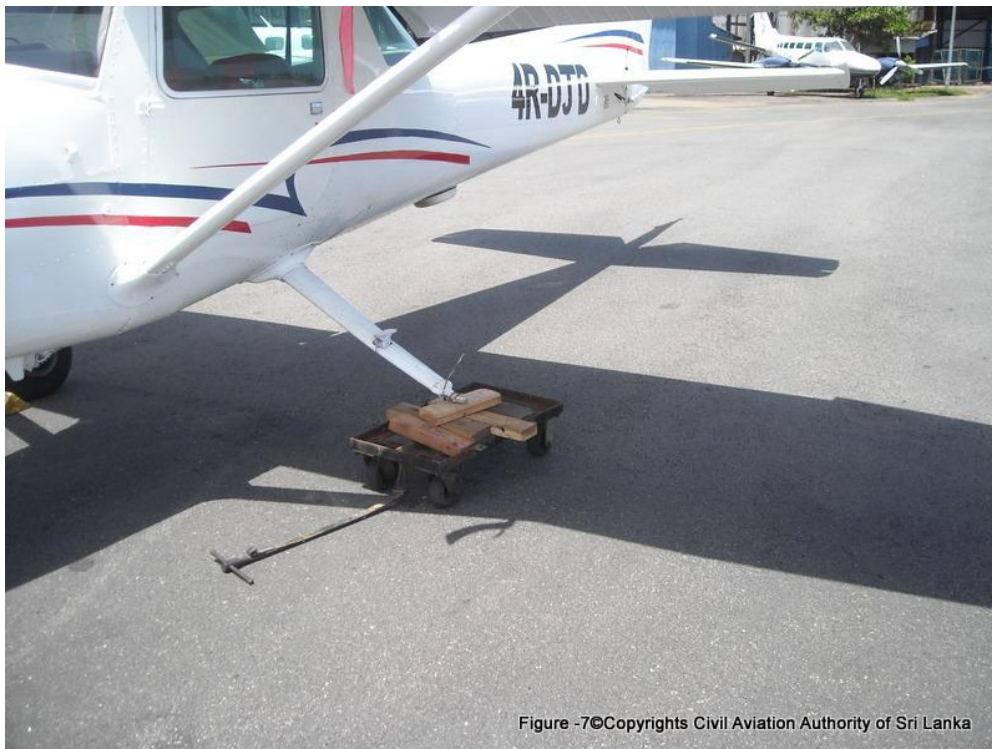
Figure 7: View of 4R-DJD, Cessna 152 aircraft without left wheel

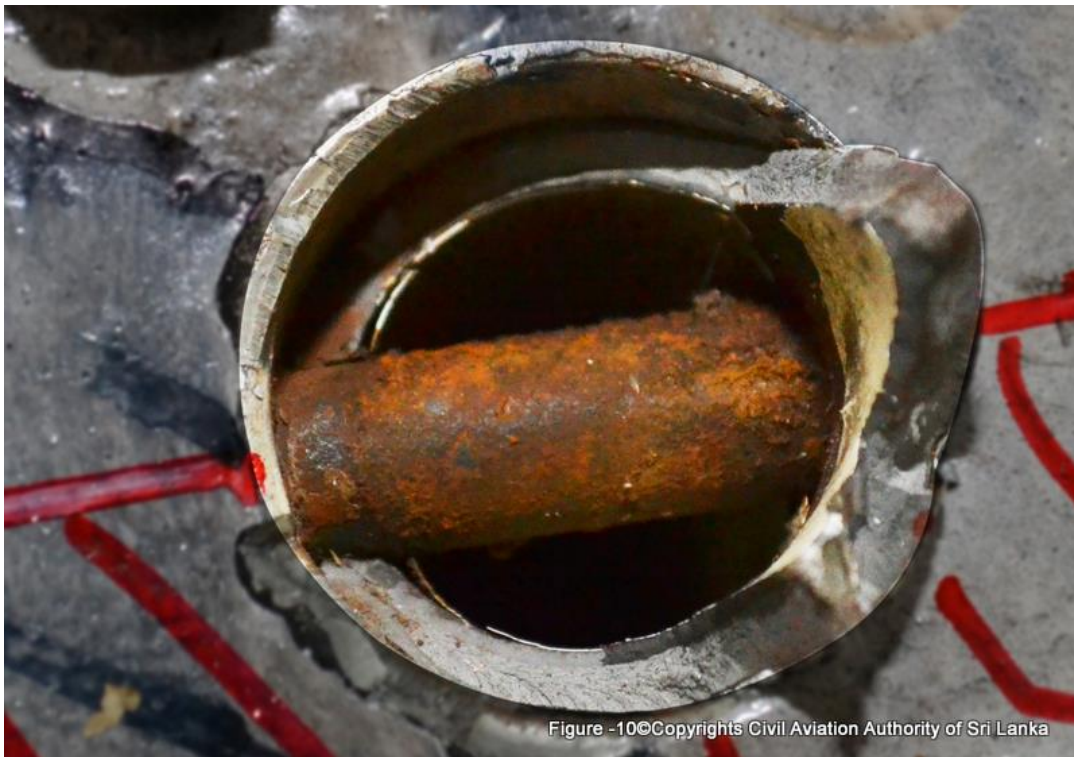
Figure 10: View of damaged Strut

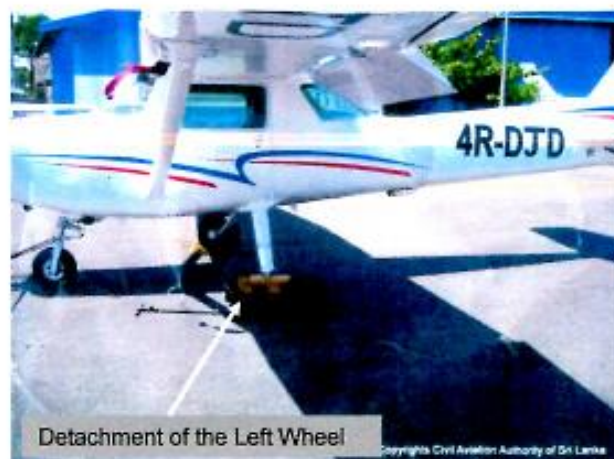
During landing only with the wheels on the front and right landing gears the left trust was severely damage due to the absence of the wheel (Fig. 1).

Figure 1: Cessna 152 Aircraft after Detachment of the Left Wheel

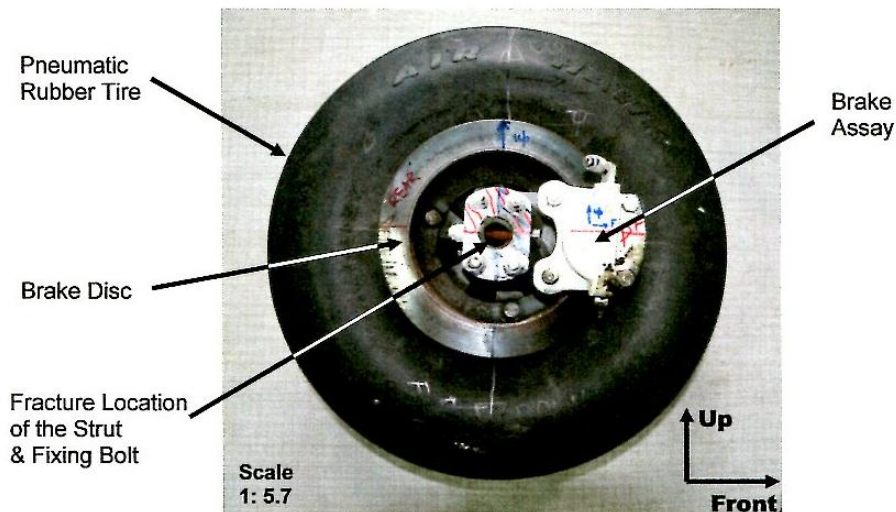
The wheel was observed initially by naked eye and it was found that the strut was fractured and completely separated from the fixing location of the wheel hub (Fig. 2). In Figure 2 the indication 'UP' is for the direction showing the upper side wheel attachment and 'Front' is for the flying direction of the aircraft.

Figure 2: Detached Wheel & Accessories (View from Inside)

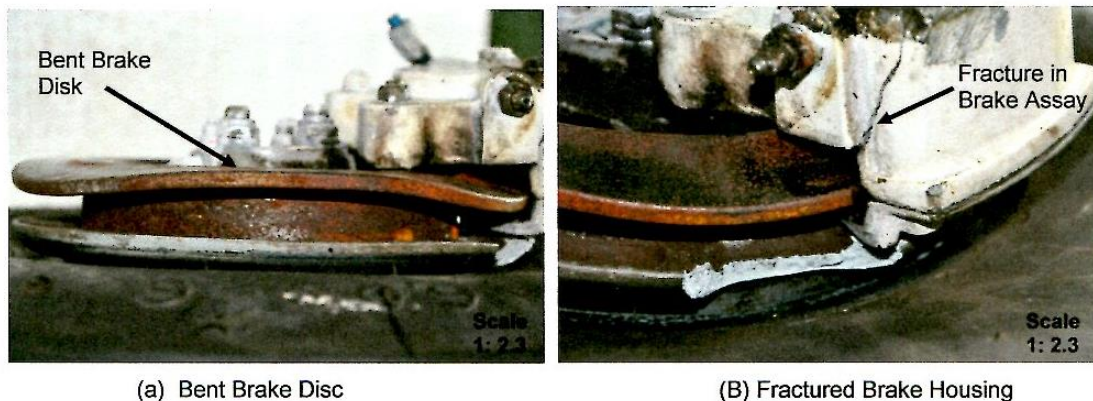
The bolt fixing the strut to the hub was not damaged but the brake disc was bent and the housing of the brake assay was fractured (Fig. 3).

(a) Bent Brake Disk

(B) Fractured Brake Housing

Figure 3: Damages to the Accessories of the Wheel

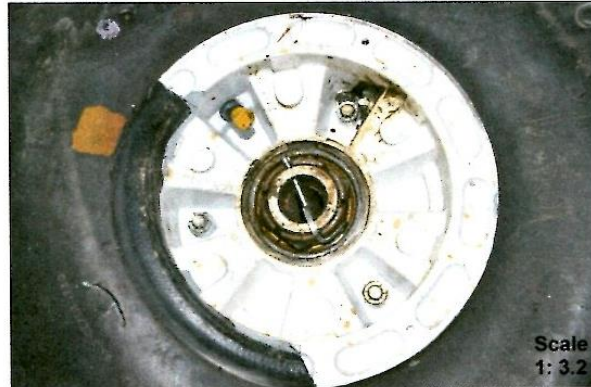
On the outer side of the wheel the rim was severely damaged and all fractured pieces were not available for the investigation (Fig. 4).

Figure 4: Fractured Rim (View from outside)

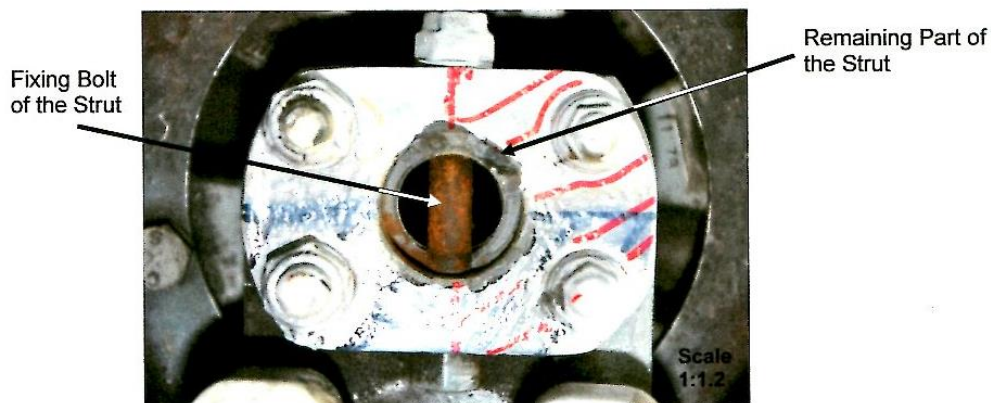
During further observation it was found that the fixing bolt was severely corroded, especially the area inside the strut (Fig. 5).

Figure 5: Corroded Fixing Bolt and the Remaining part of the Strut

During observation of the outer side of the wheel it was found that a part of the strut was still inside the wheel hub and the bolt which secure the strut in the wheel was intact (Fig. 5). After dismantling the wheel components it was found that the strut and the bolt was severely corroded especially, the area where strut was inside the hub (Fig. 6). Furthermore, a secondary crack was also observed close to the main crack (Fig. 8). The main fracture propagated from the bolt hole (from right hand side of Fig. 9) in the strut. The other bolt hole was not damaged.

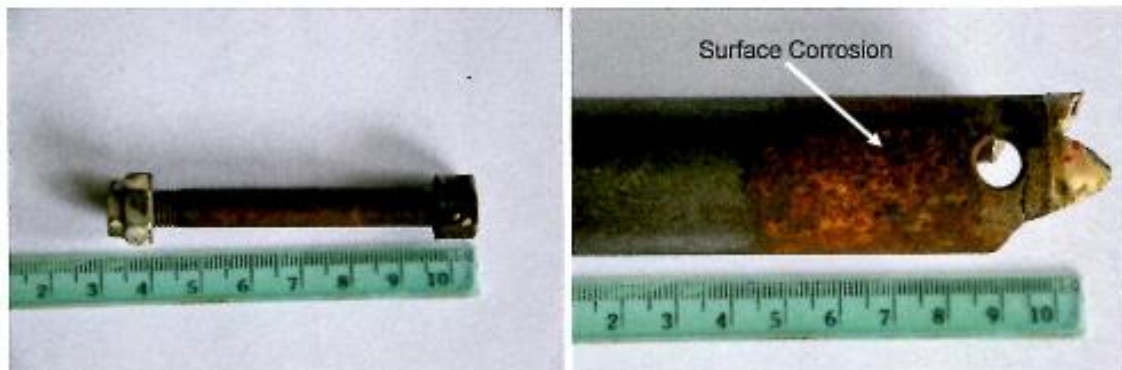
For detailed investigations the wheel components were dismantled and the remaining part of the strut, which was stuck inside the fixing hole, was taken out. It was tightly fixed to the fractured part of the trust and very difficult to remove. During macroscopic observation it was found that both strut and the bolt, were severely corroded (Fig. 6).

Figure 6: Corroded Fixing Bolt and the Remaining part of the strut

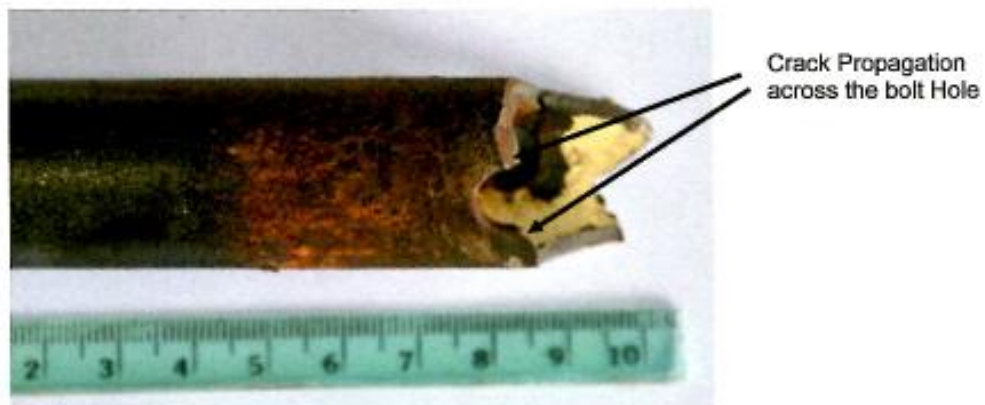
Removed bolt and the remaining part of the strut were closely observed initially with magnifying glass and then with a stereo microscope. Then it was found that the bolt was not fractured but corroded on the surface (corrosion layer is not visible in Figure 6 since that layer was removed during dismantling). In contrast to that the fractured part of the strut was severely corroded. Further, it was observed that the main fracture which has separated the strut from the wheel has propagated across the bolt hole (Fig. 7).

Figure 7: Corroded Remaining part of the Strut with the Crack

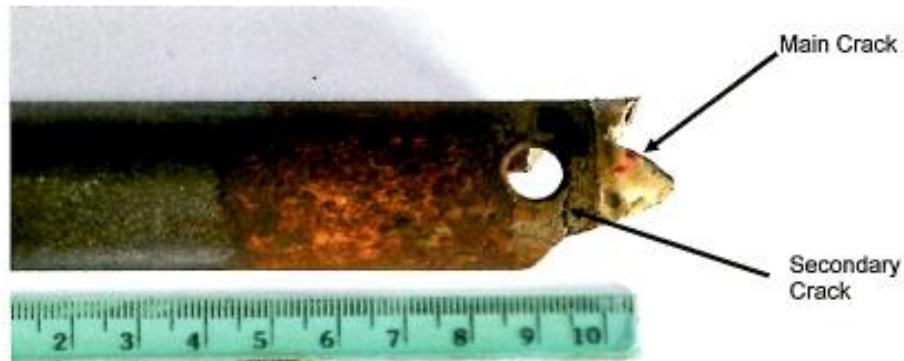
In addition to that on the other side of the fractured strut another crack was observed.

Figure 8: Other side of the Fractured Strut with the Cracks

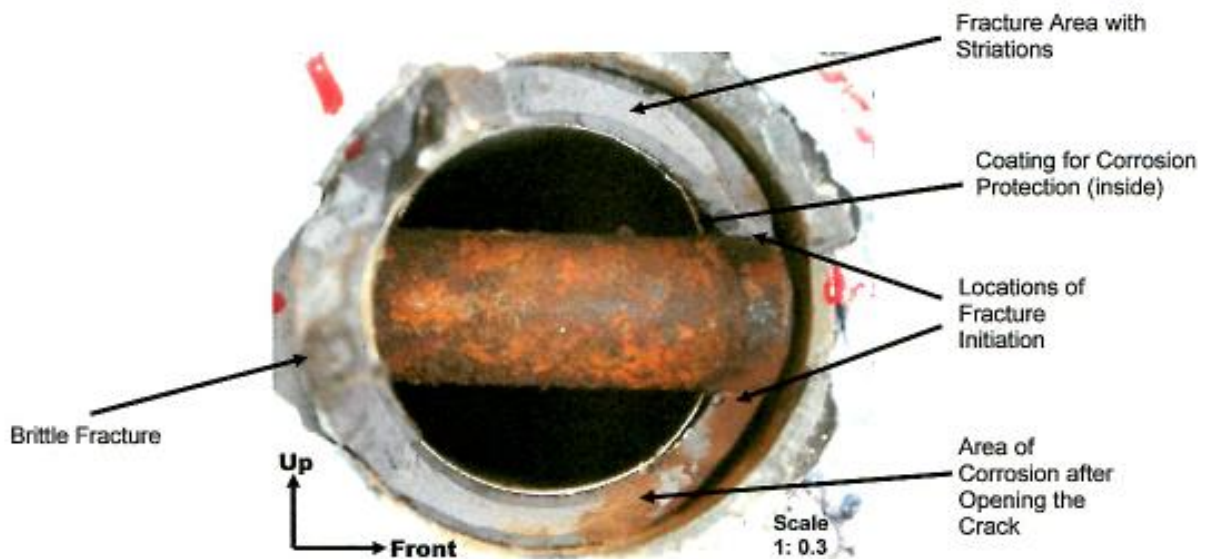
Under Higher magnification it was possible to identify the fracture initiation and it is the circumference of the bolt hole (Fig. 9). The fracture has propagated through the walls of the strut and final separation was on the other side of the hole showing a brittle nature. Furthermore, a certain area of corrosion was observed on the fracture surface which indicates that the crack was opened some time before the final fracture has been occurred (before the detachment of the wheel from the strut).

Figure 9: Magnified Image of the Fracture Surface

With higher magnification it was revealed that the main fracture shows striations (beach marks) which were initiated from both sides of the bolt hole and progressed towards the final brittle crack (Fig.9 - left side). This shows a fatigue nature of the fracture and therefore, it can be concluded that the fracture was initiated and propagated well before the accident. This confirms that some corrosion patches on the fracture surface close to the fracture initiation point (Fig. 9 - right side). The main reason for the fracture was the severe corrosion in the strut and the fixing bolt. With metallographic observation it was found that the outer surface of the strut was damaged through general and pitting corrosion. These surface damages have certainly initiated the fracture (possibly Stress Corrosion Cracking with inter-granular crack propagation. However, the facilities available in the laboratory was not sufficient to observe inter-granular corrosion). The corrosion was mainly on the outer side of the strut where inner side was protected by a non metallic coating.

1. Root cause for the detachment of the wheel was a fatigue crack initiated from the bolt hole of the strut.
2. Severe corrosion was found in the strut-end as well as in the fixing bolt which has contributed to the crack initiation.

1. It is recommended to ground all this type of aircrafts and inspect the strut fixing bolt area after dismantling the wheel components.
2. It is also recommended to perform ultrasonic testing for the bolt as well as the strut for micro cracks. Dye penetration or eddy current inspection can also be used for the inspection. This should be included in periodic inspection schedule.

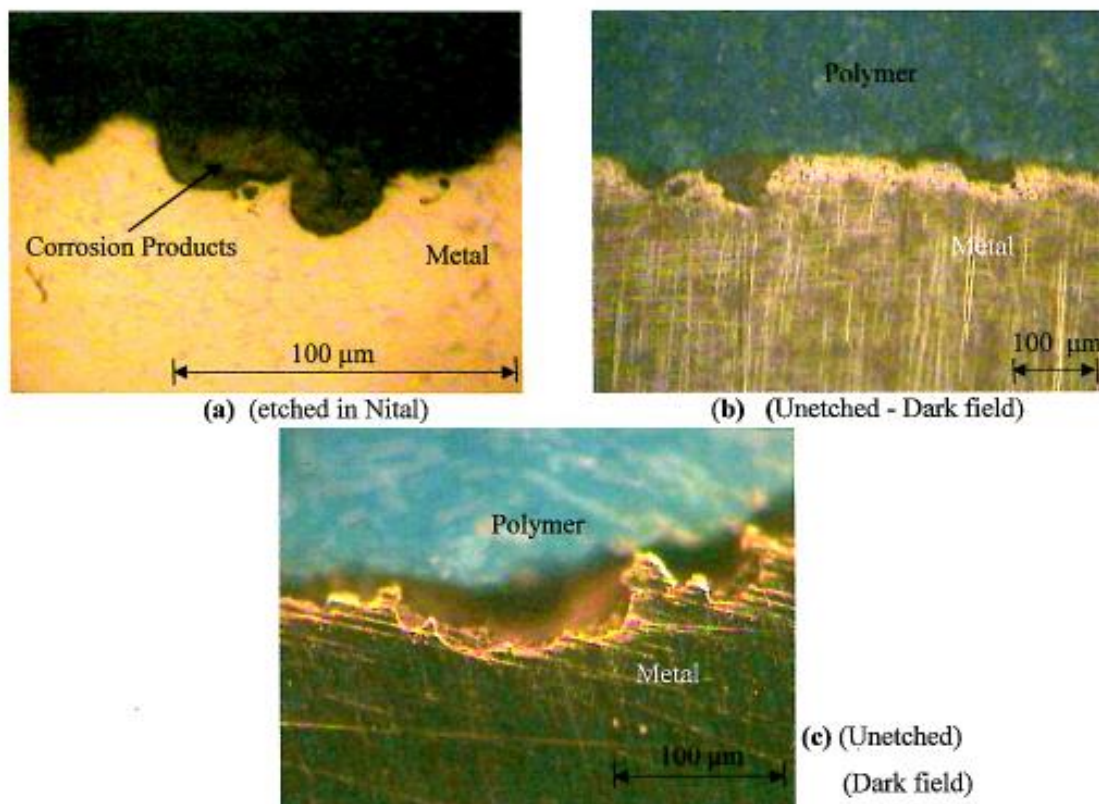
Figure 11: Micrographs of the Cross Section of the Corroded Strut

With the microscopic observation it was very clear that the surface of the strut was severely corroded. In the Figure 11(a), with higher magnification, it is possible to observe pitting corrosion (wide and shallow pits) in addition to the general corrosion. The surface corrosion attack is very clear in dark field observation also (Fig. 11(c)). With these observations it can be concluded that the corrosion attack on the strut was significantly high, mainly in the area where the strut fixed to the wheel hub (Fig. 6).

A special coating was found on the inner side of the strut which has protected only the inner surface. However, it was found that even that coating was damaged and in damaged places some corrosion has taken place.
