# **FINAL REPORT**

**ACCIDENT OF SRILANKAN AIRLINES FLIGHT UL316  
AIRBUS A330-243, 4R-ALA  
ON 16<sup>TH</sup> OCTOBER 2005  
AT BANDARANAIKE INTERNATIONAL AIRPORT, COLOMBO,  
KATUNAYAKE – SRI LANKA**

Released by the Director General of Civil Aviation Sri Lanka

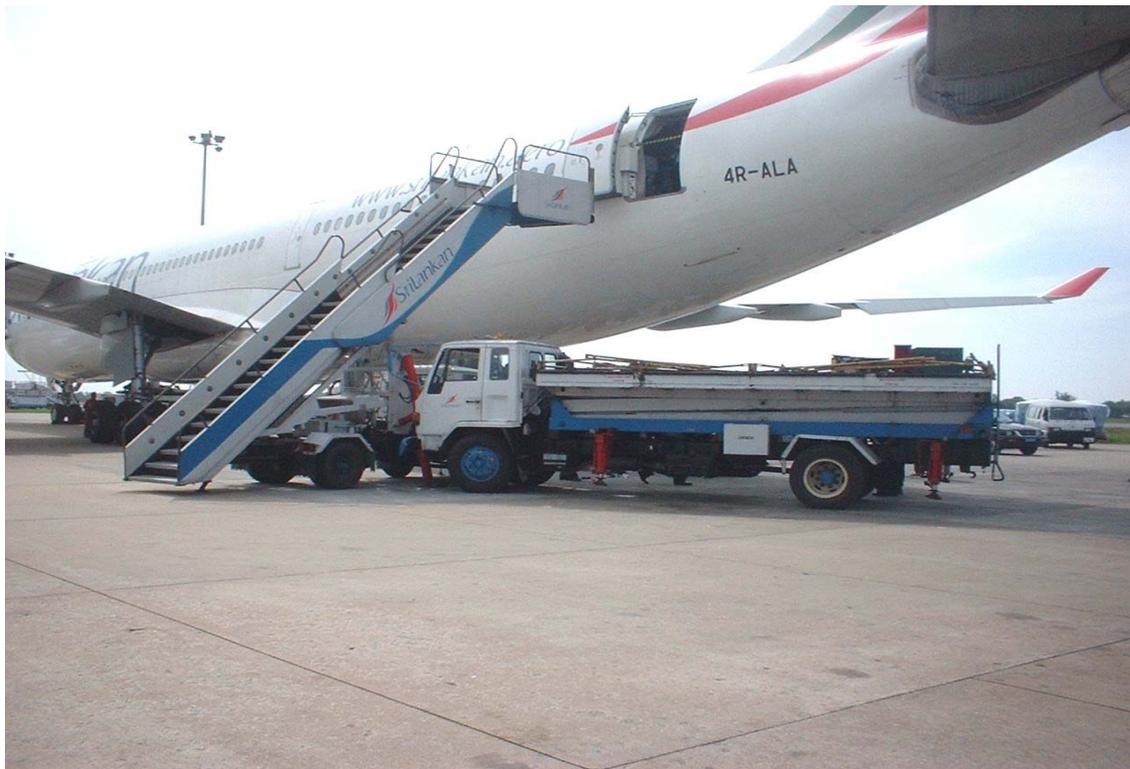
**The Maintenance step vehicle after colliding with the stepladder**

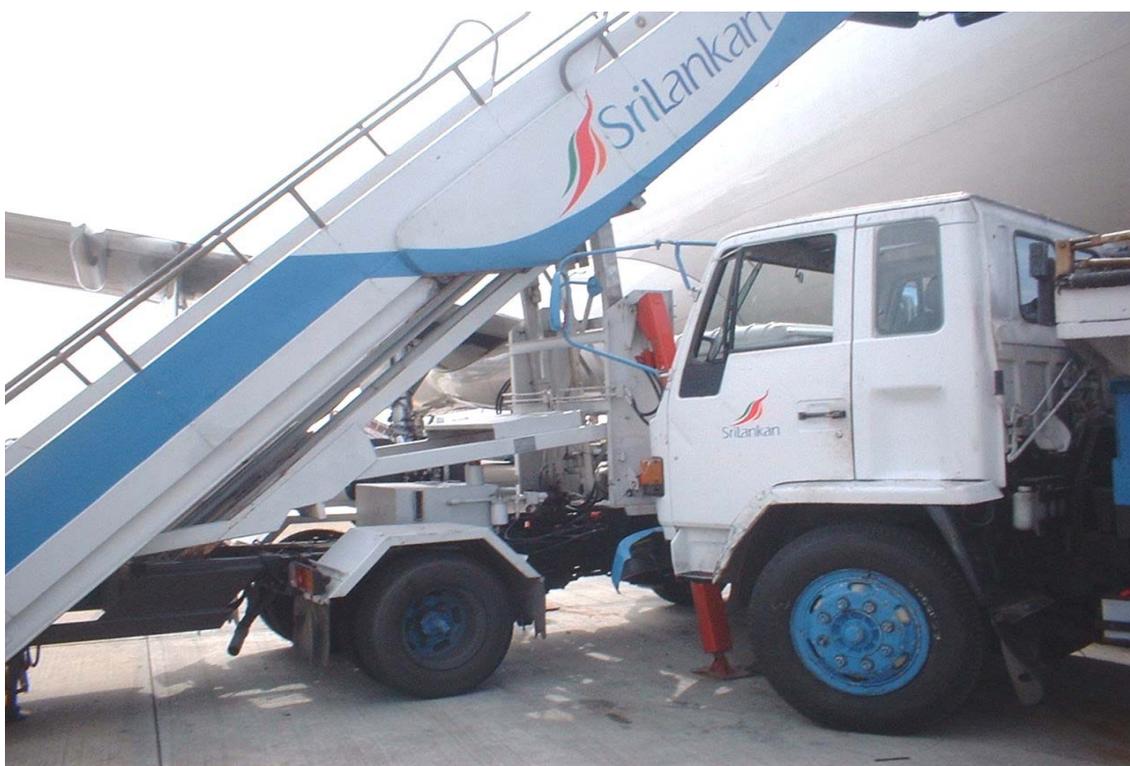
**The Maintenance Step vehicle stopped after colliding with the stepladder**

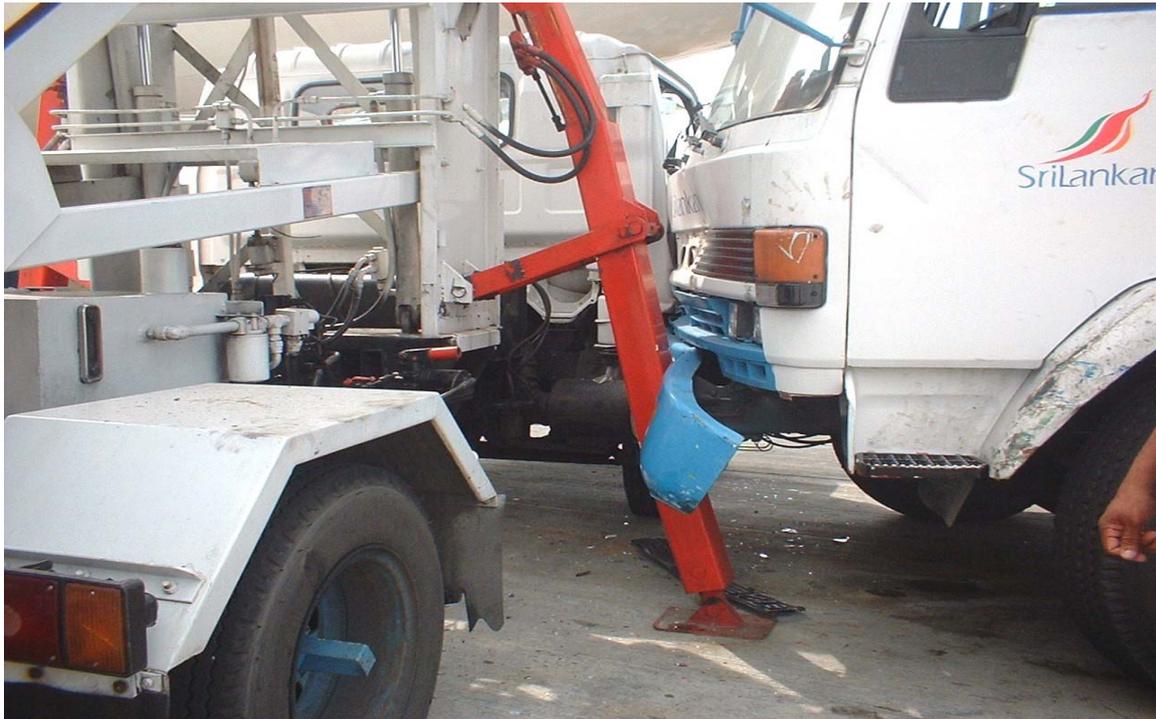
**1.4. Other Damages:** The subjective MPV and the stepladder, which was positioned at L4 door, were damaged.

**The damaged equipment after collision.**

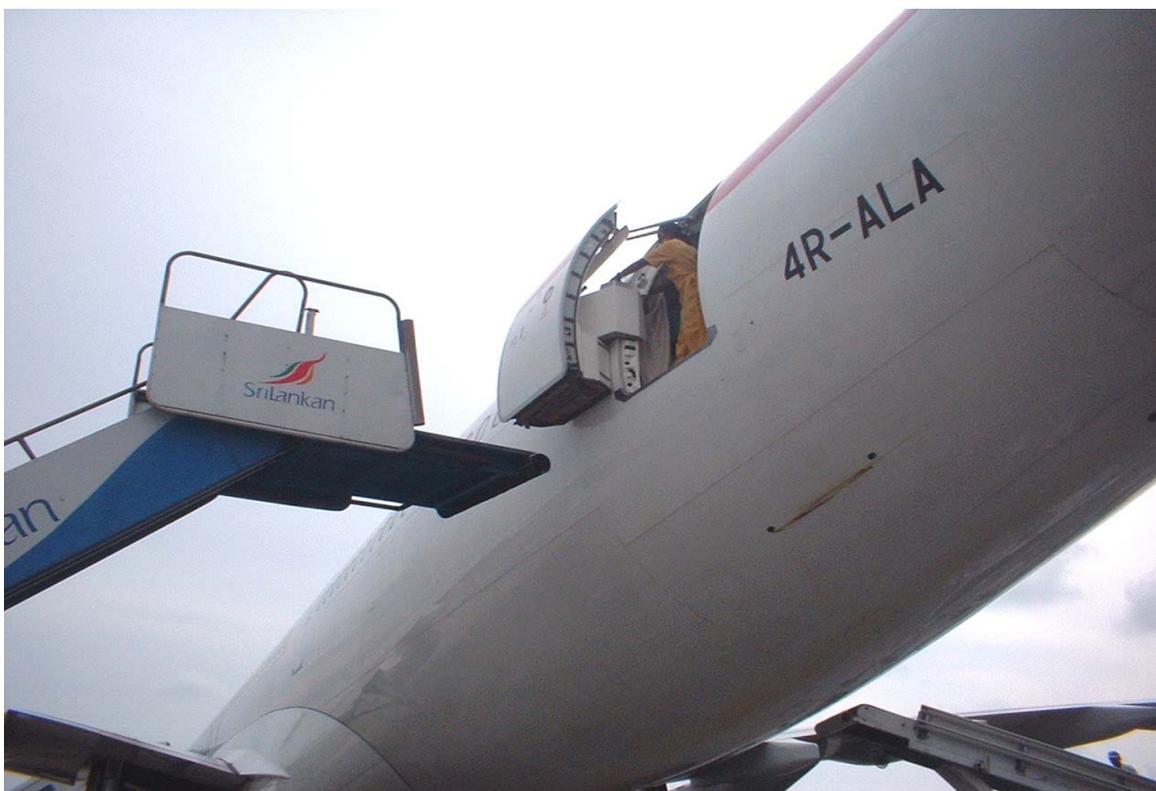
The stepladders were positioned at L1 and L4 doors for passenger disembarkation. All business class passengers disembarked through the L1 door stepladder and economy-class passengers started disembarking subsequently. While the passengers were disembarking through L4 door stepladder, the maintenance platform vehicle (i.e. MPV/Hi-Lifter), which approached the aircraft to position under the APU for maintenance collided with the L4 door stepladder displacing it and causing a passenger to fall through the gap thus created.

**The gap created between the aircraft and the displaced stepladder**

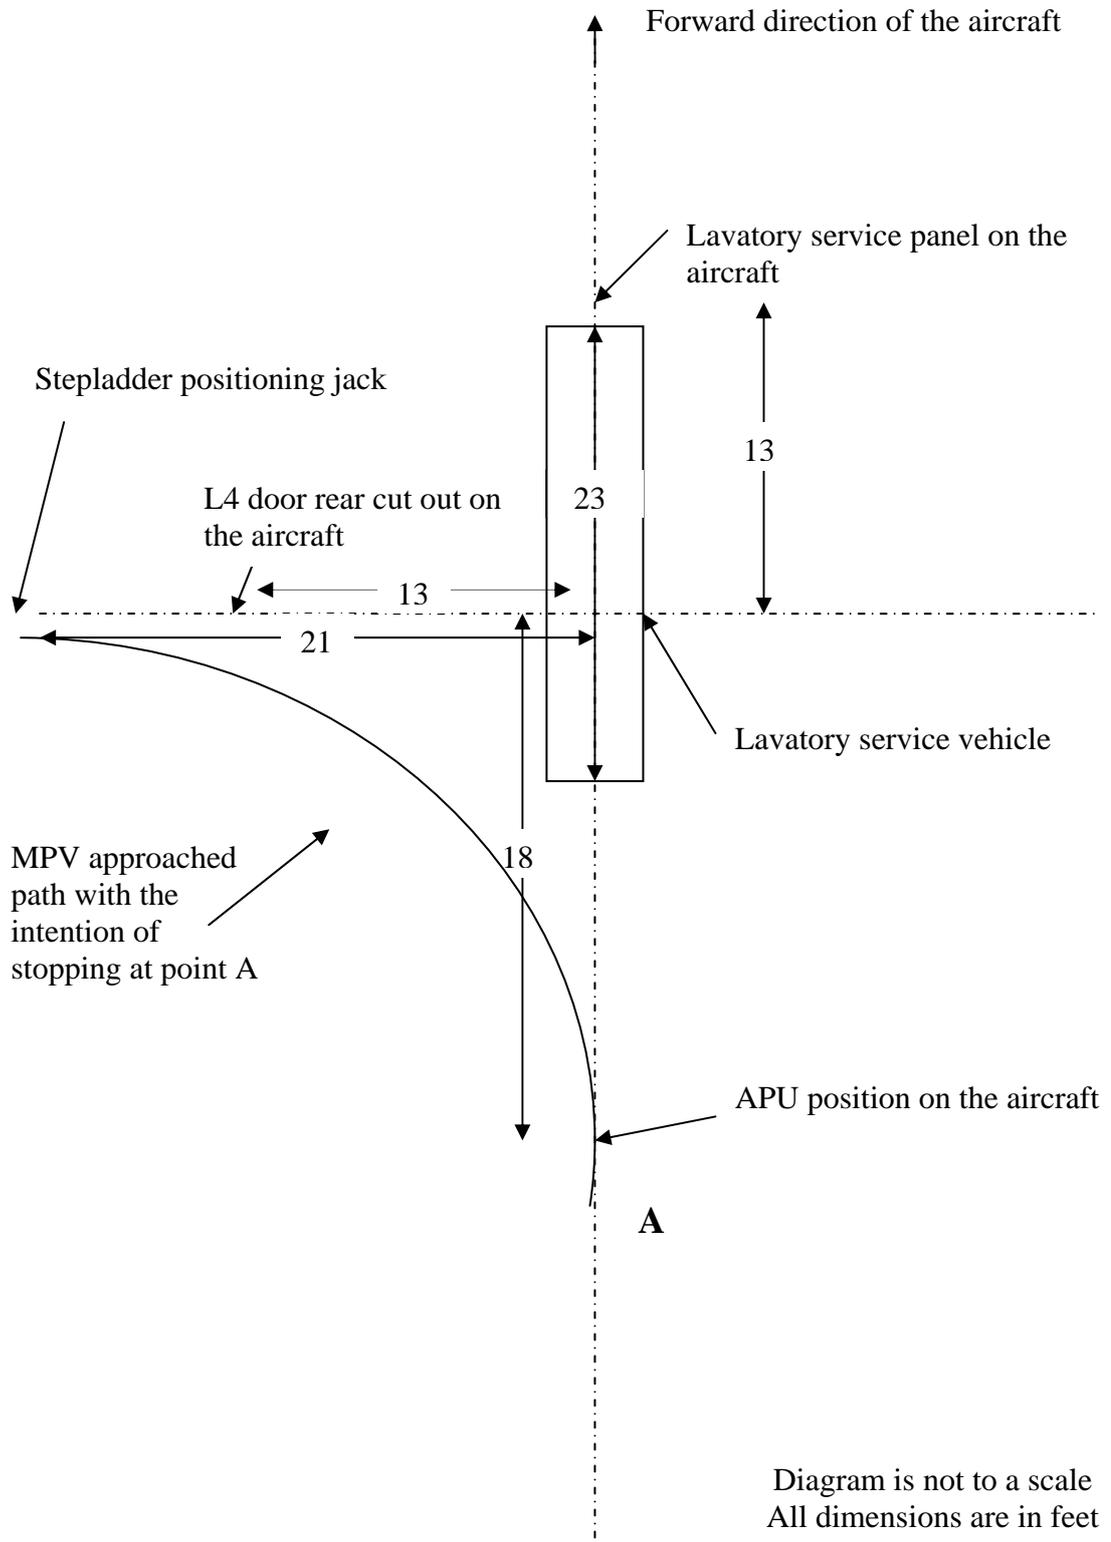
**APPENDIX – 2 - SKETCH OF THE ACCIDENT SITE**

**2.2. Handling of vehicle at the aircraft:** The MPV operator stated in his statement that he turned the equipment to the left side to avoid the collision with lavatory service vehicle, which was parked right under the aircraft tail section under the lavatory service panel (refer to Appendix - 2). Positioning of service vehicles and equipment are specified by Airbus Industries in one of its documents entitled "Airplane Service Arrangement" which recommends inter alia positioning the lavatory vehicle at right side of the airplane tail section. According to this document, the parking of the lavatory vehicle under its lavatory service panel was not in conformity with the recommendations in the aforementioned document. There were no written procedures relating to safe operation of vehicles or equipment in the vicinity of aircraft for the guidance of vehicle/equipment operators.
