## FINAL REPORT

**Aircraft Incident of Sakurai Aviation Academy,  
Piper PA 38-112 Tomahawk, bearing registration no 4R-ASJ, emergency landing  
at Payagala Beach, Kaluthara, Sri Lanka on 22<sup>nd</sup> December 2021**

Released by the Civil Aviation Authority of Sri Lanka

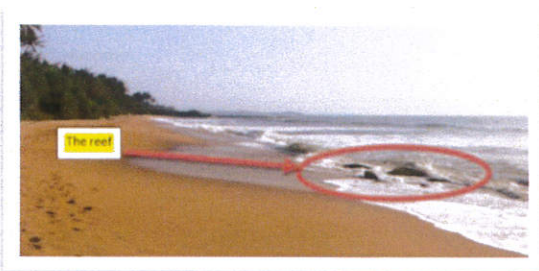
Figure 02: Presence of a reef

There was no extensive damage to the aircraft, except the damage on the aircraft left main wheel assembly. As the left main wheel had hit a reef during landing, it was found with a big hole on the outer side wall of the tyre and the wheel hub was found with an impact damage.

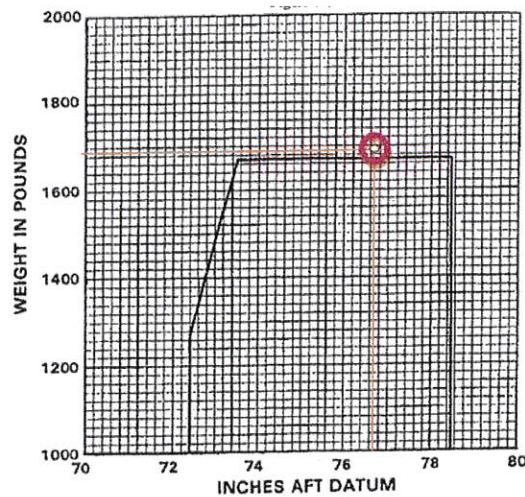
Figure 9: Weight / Balance chart

As per the weight and balance graph, loaded moment remained within the given limit of Centre of Gravity (CG) by the Manufacturer. However, it was observed that the aircraft was overloaded since the total weight exceeds the Maximum Take-Off Weight (MTOW) by 41 Lbs. (Refer Appendix: 08)

- c) It was found that the aircraft was overloaded since the total weight exceeds the Maximum Take-Off Weight (MTOW) as per the calculation carried out by the Investigation Team.

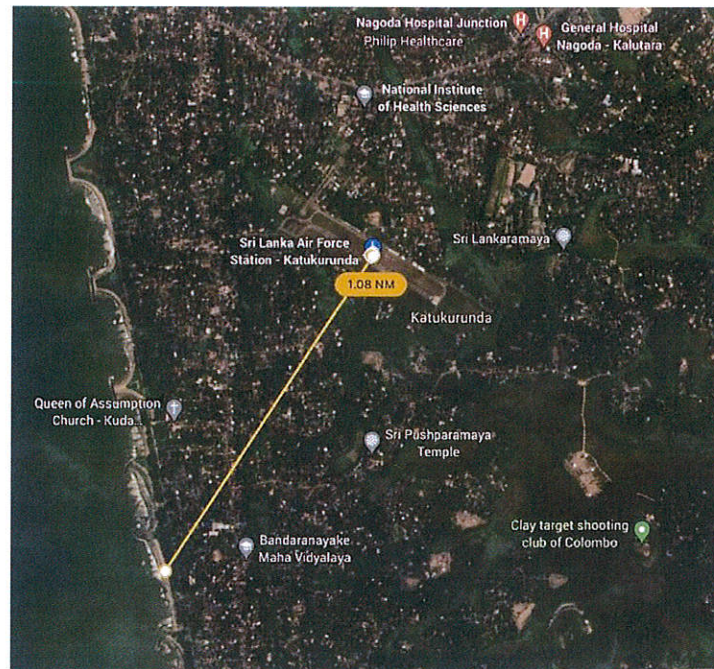
Figure 10: Distance from landing site to VCCN

The distance from the landing site to VCCN air field was approx. 1.08NM as measured by the GPS coordinates. As per the glide path and the radar image, the approx. distance to the VCCN air field from the point where the engine RPM drop identified was approx. 1.2 NM.

Hence, if the PIC had been closely monitoring the engine instruments continuously, he might have identified the engine RPM drop at the initial stage. Furthermore, if he had taken a timely decision, he could have carried out emergency landing at VCCN air field instead of Payagala beach, subject to the prevailing wind conditions.

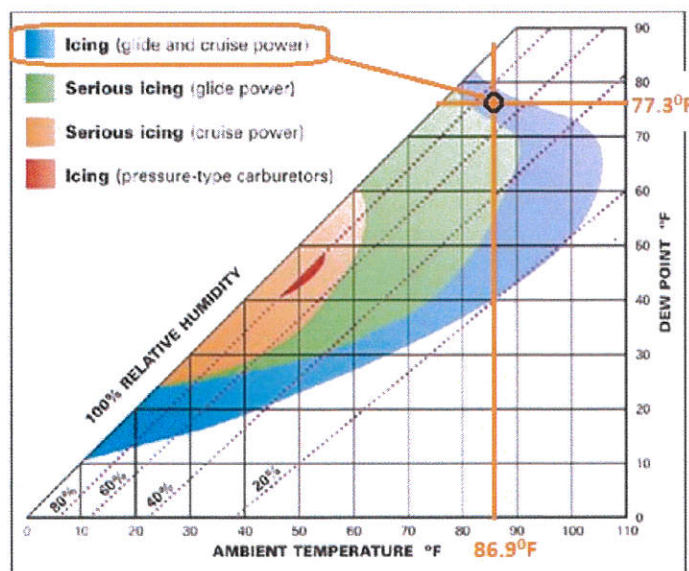
Figure 14: Carburetor icing chart (source: Special Airworthiness Information Bulletin on Carburetor Icing Prevention ref: CE-09-35 dated 06<sup>th</sup> June 2009 issued by Federal Aviation Administration.)

At the time of this incident, the interpolated temperature and the dew point were 30.5 °C (86.9 °F) and 25.16 °C (77.29 °F) respectively. In these conditions, there was a possibility of carburetor icing at glide and cruise power settings.

Hence, in the absence of the conclusive evidences to identify any defect on the engine, fuel or fuel system components and failure of engine controls for RPM drop and based on the available facts, other evidences and statements, it can be determined the formation of carburetor icing was one of the probable cause for this incident.

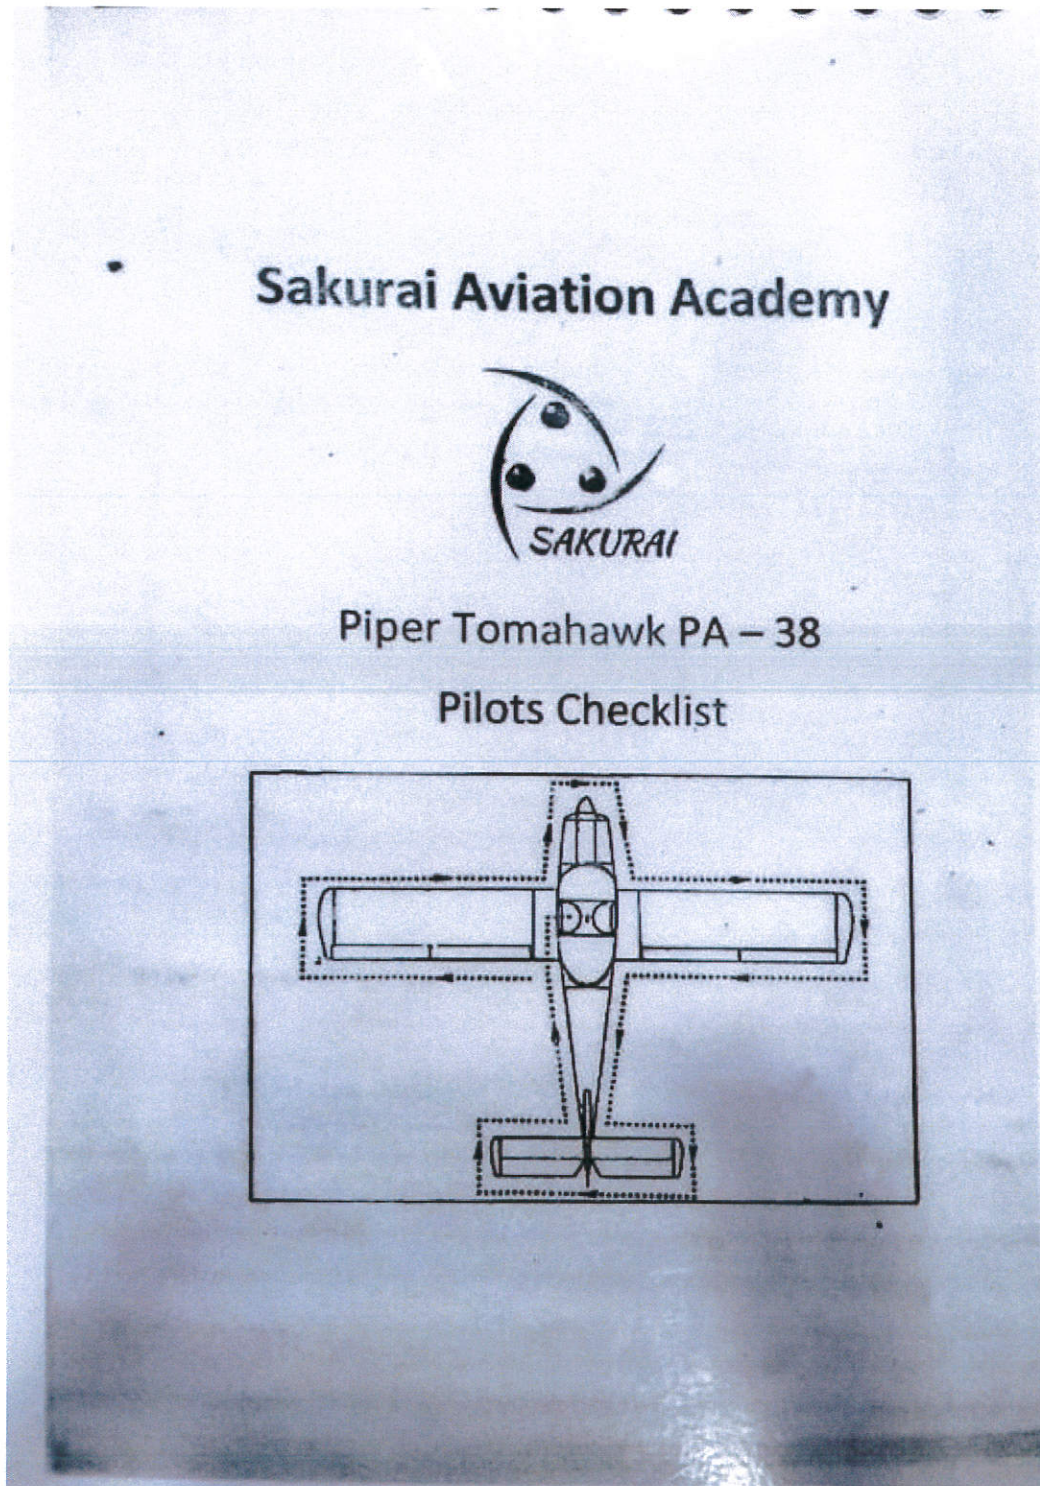
**APPENDIX 10: PIPER TOMAHAWK PA-38-112-PILOTS CHECKLIST USED BY THE  
TRAINING ORGANIZATION**

A review of the PA-38-112 check list issued by the Training Organization to Instructors and the students, found to be inadequate and not in compliance with respect to the check list information contained in the Piper Tomahawk Pilot's Operating Handbook (POH) issued by the Aircraft Manufacturer.

- i) Some areas of the check list mentioned above (h), is illegible and contained alterations (refer Appendix 10).
- j) The PA- 38 POH which was on board 4R-ASJ, found not divided into numbered Sections with a "finger-tip" tab divider for quick reference as per Introduction of Section 1 of the POH.
