FINAL REPORT

**INCIDENT OF SRILANKAN AIRLINES
AIRBUS A340-313, 4R-ADG
AT LONDON HEATHROW AIRPORT, UNITED KINGDOM
ON 05TH FEBRUARY 2012**

Investigated by Air Accident Investigation Branch of United Kingdom

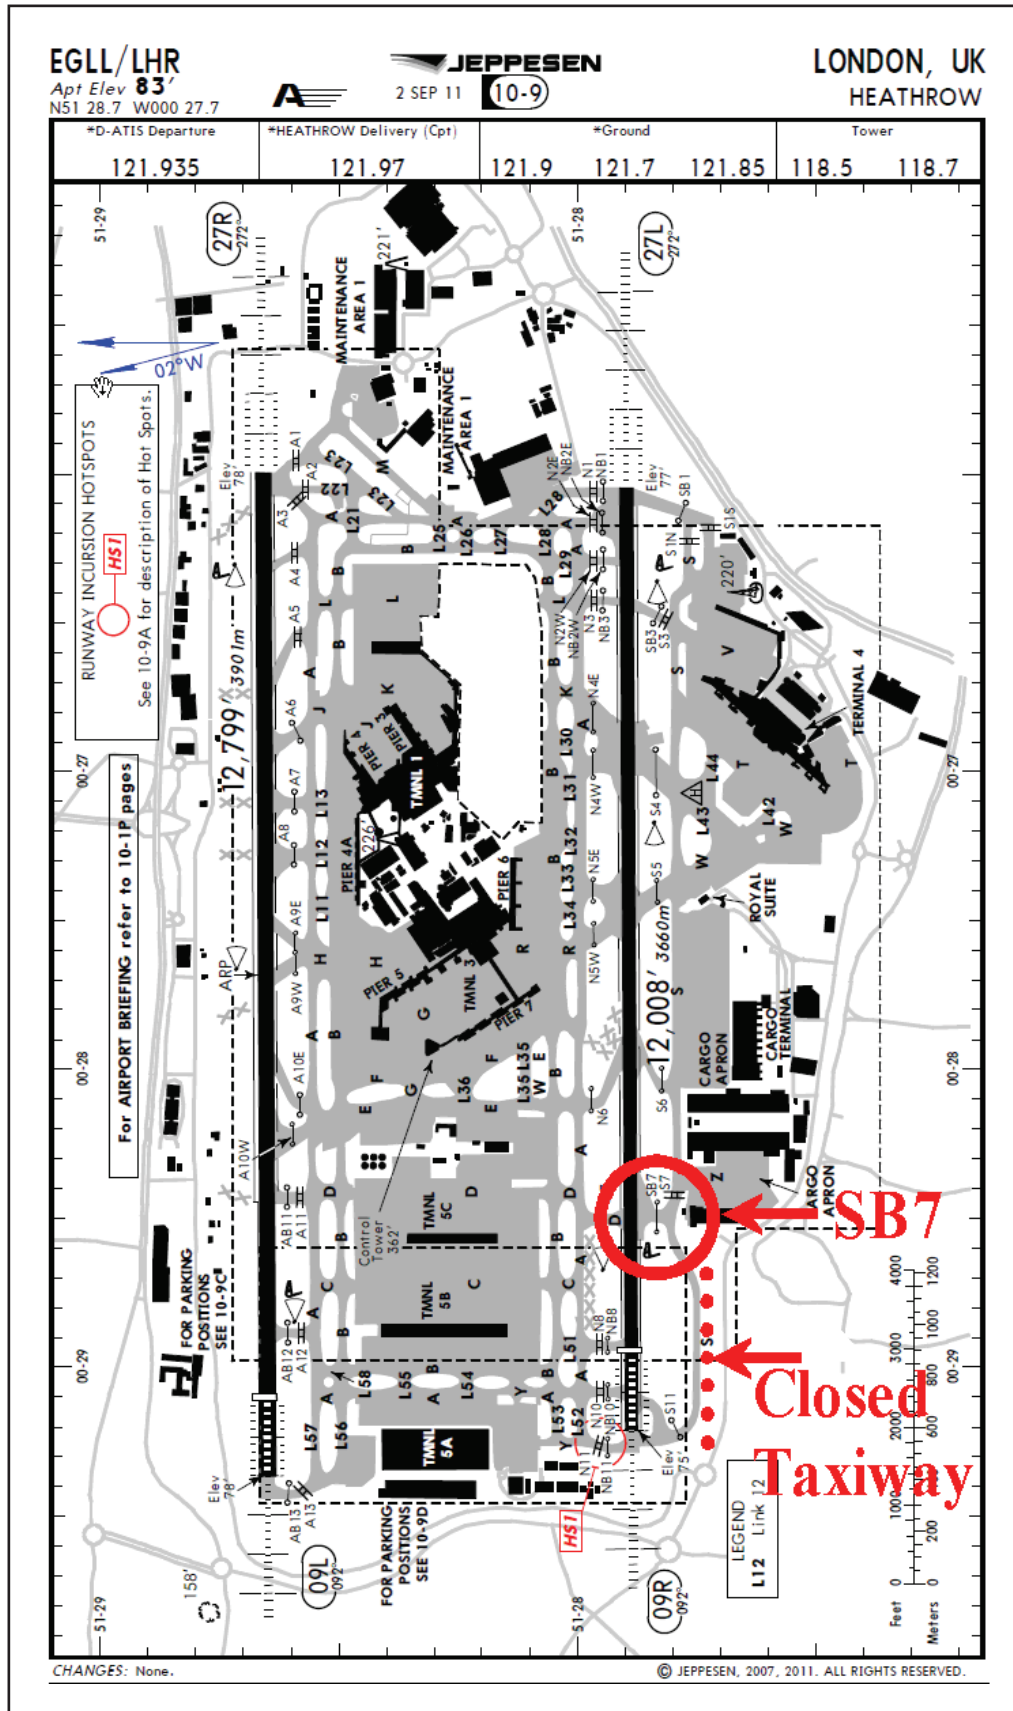
Figure 1
Heathrow Airport chart

At the time of the incident, the departure runway was 09R. The airport operator was expecting to initiate low visibility procedures (LVP) and Taxiway S, between SB7 and S11, was closed as a normal part of the preparation for such operations. Crews departing from Terminal 4 were offered the option of departing from the SB7 intersection or, if the aircraft required a longer runway, then they could be required to cross to the north of Runway 09R for departure. A chart of the airfield showing the SB7 intersection and the section of taxiway closed is shown in Figure 1.
