Final Report

AIRBUS A320, REGISTRATION 4R-ABN DAMAGE TO RUNWAY EDGE LIGHTS ON LANDING

21 MARCH 2019

AIB/AAI/CAS.178

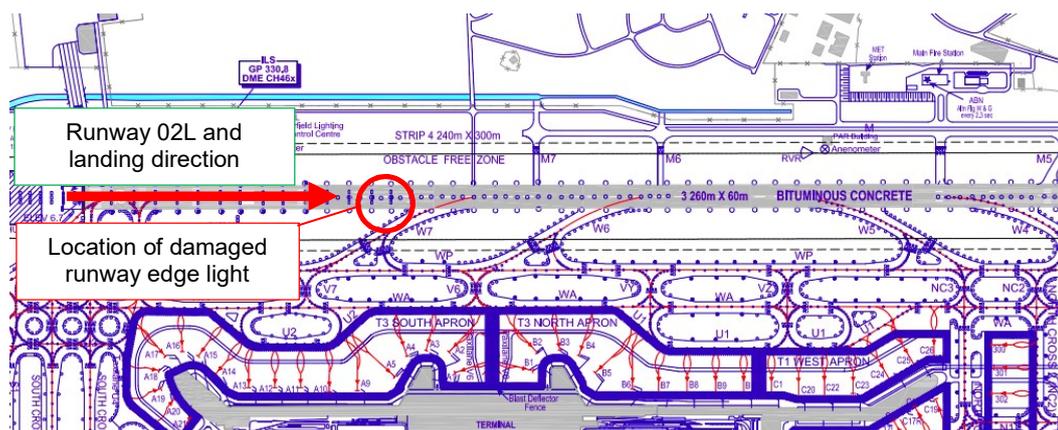
1.4.1 One runway edge light near rapid exit taxiway (RET) W7 was damaged (**Figure 1**). There were tyre marks on the runway pavement leading to the damaged edge light. (**Figure 2**).

Figure 1. Location of damaged runway edge light

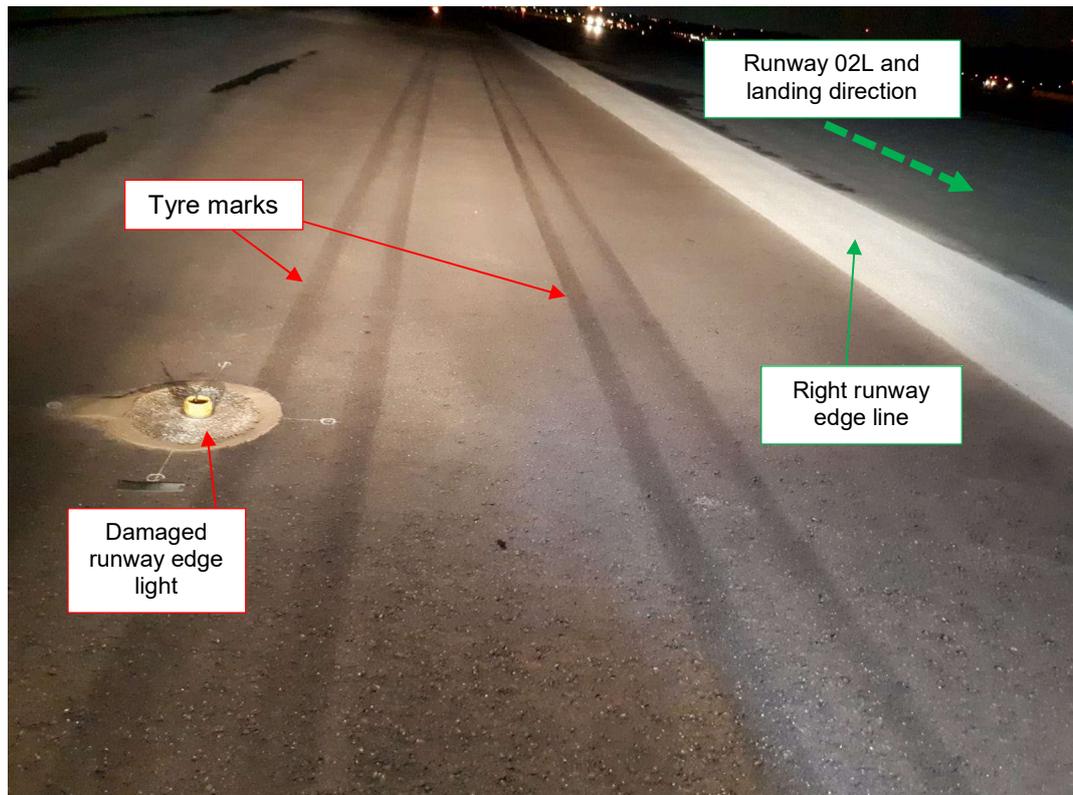
Figure 2. Damaged runway edge light and tyre marks

1.8.1 The recording of the aerodrome's runway surveillance camera showed that the aircraft had contacted the runway edge light causing the light to be broken and flung into the air.

- 3.2 The aircraft touched down to the right of the runway centreline and veered past the right runway side stripe marking, damaging a runway edge light in the process.
