## **FINAL REPORT**

**Incident of lateral runway deviation of SriLankan Airlines Flight UL707, Airbus Industries A320-214, bearing registration 4R-ABN during landing at Seychelles International Airport, Seychelles on 17<sup>th</sup> December 2022.**

Released by the Civil Aviation Authority of Sri Lanka

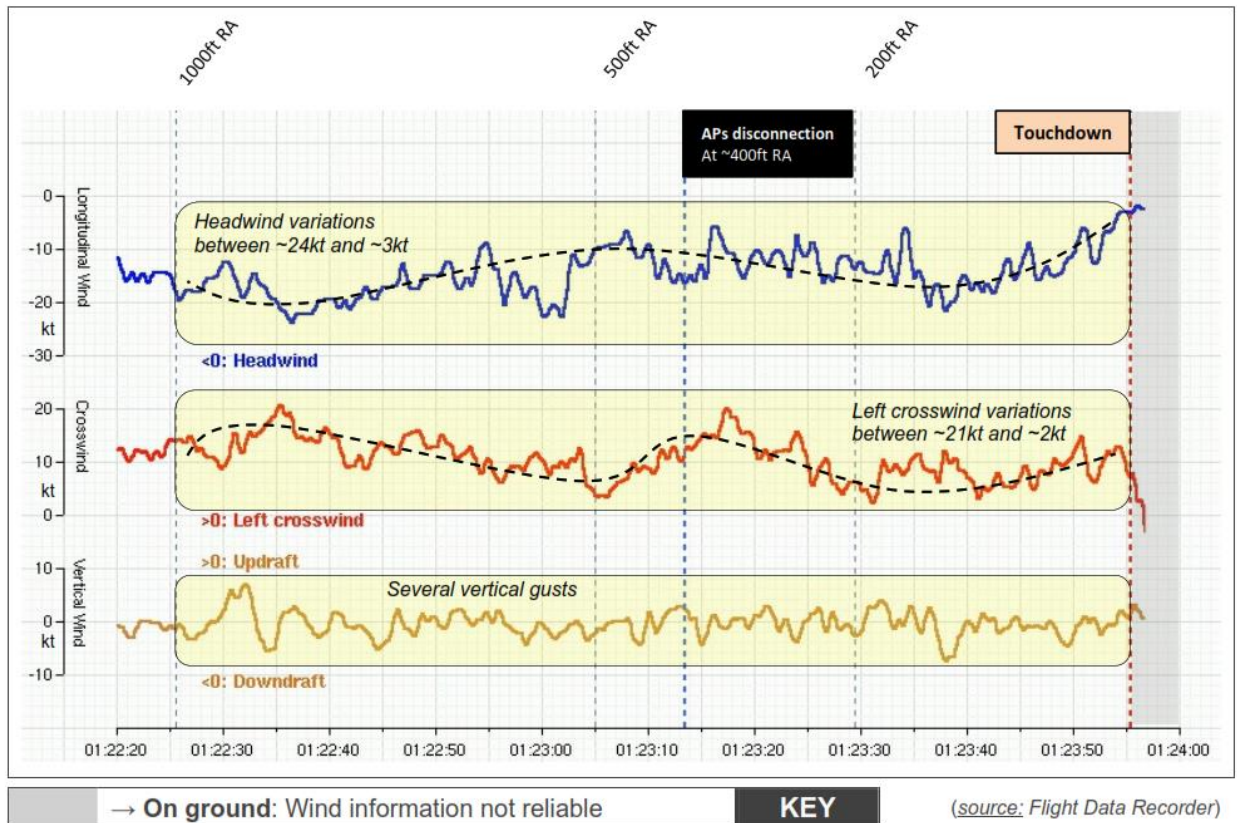
Figure 01: Reconstructed wind along the runway axes

Between 1000ft RA (01:22:26 UTC) and touchdown (01:23:55 UTC), the average wind comes from 265° at 20kt (with variations up to 33kt):

- Headwind component varied between ~24kt and ~3kt.
- Left crosswind component varied between ~21kt and ~2kt.
- Several vertical gusts were encountered.

According to the DFDR analysis report, all available weather information sources are consistent and highlight gusty wind conditions during final approach and landing. When considering a wet runway, the most restrictive crosswind is 20kt according to FCOM Limitation. Thus, the crosswind experienced by the aircraft in the last feet (~10kt) was compatible with the landing.

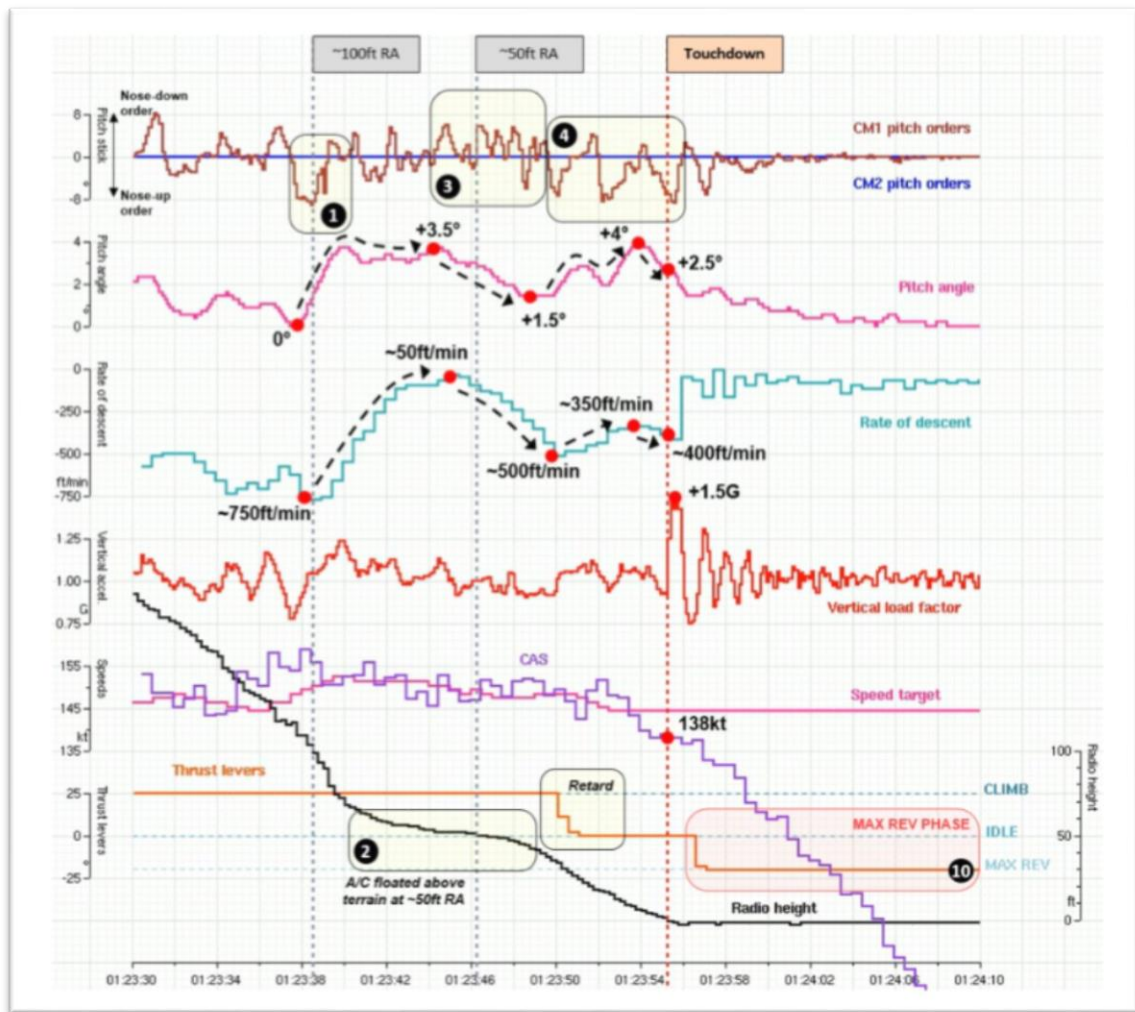
Figure 04: The Last 110ft – Longitudinal axis

**On the longitudinal axis (Please refer to above Figure)**

- e) At ~110ft RA, a half of full nose-up order ( ❶ ) was applied by CM1 (PF) and led: the pitch angle to increase from 0° to +3.5° and the rate of descent to decrease from ~750ft/min to ~50ft/min.

As a consequence, the flight path angle decreased from -3° to 0° and the aircraft thus floated above the runway at ~50ft RA ( ❷ ).

- f) at ~50ft RA, most probably in order to stop floating above the runway, PF applied for several nose-down and nose-up orders up to ~2/5 of full deflection ( ❸ ), with a nose-down tendency, leading the pitch angle to decrease & stabilize around +1.5° and the rate of descent to increase up to ~500ft/min.

In the last 35ft, PF applied for several nose-up orders up to half of full deflection and some slight nose-down orders ( ❹ ). Consequently, the pitch angle gradually increased from +1.5° to +4° then decreased to +2.5° prior to touchdown and the rate of descent decreased from ~500ft/min to ~350ft/min then increased up to ~400ft/min before touchdown.

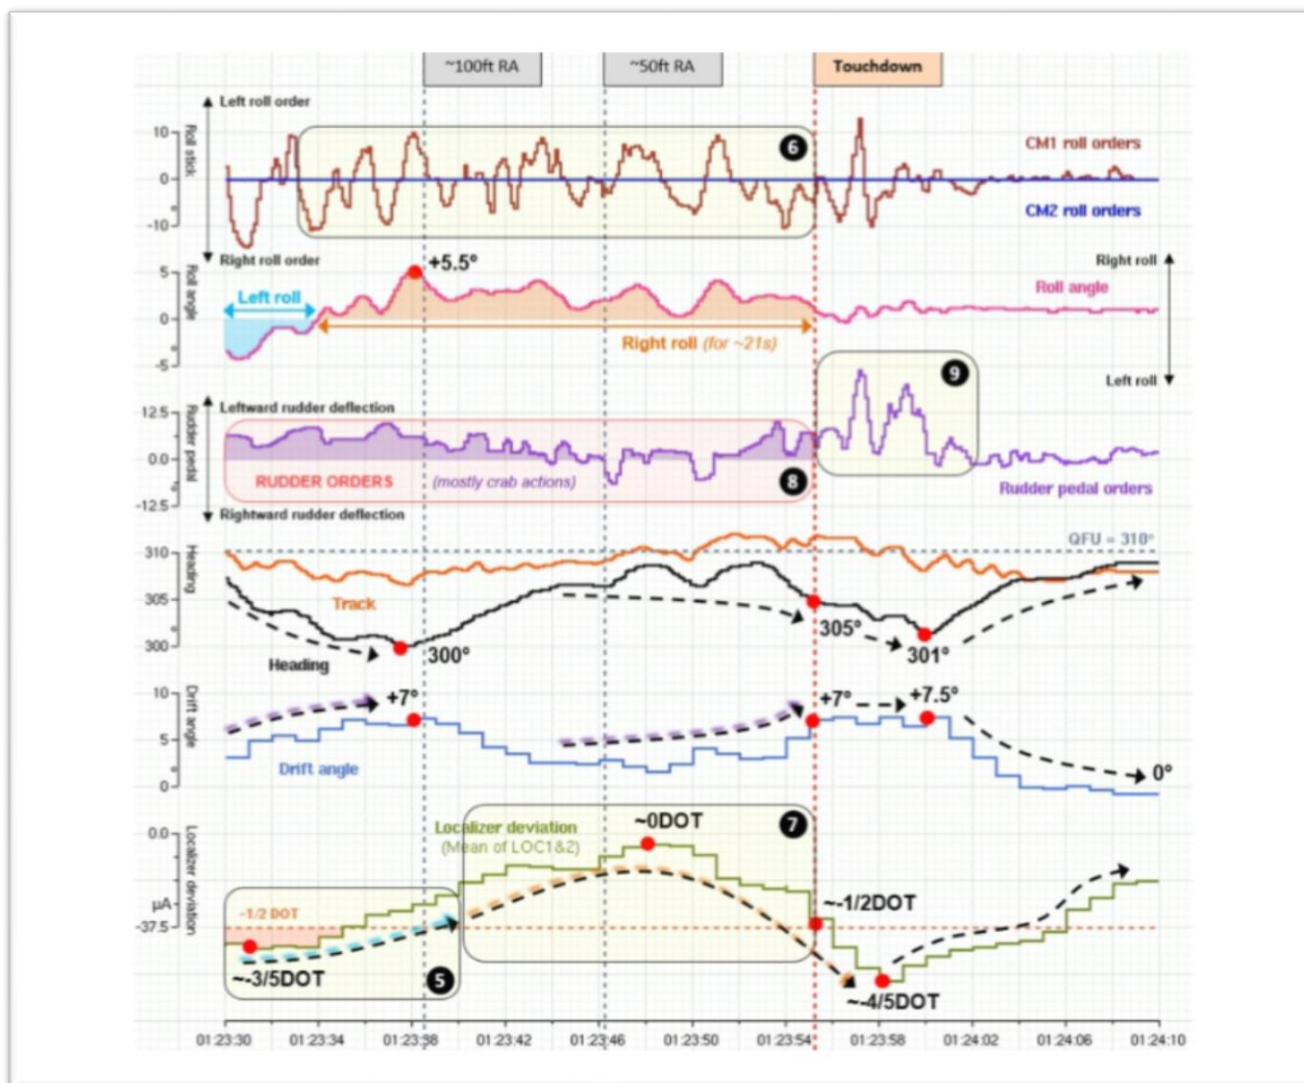
Figure 06: The last 200ft/Lateral & Directional axes

At ~400ft RA, just after APs disengagement, PF applied three right roll orders up to a quarter of full deflection leading the roll angle to increase up to +7° (right roll). Simultaneously, the flight crew applied a slight rightward rudder pedal input.

This **right roll angle**, associated with the rudder input, led the localizer deviation to increase up to around - 3/5DOT (reached around 180ft RA): **The aircraft deviated to the right of the correct lateral flight path.**

This deviation was progressively corrected with a commanded left roll order: the localizer deviation thus started to decrease (5).

In the last 160ft, several right and left roll orders up to half of full deflection (6) were applied by CM1 leading the roll angle to increase up to +5.5° (right roll).

With a **right roll angle maintained for ~21s**, the localizer deviation stopped to decrease and reached ~0DOT at ~40ft RA, then started to increase again prior to touchdown (7): **The aircraft deviated to the right of the runway centerline.**

In addition, during the float above runway, **the left crosswind component slightly contributed to increase the deviation of the aircraft to the right of the runway centerline.**

Most probably in order to try to counter the right deviations (around 200ft RA and prior to touchdown), the flight crew applied several rudder pedal orders (mostly crab actions) up to ~2/5 of full deflection (8).

**These orders participated twice to increase the left drift angle up to +7°, but did not change significantly the aircraft trajectory to cancel the increasing lateral deviation.**

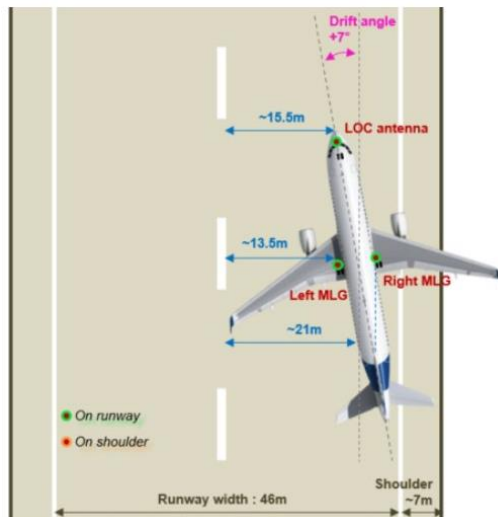
According to the roll angle recorded at touchdown (+1°), the right main landing gear touched down first followed by the left main landing gear. The aircraft touched down at ~900m after the runway threshold with a **localizer deviation around -1/2DOT to the right of the runway.**

The aircraft was thus on the right of the runway. The LOC antenna located at the cockpit level was at ~7.5m from the runway shoulder, but with the high left drift angle (+7°) at touchdown, the right main landing gear was close to the right side stripe marking of the runway (at ~2m from the runway shoulder).

Note: Aircraft lateral position was computed based on localizer deviation, threshold/aircraft distance and runway length. Computation at touchdown returned a LOC antenna position (being located under the radome) around 15.5m on the right of the runway centerline.

Then based on drift angle and aircraft geometry, another computation gave:

- A left main landing gear position around 13.5m on the right of the runway centerline.

- A right main landing gear position around 21m on the right of the runway centerline.

With a runway width of 46m, the side stripe marking was at 23m on the right of the runway.

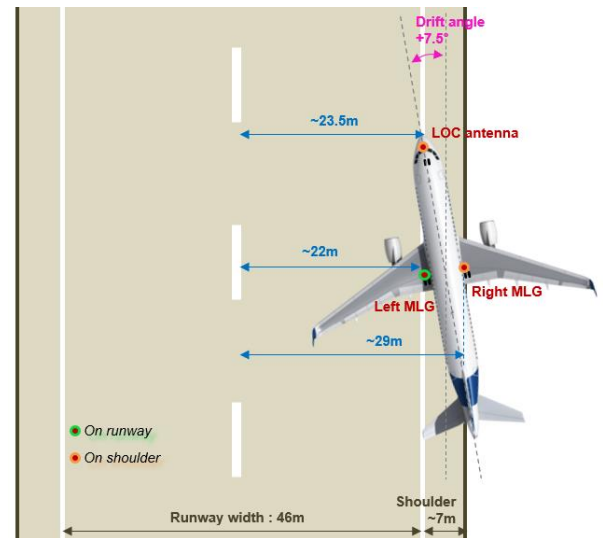
There is a shoulder of around 7m between the runway side stripe marking and the unpaved surface.

During the lateral runway deviation, MAX REV thrust (10 - figure) was applied by the flight crew for ~17s.

As recommended in the following FCTM extract, in case of lateral control problem, **the flight crew should consider to set the reverse thrust to REV IDLE** instead of MAX REV, as the reversers have a destabilizing effect on the airflow around the rudder and thus decrease the efficiency of the rudder. Furthermore they create a side force, in case of a remaining crab angle, which increases the lateral skidding tendency of the aircraft.
