FINAL REPORT

**Aircraft Accident of Sakurai Aviation Limited, Cessna 172L Skyhawk
bearing registration mark 4R-GAF crash-landed
at Kimbulapitiya, Negombo, Sri Lanka on 27th Dec 2021**

Released by the Civil Aviation Authority of Sri Lanka

Issued on: 13th July 2023

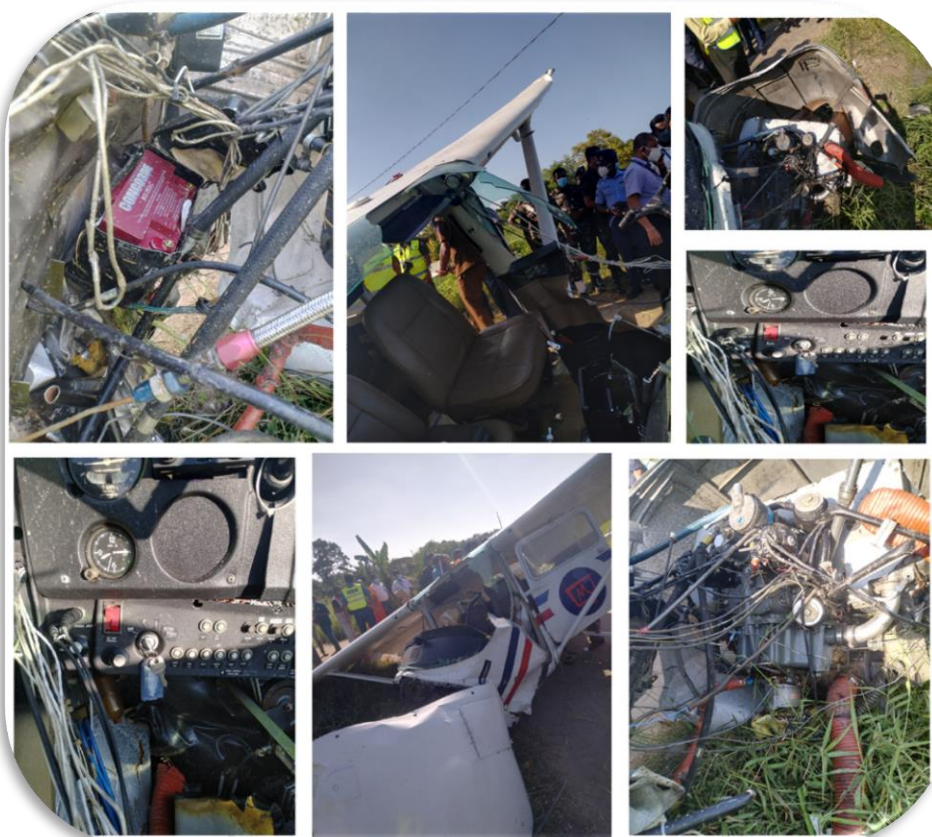
Figure 04: Wreckage of 4R-GAF

The aircraft sustained substantial damages to the RH main landing gear, the landing gear attachment structure and fuselage, the propeller, engine mounts, and cowlings.

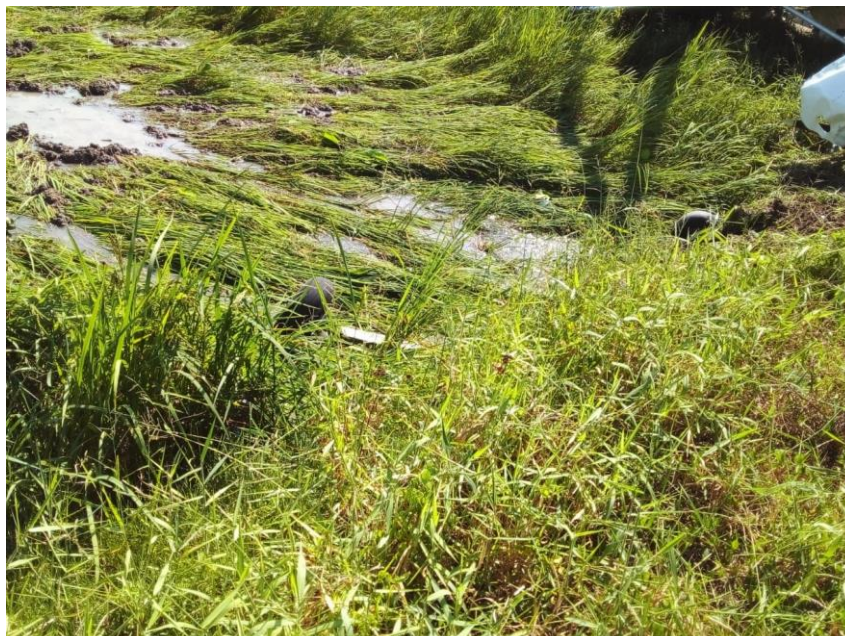
Figure 07: Landing area at Paththayam Watta, Kimbulapitiya

The aircraft had carried out a crash landing in a paddy field located at Paththayam Watta, Kimbulapitiya, Negombo located in Gampaha District in Sri Lanka. There were prominent ground marks visible in the rice paddy.

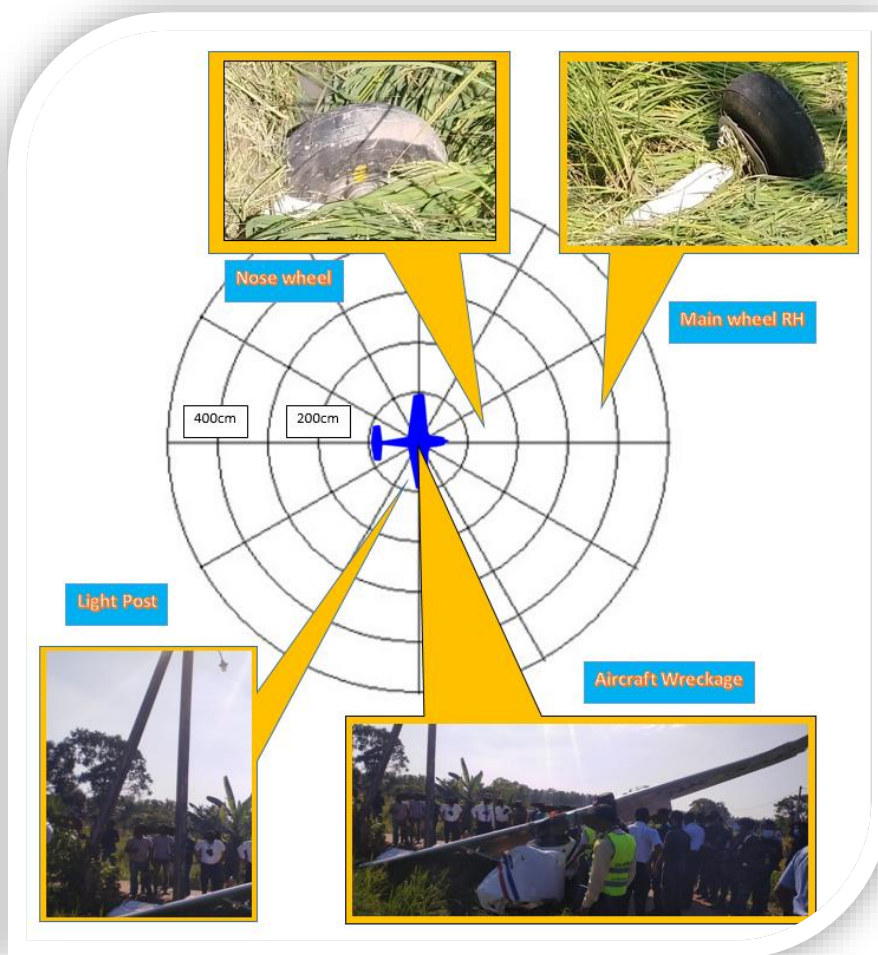
Figure 09: Wreckage distribution chart

The aircraft had crash landed on a paddy field. The nose wheel and right-hand main wheel had been separated and fallen at the crash site at distances from 13m and 38m from the aircraft. A Prominent ground marks were visible after landing in the rice paddy.

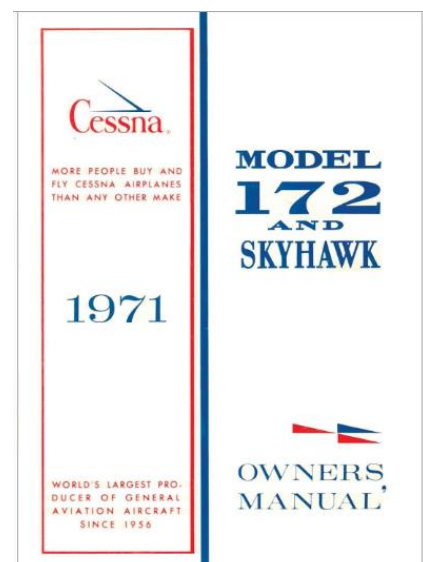
Figure 11: First page of the Owner's Manual

- There were discrepancies in items included in the laminated checklist with respect to the Owner's Manual which was on board. In addition, the pages of the onboard Owner's Manual were not in order.

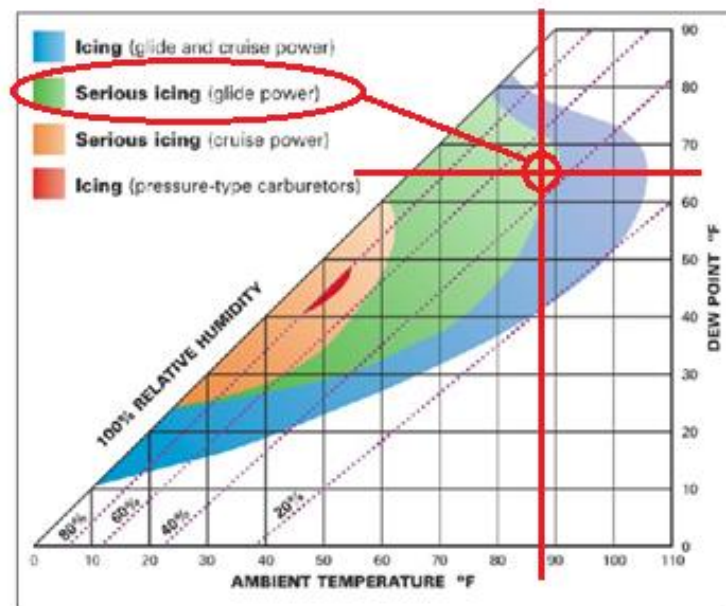
Figure 20: Carburetor icing chart – derived point for this scenario

At the time of this accident, the interpolated temperature and the dew point were 31.2°C (88.16 °F) and 18.4 °C (65.12 °F) respectively. In these conditions, there was a high possibility of carburetor icing at glide and cruise power settings.

According to the evidence, tests, and examinations, it can be concluded that the carburetor ice was the probable cause for this accident.

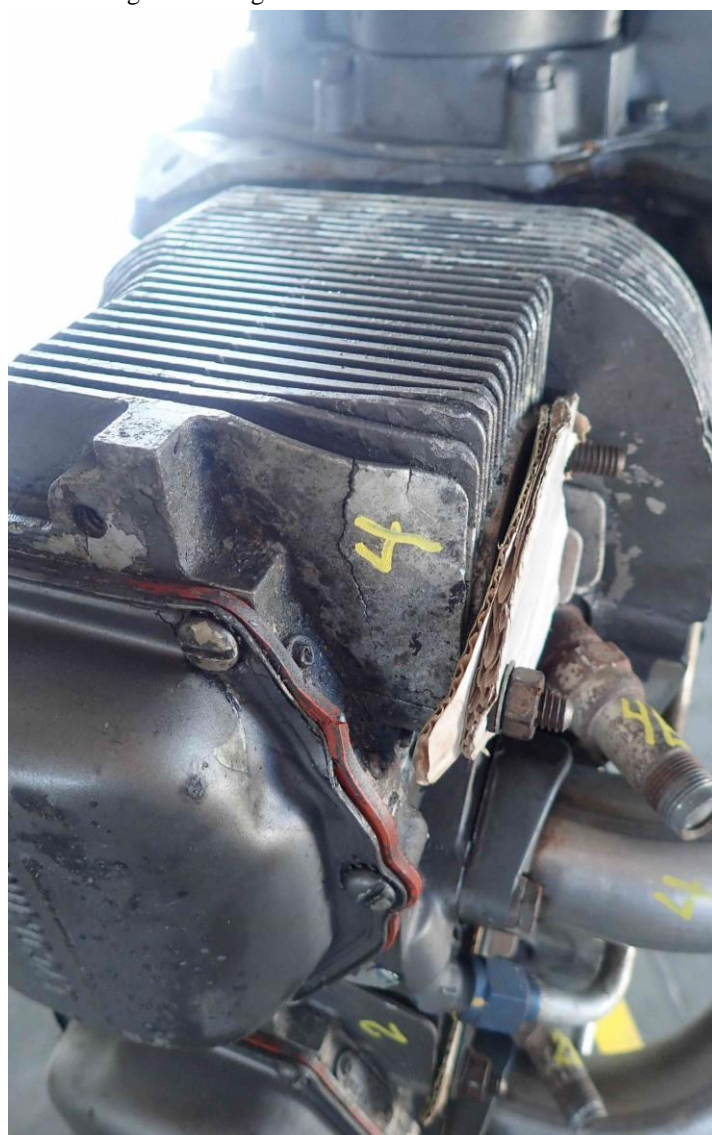
The engine was intact and appeared to have sustained damage limited to bending of the number 4 cylinder cooling fins in the area of the exhaust port (figure 2); crushed number 4 cylinder intake tube (figure 3); small dent to the number 3 cylinder rocker box cover and an associated broken oil fitting (figure 4).

Figure 2 – Number 4 cylinder fin damage

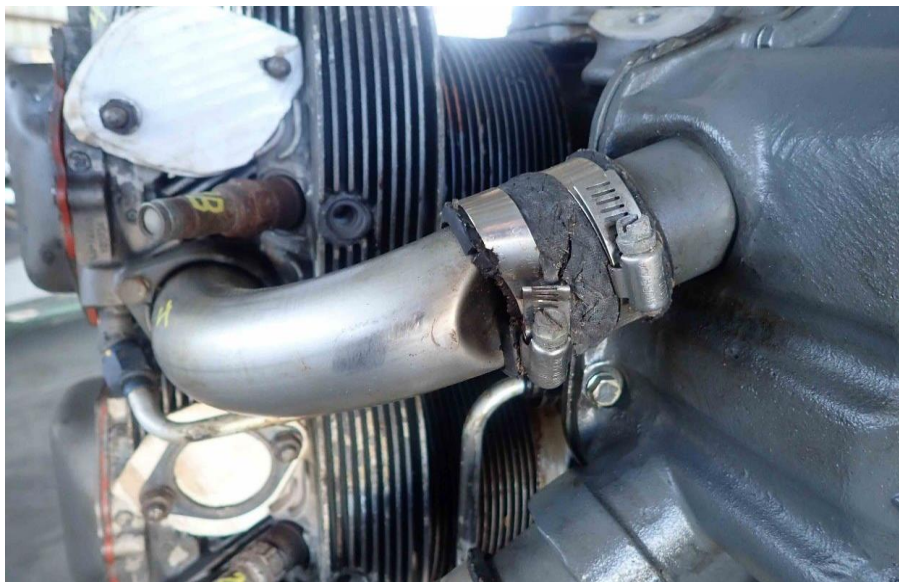
Figure 3 – Number 4 cylinder inlet manifold damage

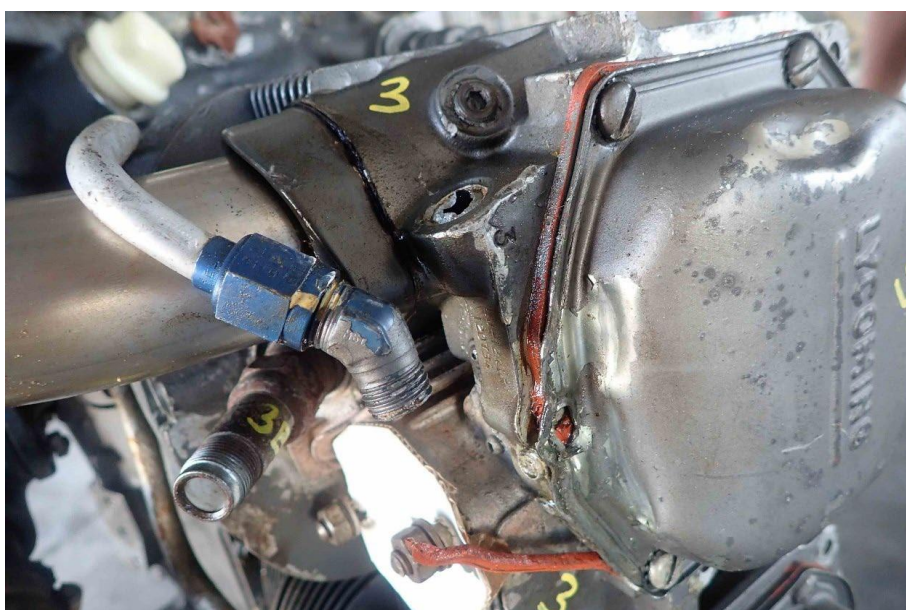
Figure 4 – Number 3 cylinder rocker cover and oil return fitting damage

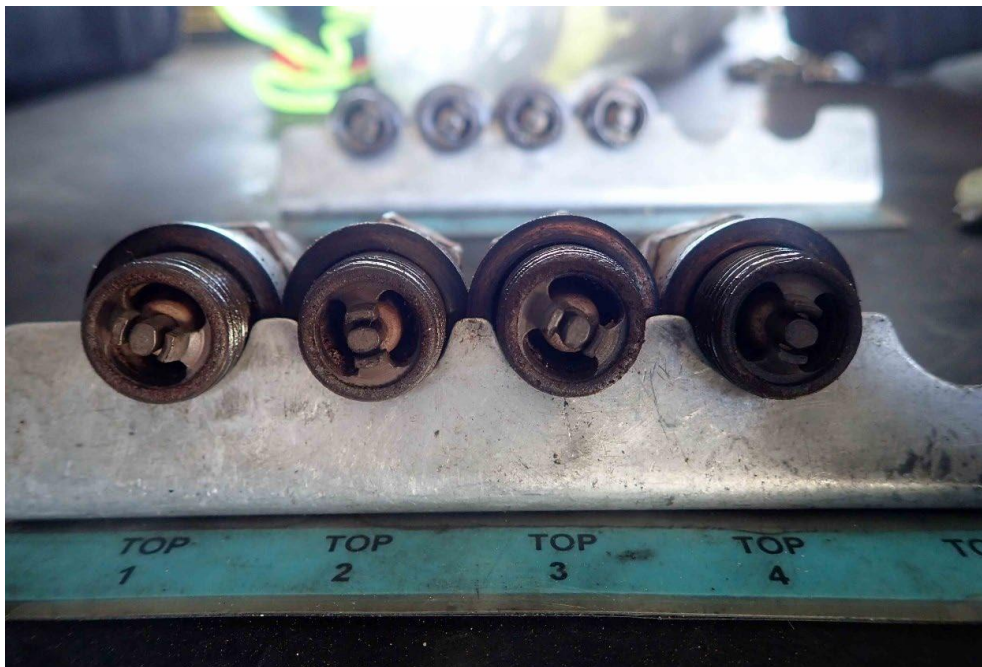
The top spark plugs were removed and examined. All electrodes were coated in light/dark grey deposits and exhibited “normal” to, “worn out-normal” wear signatures (figure 5) when compared with the Champion Aviation Products AV-27 “check-a-plug” chart (attachment 1).

Figure 5 – Top spark plugs

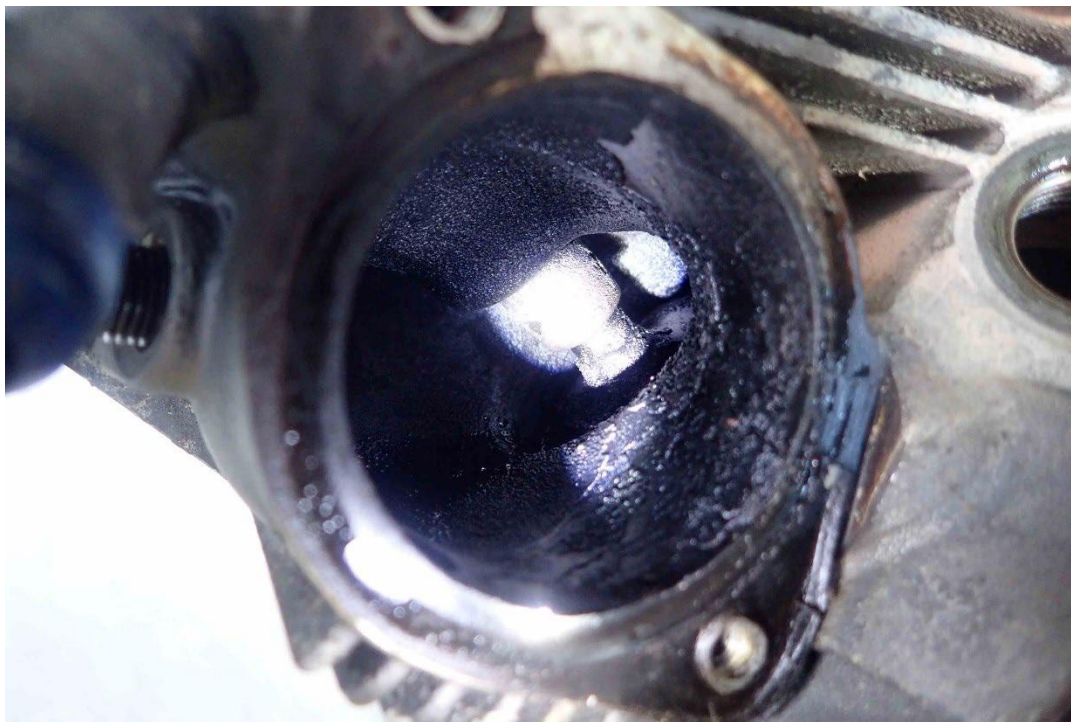
Examination of the inlet ports at each cylinder indicated that the back side of the intake valve head and upper stem was coated in wet black coke-like buildup consistent with high, but not abnormal oil consumption due to leakage past the valve guides (figure 7).

Figure 7 – Intake cylinder valve guide stem and back of valve face

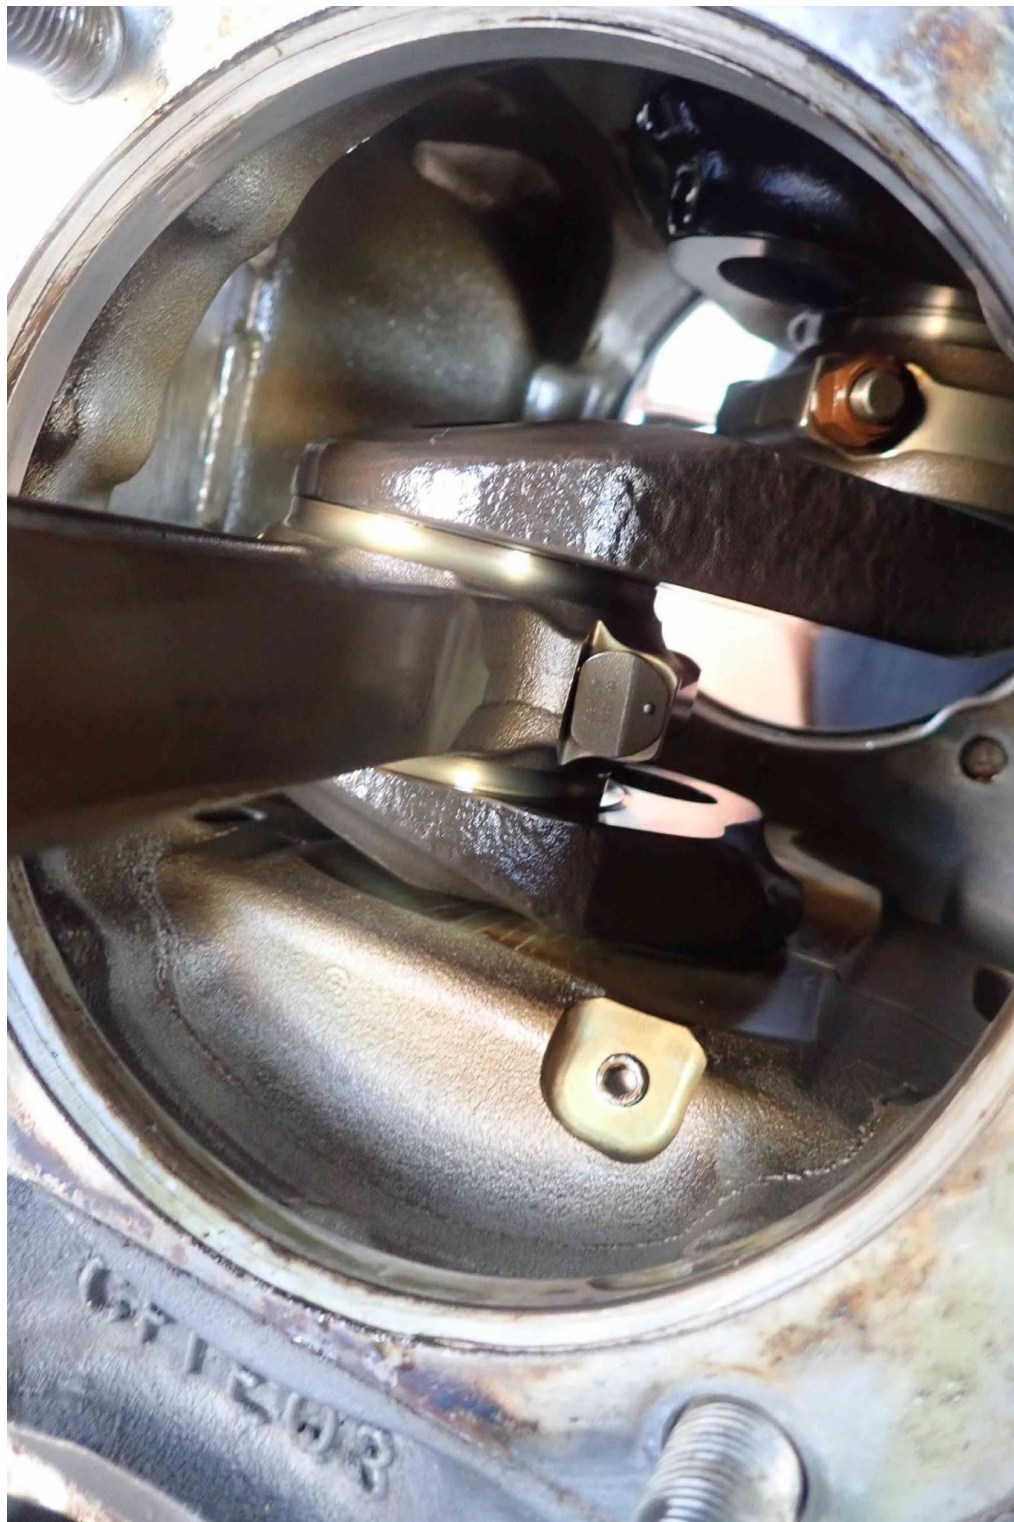
All cylinder head assemblies were removed, during which all head bolts could be unscrewed without undue pressure, and there was no evidence of thread stripping. Within the crankcase, all components were clean, coated with oil, with no evidence of thermal distress or catastrophic failure (figure 16).

Figure 16 – Piston rod and crankshaft

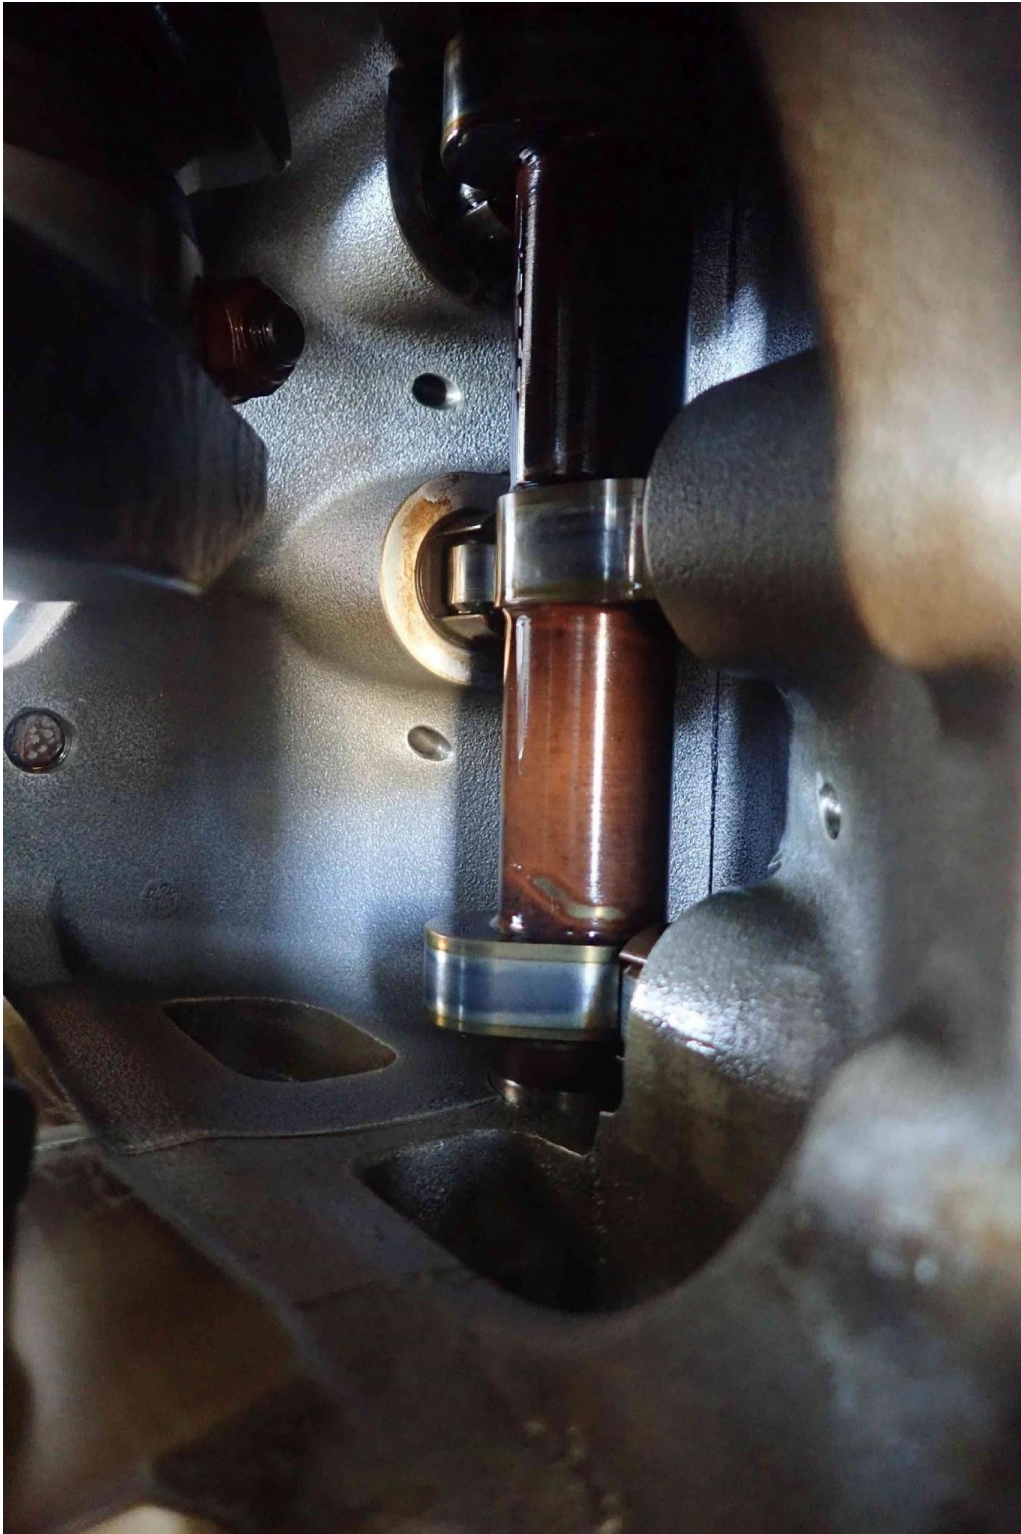
The camshaft rotated smoothly, and the cam lobes were intact with no evidence of galling or significant wear (figure 17). The tappets were clean and free of gouges or scratches, and the pushrods were straight.

Figure 17 – Camshaft and roller tappets

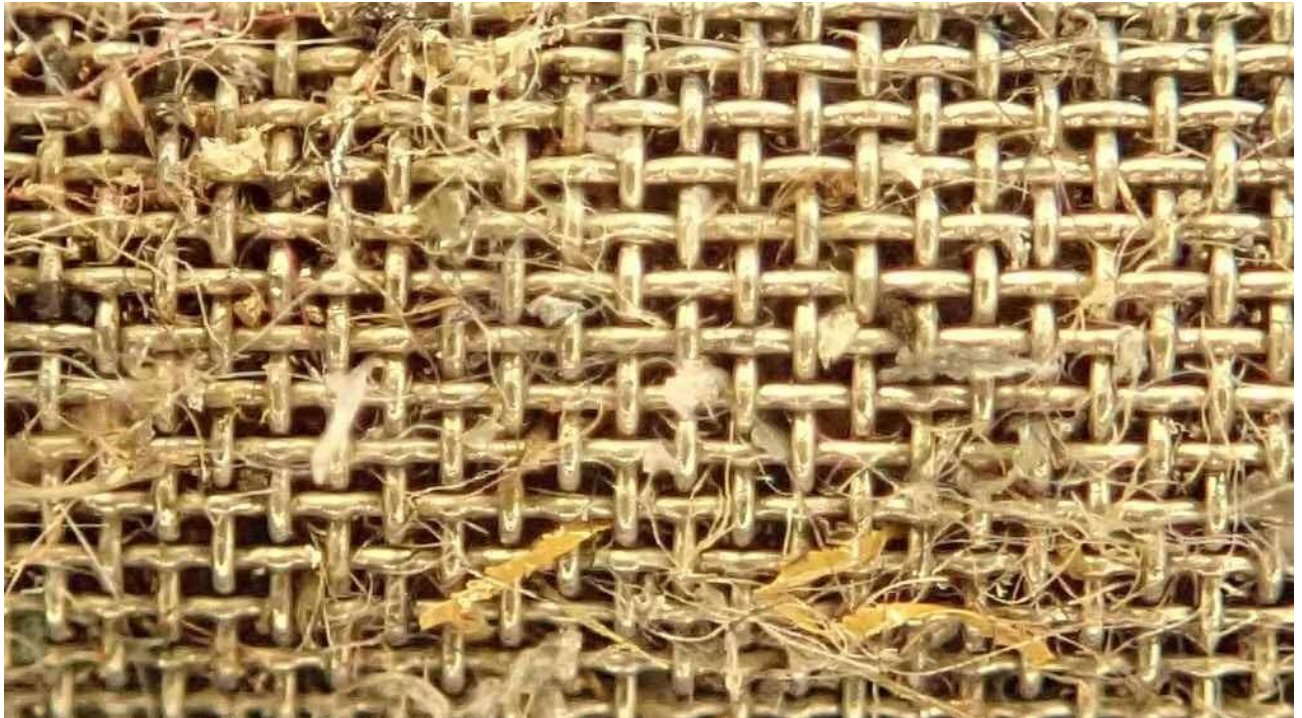
Examinations of the magnetos, carburetor fuel inlet strainer, and carburetor were conducted at FAA repair station TZ3R885L in Simi Valley, California by the appointed Accredited Representative of NTSB. The Examination revealed that the right magneto was inoperative due to a failed coil (secondary side) and there was no evidence of internal catastrophic failure. The throttle arm of the carburetor had moved freely, with the corresponding movement of the butterfly valve and accelerator pump plunger. There was no evidence of a fuel leak. There were no anomalies noted to the carburetor, except for its fuel inlet strainer, which was occluded with a fibrous material. The Examination Report on Magneto and Carburetor is attached in Annex 02.

Figure 12 – Fuel inlet strainer debris
