FINAL REPORT

**SriLankan Airlines Flight UL 303,
Airbus Industries A330-343, bearing registration
4R-ALP, Go Around due to
Wind Shear, during final approach to
Bandaranaike International Airport, Katunayake
on 05th July 2023**

Released by the Civil Aviation Authority of Sri Lanka

Issued on: 06th Sept 2023

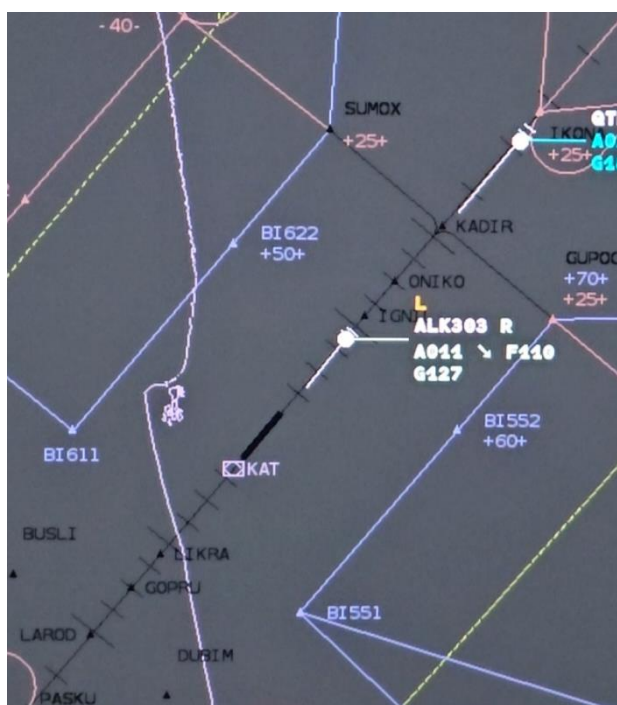
Flight UL303 intercepted ILS RWY 22 at 2000 ft and fully configured the aircraft for landing. At around 1100ft at a distance of approximately 3.5NM/6.6 km from RWY 22 Threshold, the flight crew experienced wind shear condition and subsequently, they observed the audio warning. Then PIC had initiated go-around approximately at time 1205 UTC (1735 Local) while informing ATC and requested right turn to avoid the weather patch which was indicated on weather radar.

Figure 1: Aircraft initiation of Go Around at 1100ft

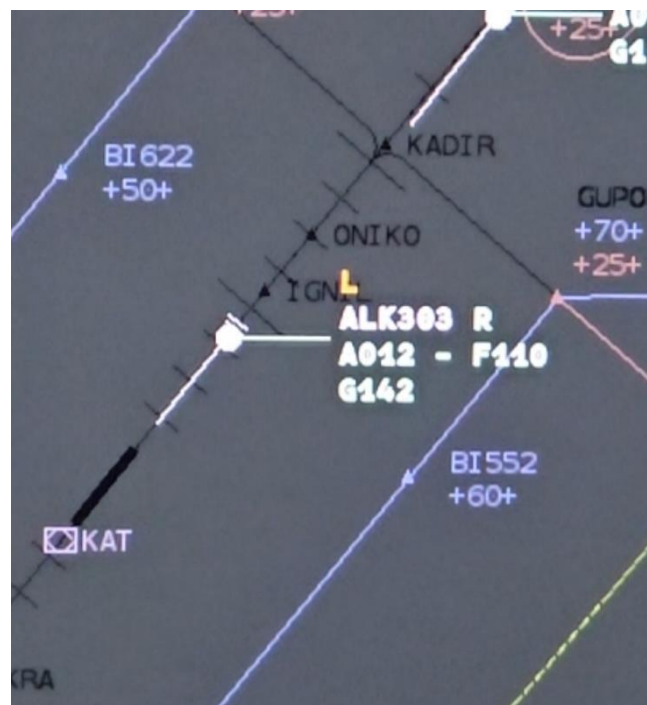
Figure 2: Aircraft on the climb passing 1200ft

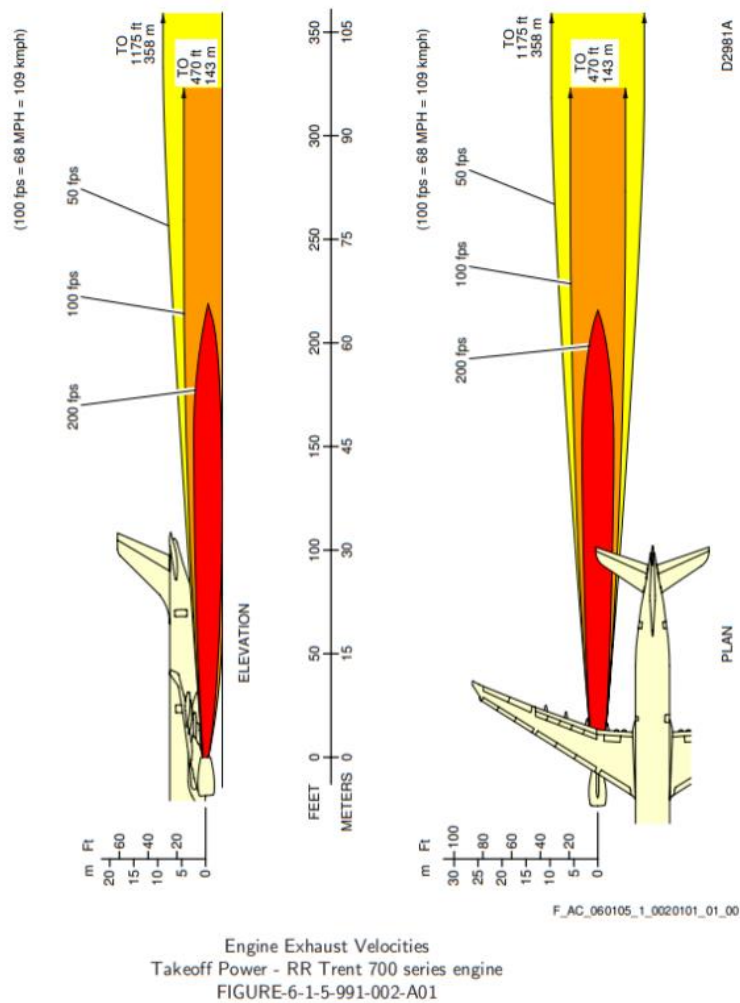
According to the flight crew and DAR data indicated that during go-around the flight crew had applied engine power to TOGA. The maximum danger range of the exhaust wake of TRENT772B engine is 470ft either side of the aircraft longitudinal axis (with a height and width of 30ft approximately) as shown by the figure 6 & 7 below. When the aircraft initiated the go around it was at 1163ft (RA) on the final approach path and the minimum (Computed) distance between the aircraft and ground in the longitudinal axis of the aircraft was approximately 2km (approximately 6500ft) ref Appendix D.

Figure 6: RR Trent 700 exhaust wake velocities (Source: AIRBUS A330-700L Aircraft characteristics airport and maintenance planning.

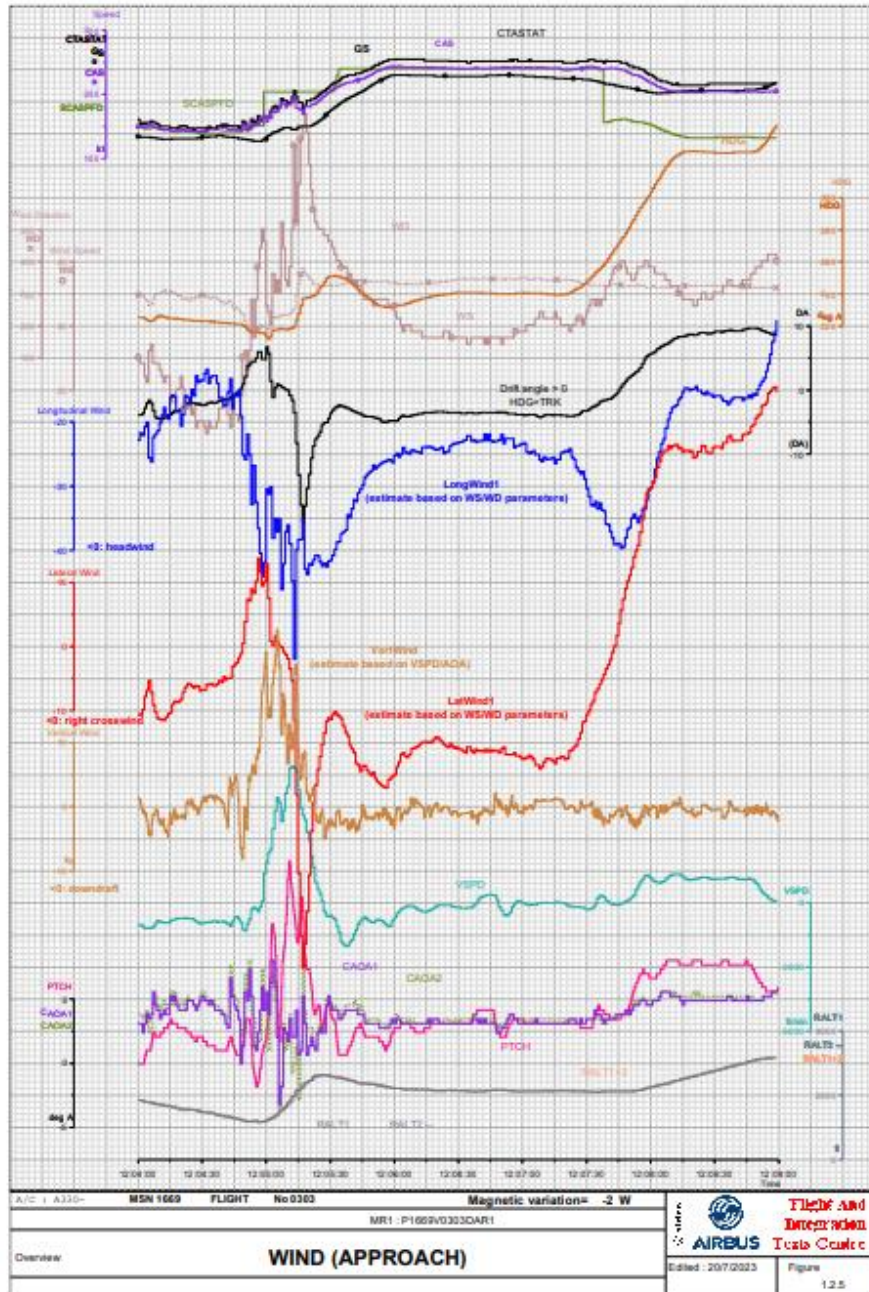
Figure 8: Wind variation along runway approach path (Source: Based on computed DAR parameters)

Based on BEA Report of the event (Refer to Appendix D), computed wind components varied as follows between 12:04:00 UTC and 12:04:55 UTC,

- Tailwind varied between -33 kt and -11 kt.

- Lateral wind varied between -12 kt (right crosswind) and +10 kt (left crosswind).
- Vertical wind varied between -8 kt (downdraft) and +5 kt (updraft).
- Wind speed varied between +13 kt and +34 kt.

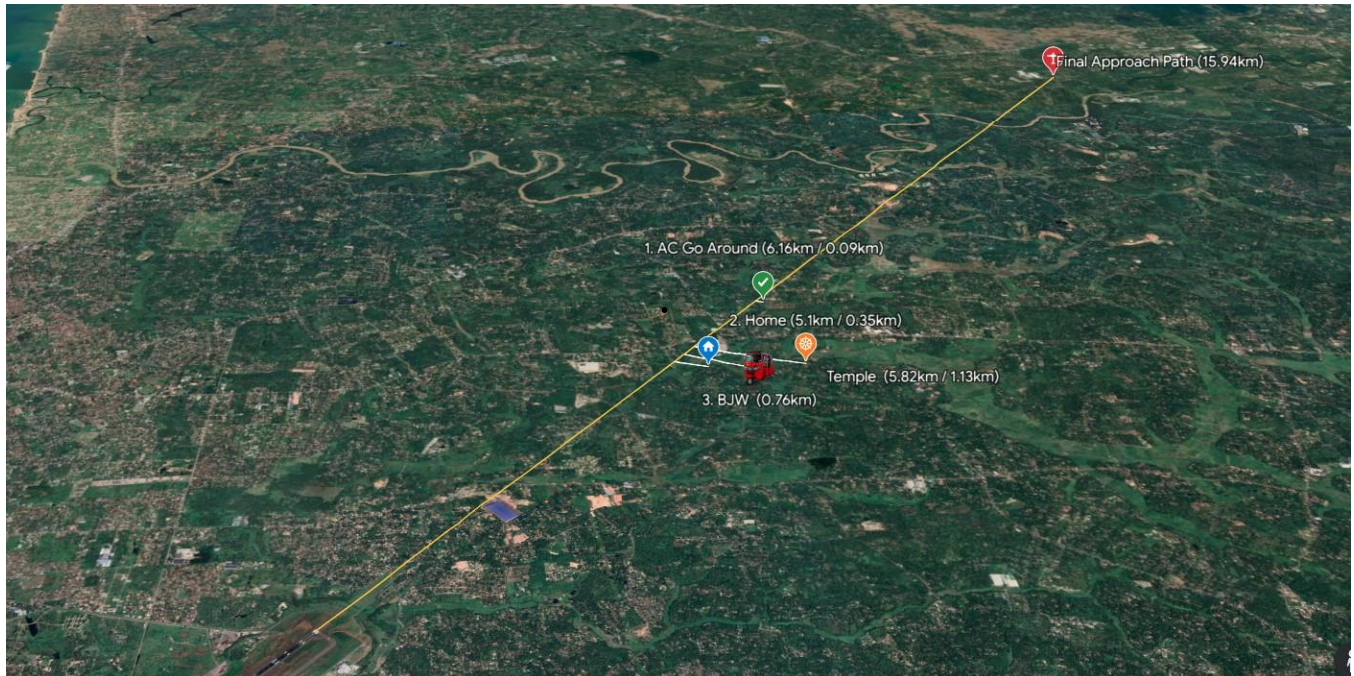
Figure 9: Distances from Runway 22 to damaged properties and go-around initiation point on the standard approach path

1. Go around initiation point approximately 6.16 km from the RWY 22 Threshold
2. Reported damaged house (complain no 1) 5.1km from RWY 22 Threshold and 350 meters approximately left of the approach path.
3. Reported three-wheeler location was identified in between the above house and temple at an approximate distance of 700 meters left of the approach path. (Location was identified based on the direction provided by the Victim of complaint no 2)
4. Reported damaged temple (complain no.3) is approximately 1.13 km left of the approach path.

According to Airbus documentation on engine exhaust velocities, the distances of above locations of reported damages (above 2,3 and 4) are out of the area where the exhaust velocity is still notable.

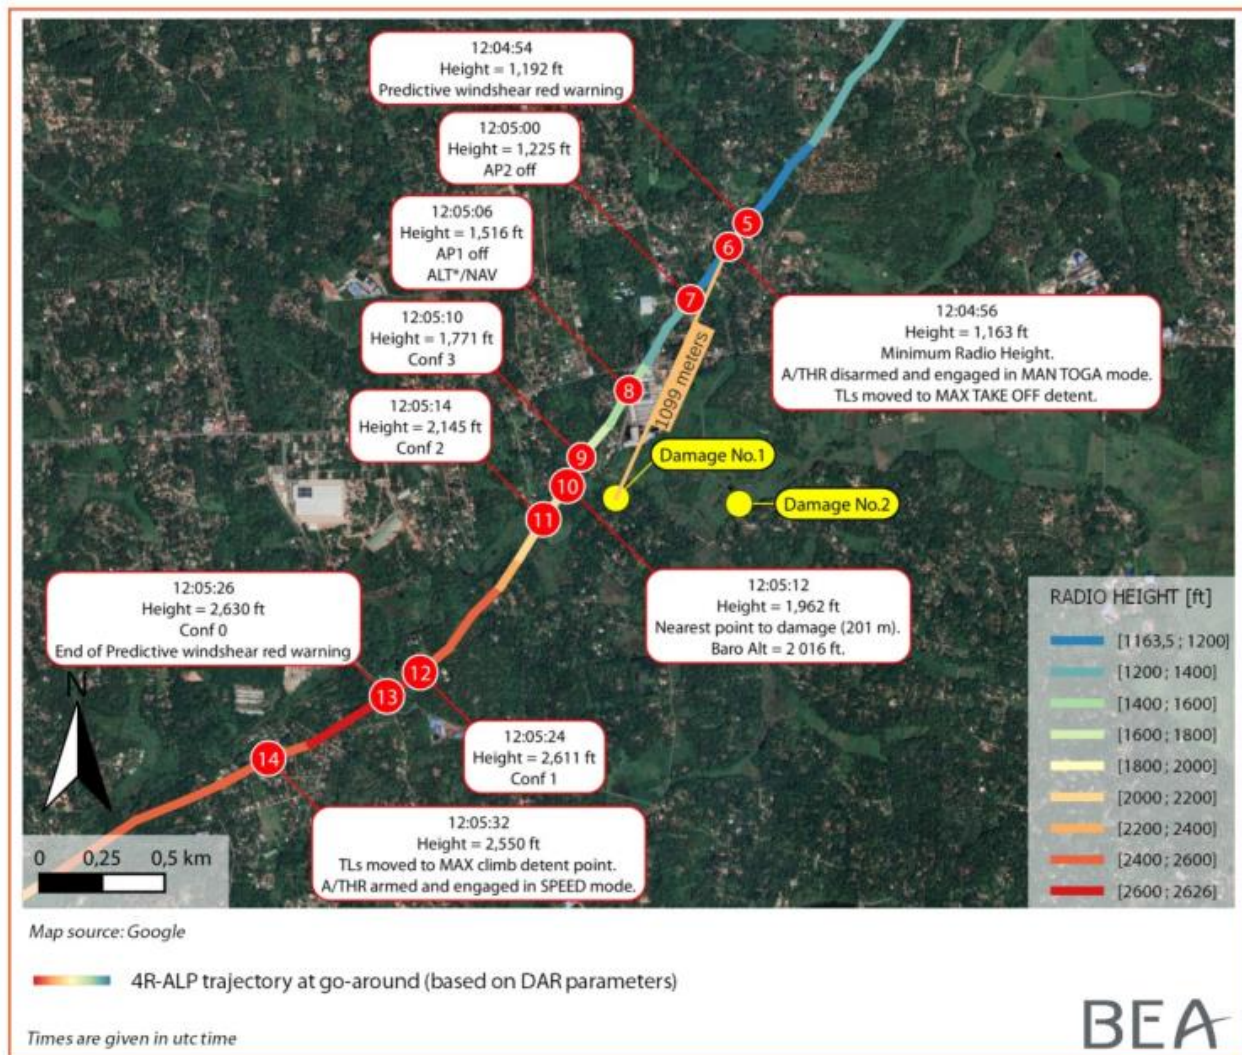
The diagram below was obtained from BEA analysis report (Ref appendix D) indicates flight path, altitudes (from mean sea level), heights (Radio Heights), times (UTC) and positions. **Point 6** indicates the initial point of go-around at the recorded height of 1163 ft, which is the lowest height reached by the aircraft until the commencement of the second approach. At this point, the aircraft had used TOGA power to initiate the go around (Wind shear escape manoeuvre). This location is approximately at a distance of 1099 meters (approx. 1.1km) prior to the damaged house (complaint number 1).

Figure 10: Trajectory of the aircraft during the event (DAR parameters)

Note: Damage No 1& Damage No 2 refer to Complain No.1 & Complain No.2 respectively.

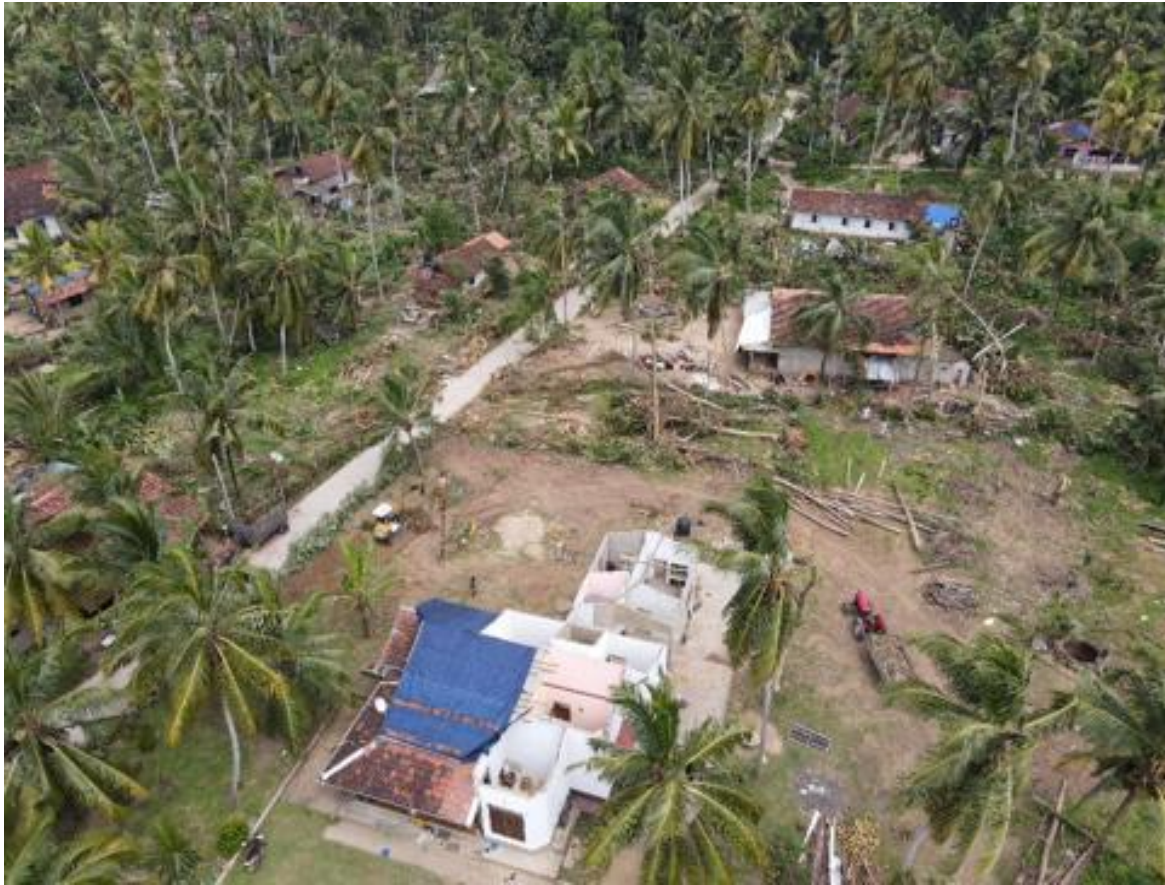
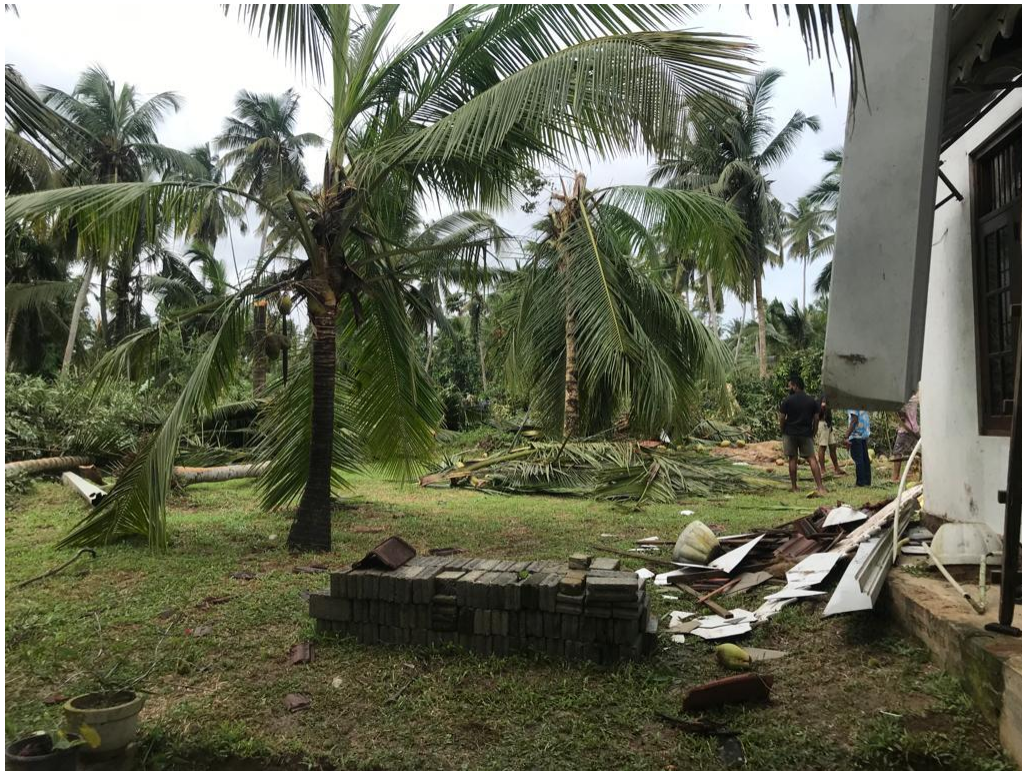
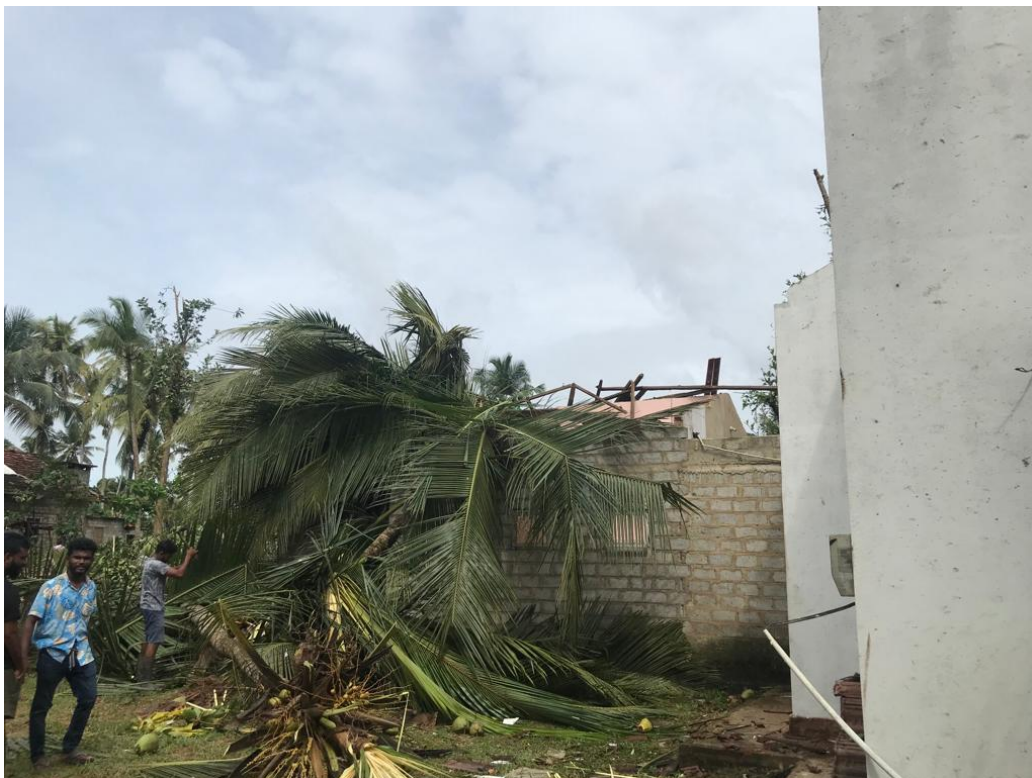
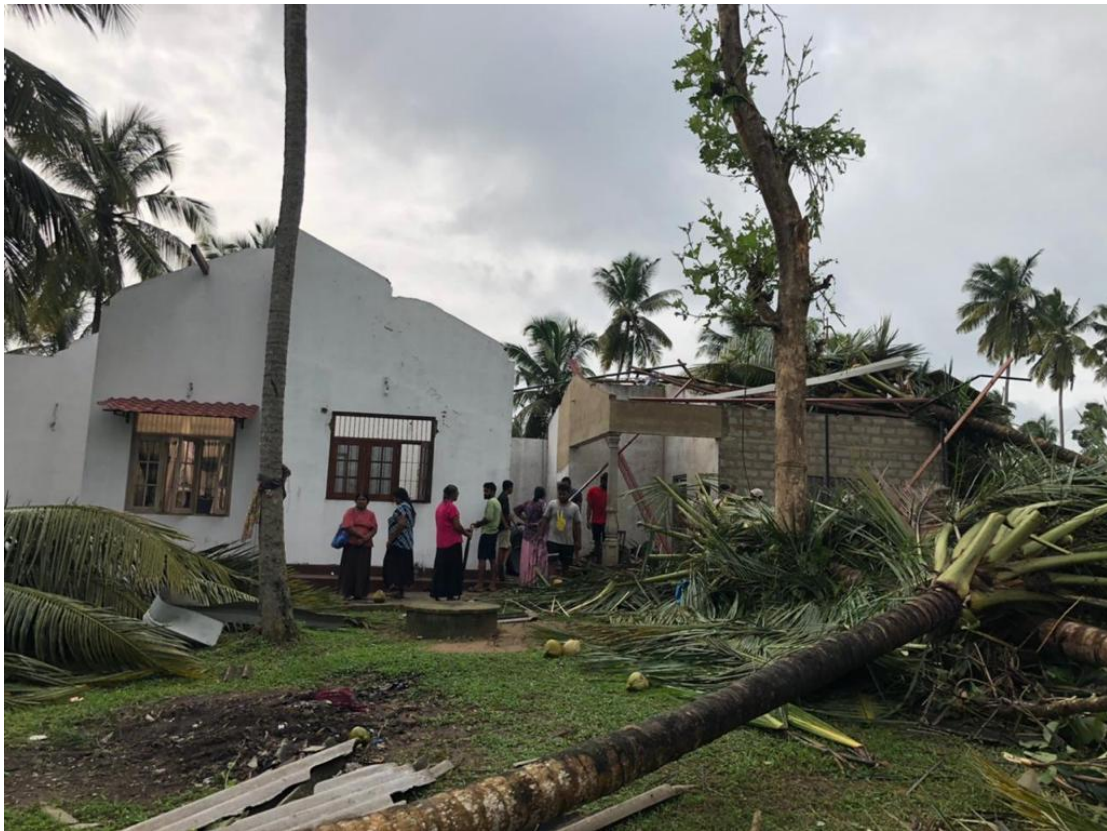
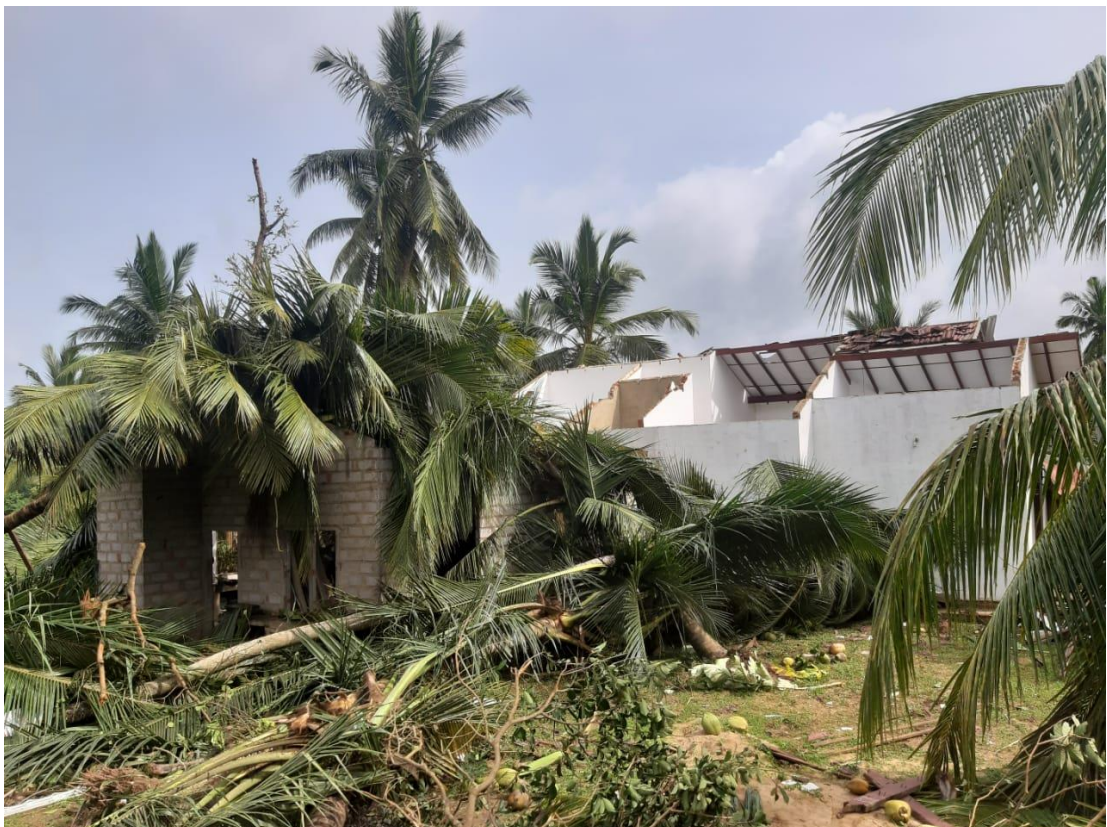
APPENDIX: A - SITE OBSERVATIONS OF AAIB

On 10th, 11th and 27th July 2023 (5 days, 6 days and 22 days after the incident respectively) CAASL received three (03) complaints (complaint no.1, complaint no. 2 and complaint no. 3 respectively) from residents who are living around Runway 22 approach path of VCBI, claiming that, their properties were damaged. Complaint no. 2 reported that they had minor injuries.

GPS coordinates of the damaged house: N 07° 13' 42.2" ; E 079° 55' 21.6"

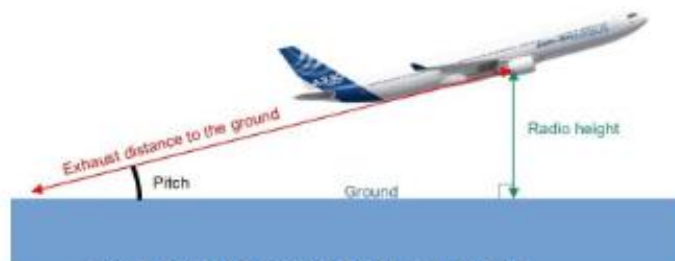
- **In the aircraft longitudinal axis, the distance between the aircraft and the ground** (see Figure 1) has been computed using the radio height and pitch during the go-around. This distance gives an **approximate** value for the **distance that the engine exhaust should reach to meet the ground**.
The minimum value is ~2086 meters and is obtained at 12:05:11 UTC when the aircraft is at 200 m north of the point of damage (thus in the direction opposite to the damaged house location). According to Airbus documentation on engine exhaust velocities (attached to this report), the computed distances are out of the area where the exhaust velocity is still notable. For the engine exhaust to reach the ground at high speed, the aircraft would need to be quite low and with a high pitch.

Figure 1: Engine exhaust distance to ground

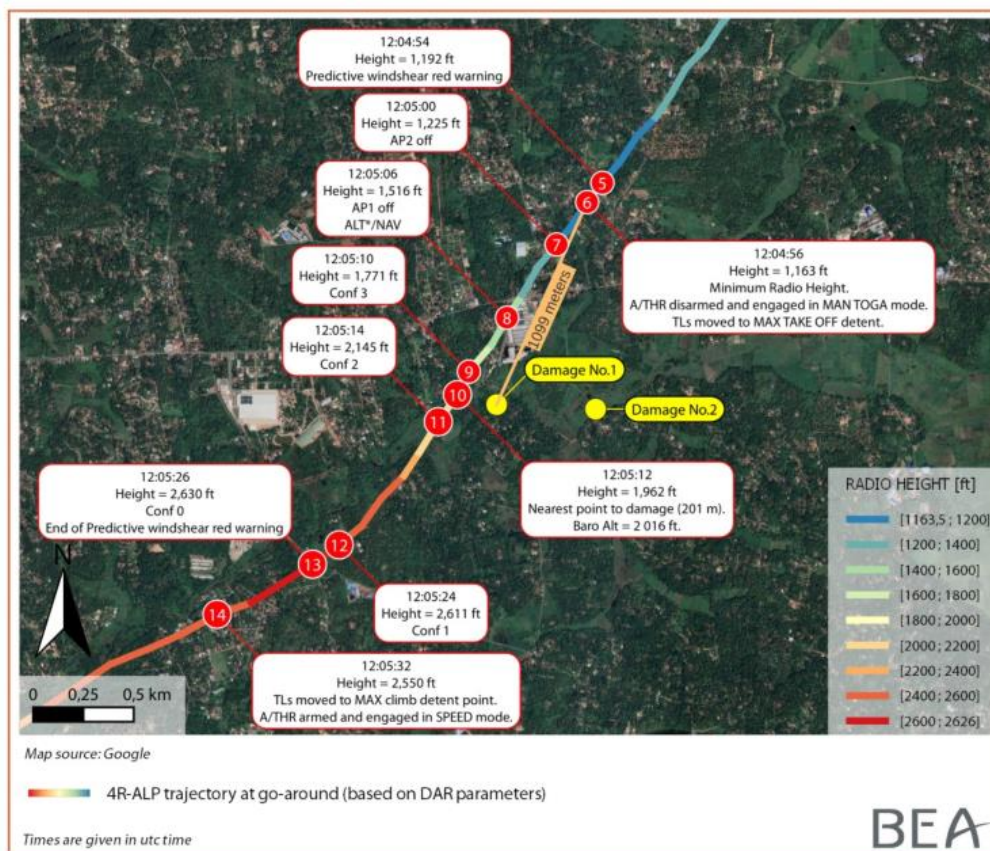
- It can be noted that the presence of a windshear area might contribute to the mild VFE exceedances identified in the DAR sequence of events.
- According to the trajectory of the aircraft and the GPS coordinates of the damages of complaint No.1 (see Figure 2):

- The lowest point on the trajectory (minimum radio height) is located at **1099 meters** (3 606 ft) from the damages n°1 (measured horizontally).
 - The nearest point of the trajectory to damages n°1 is located at a radio height of **1 962 ft** (2 016 ft QNH).

Figure 2: Trajectory of the aircraft during the event (DAR parameters)
