# **FINAL REPORT**

## **AIRCRAFT INCIDENT**

### **FLY SOUTHERN (PVT) LTD CESSNA 172N, 4R-FSA RUNWAY EXCURSION AT RUNWAY 22 COLOMBO INTERNATIONAL AIRPORT - RATMALANA, ON 01<sup>ST</sup> NOVEMBER 2023**

Issued on: 06 December 2023

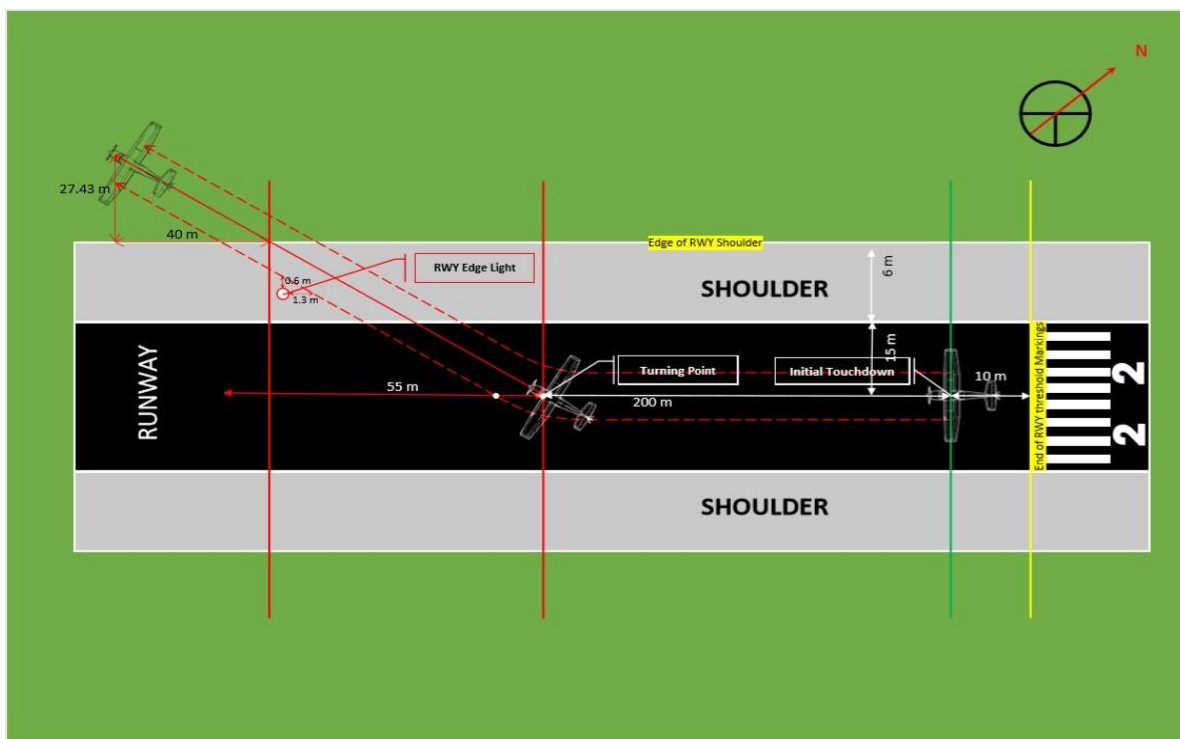
**Figure 01: Illustration of the aircraft path during and after landing**

During the landing roll student felt that the aircraft tend to yaw to the left of the centerline and he has applied right rudder and breaks to position back the aircraft on to the centerline. However, the aircraft was veered off to the right and entered into the runway right side grass patch and stopped 33.43m away from the runway edge.

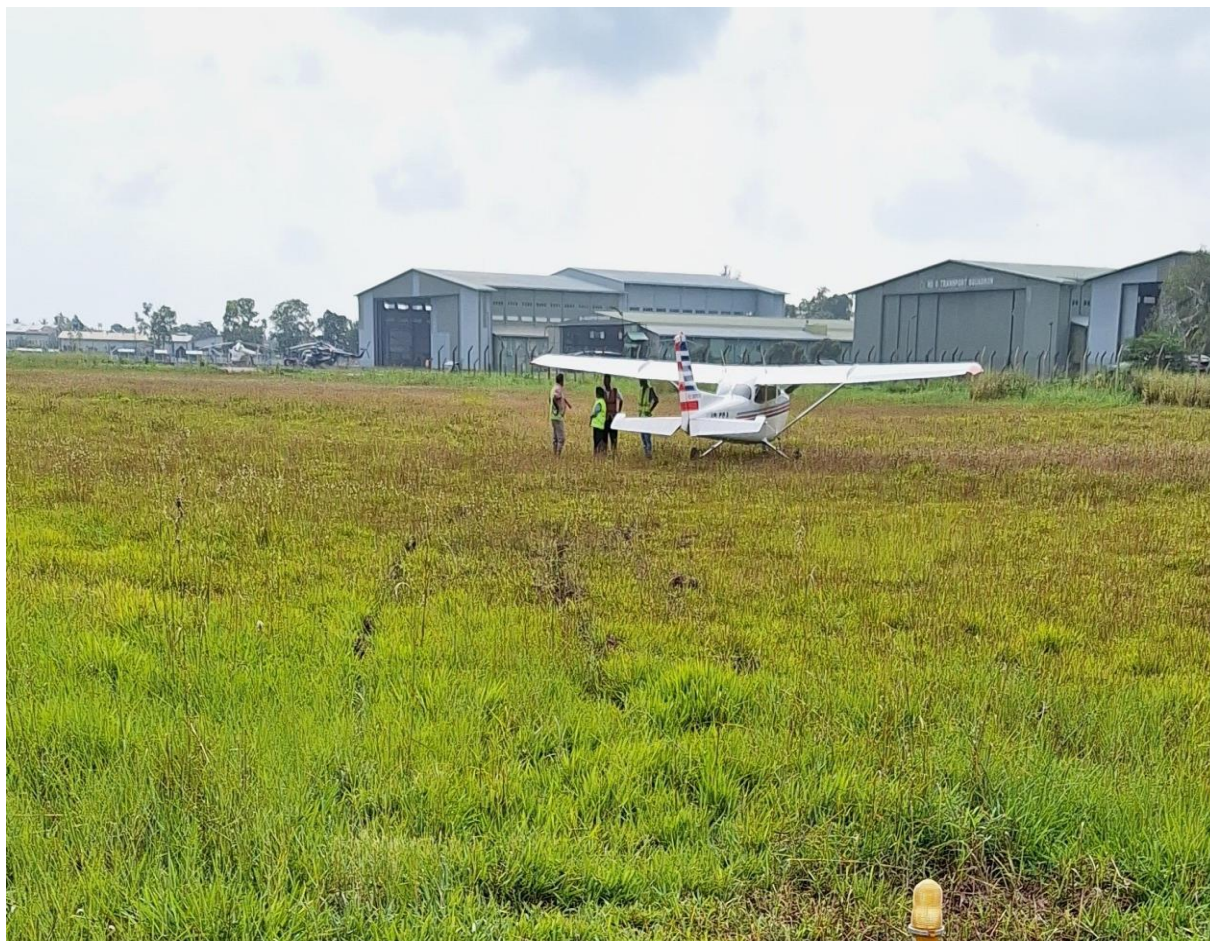
*Figure 04: Incident site picture -aircraft resting on grass patch*
