FINAL REPORT

**Incident on separation breakdown between Emirates Airline flights
UAE 359 bearing aircraft registration no. A6-EGI, Boeing 77W
and UAE 5CL bearing aircraft registration no. A6-EVG, Airbus
380, Over Colombo Oceanic Control Area on 31st May 2023**

Released by the Civil Aviation Authority of Sri Lanka

Issued on: 10.04.2024

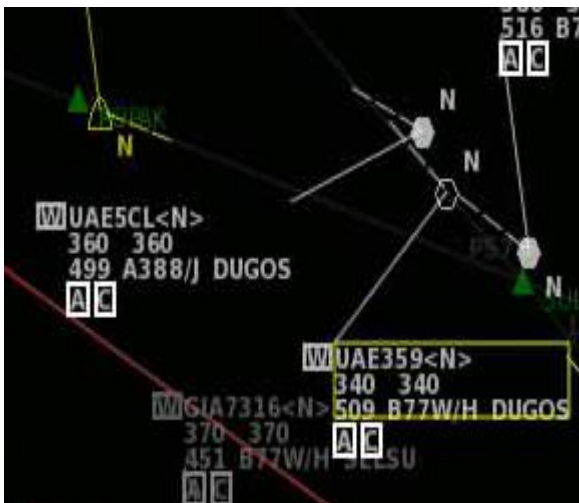
Figure 1: Air Situation Display Screen Shot

Approximately about 11 minutes later with the ADS update the Controller had noticed that both aircraft were maintaining the same flight level without the adequate longitudinal separation, which should have been 50 nautical miles. The Controller on realising this, had descended UAE359 to FL340 once more to establish vertical separation.

The Controller had identified the infringement caused only after, approximately 11 minutes, when he had observed the level change in the Air Situation Display (ADS) with the update of the ADS position report of the aircraft.

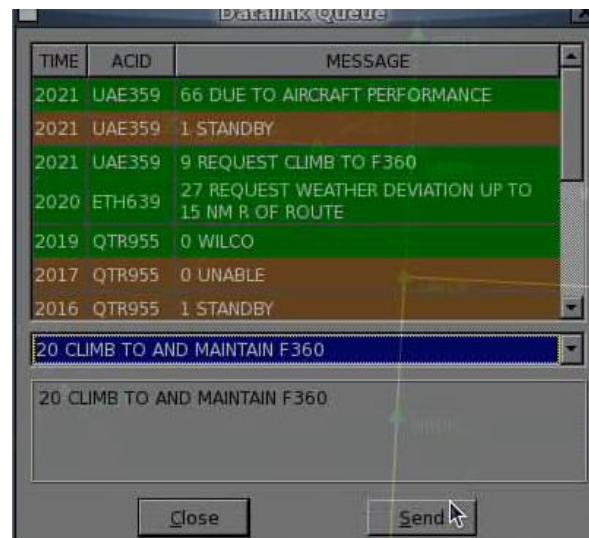
Figure 2: CPDLC Data Link Queue

The Controller had a residual un-cleared CPDLC message queue stemming from 1918UTC at 2023UTC, for which some had been responded and some had not been responded. The Controller seen rushing, clearing those message queue responding to some, observed at the same time new messages were also being received, which required more attention from him rather than clearing of old messages.

The Controller has assumed duties at 2000UTC. When the individual clears CPDLC messages that has been received since 1918UTC during the period of occurrence, it points out to the fact that handing-over Controller at 2000UTC had not cleared CPDLC message queue at the time of handing over and the Controller concerned has accepted control of traffic with the un-cleared residual message set.

The handing-over Controller not clearing the long CPDLC queue associated with ATC duties during his/her duty period, leaving an additional work to the taking-over Controller who has to spend an additional time at the beginning to clear the queue. It is noted that good work ethics and good working practices, like the rules and regulations, equally contribute to a safe working environment.

- II. It is recommended to issue a specific staff instruction to be strictly complied by the Controllers assigned to work at Oceanic Control Position to clear up the CPDLC message queue when handing over the control of traffic to the next Controller except for those messages that are pre-negotiated and agreed upon by the incoming Controller to provide responses for.
