FINAL REPORT

**Serious Incident of SriLankan Airlines
Flight UL266, Airbus A340-311, bearing registration 4R-ADA
at Bandaranaike International Airport, Colombo
Sri Lanka
on 02nd July 2013**

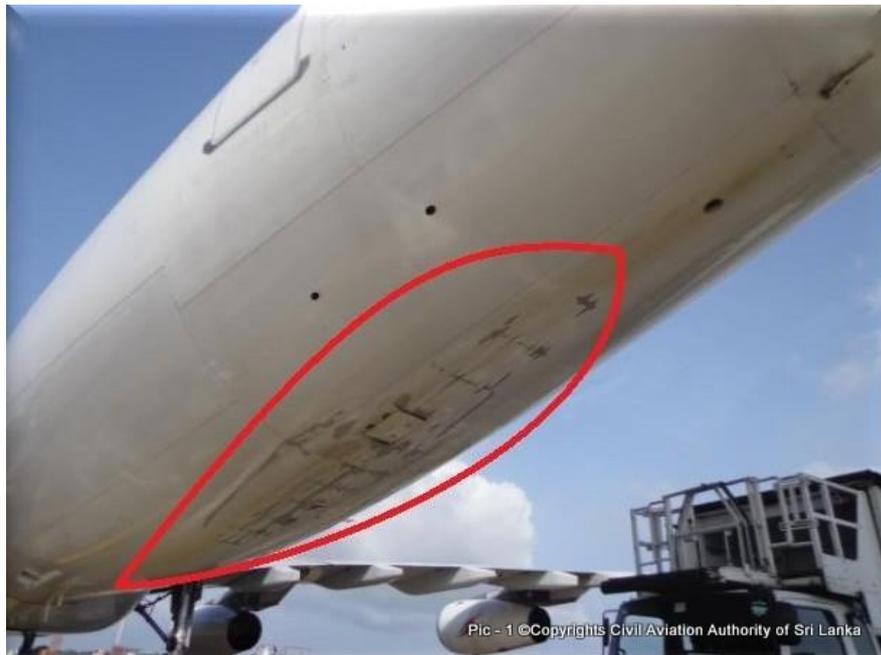
2.3. Damage to Aircraft: Aft fuselage belly was damaged. Damage was observed on Section 17 and Section 18 Skin panels between frame 67 to 83 approximately (Bulk door forward frame to aft pressure bulkhead area). There were scratch marks on the belly area and few rivets were damaged and some rivets were missing. Skin buckling was also noted. Some components of the Right Main Landing Gear had exceeded the design load limits.

Figure 1 – Aircraft scratch marks

- 1) Removal (partially) of section 17 lower skin panel & replacement
- 2) Complete removal and replacement of section 18 lower skin panel
- 3) Removal replacement of frames as described in the TD

- 1) Complete replacement of lower panel section 18
- 2) Frame 72-74
 - a. Frame 72 replacement of lower side frame segment (RH)
 - b. Frame 73 replacement
 - c. Frame 74 partial replacement

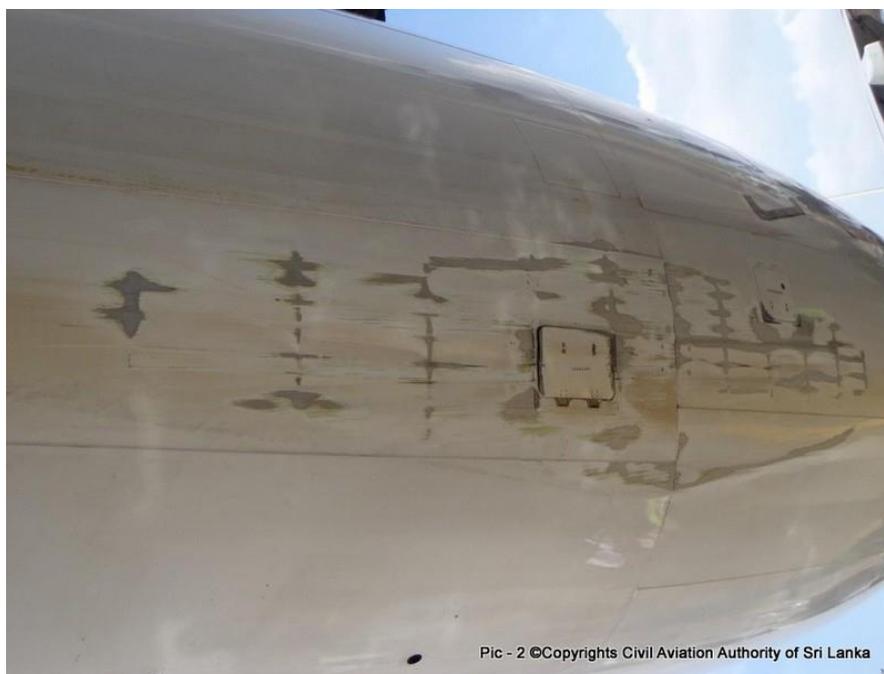
Figure 2 - Aircraft scratch marks

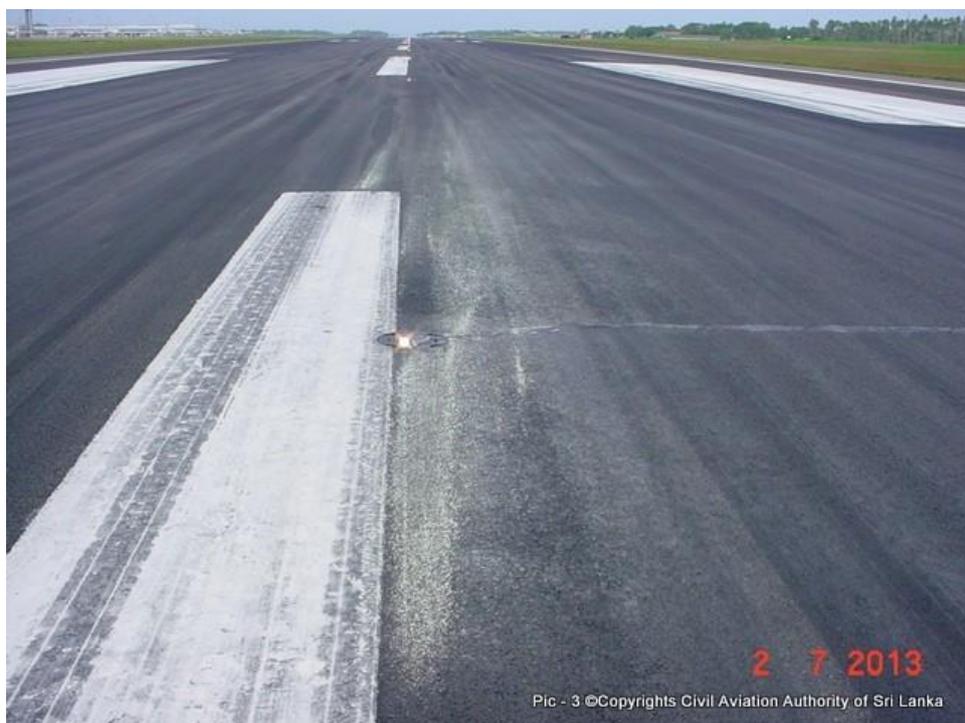
2.12. Wreckage and Impact Information: It was observed during the Runway inspection a scratch mark about 14 meter long on the centre line ending at a position abeam PAPI lights of Runway 22. The scratch mark was across the centre line by few degrees offset of the centre line. Further it was observed that one of the centre line lights was scraped but found to be serviceable. No debris or particles of the aircraft found on the runway or its precincts.

Figure 3 – Runway scratch mark

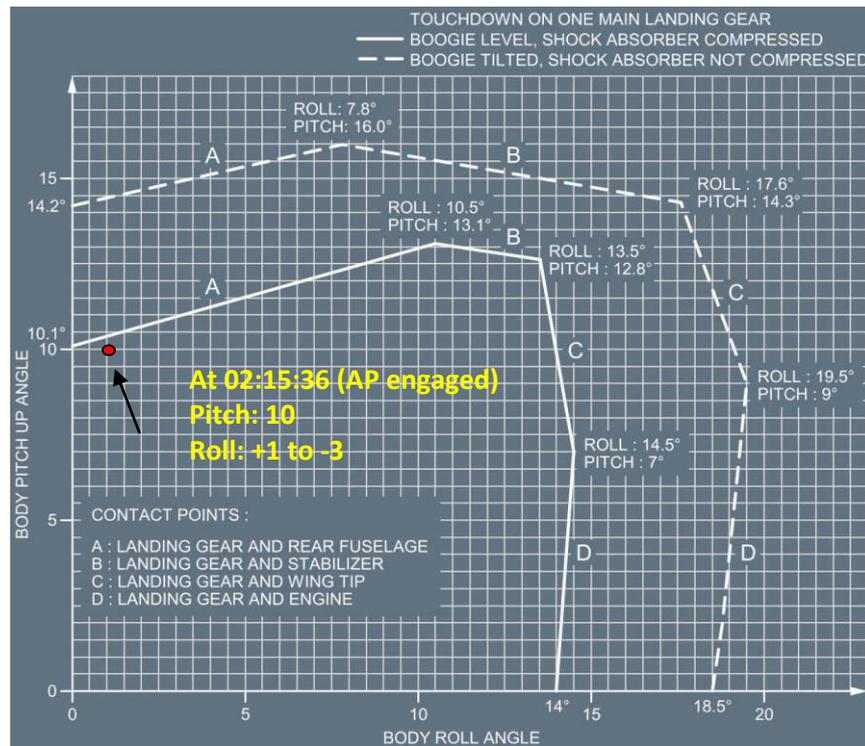
Figure 4 – Ground Clearance Diagram

3.2.4.1. A tail strike is an occurrence that directly depend on the Pitch, Roll angle and Compression of the oleo strut of the main wheels. At 2:15:36UTC, (i.e. 1 second after the touchdown), the configuration of the aircraft was, pitch and roll angles were respectively +9.9° and +0.7° (right)'; auto pilot 'engaged'; oleo strut 'compressed and damaged' due to vertical acceleration of '2g' and weight on wheels 'on. The aircraft touched down on auto landing without the inputs of the Pilots at a speed lower than the target speed, with a high rate of descent and with the aforementioned Pitch, Roll angle and Compression of the oleo strut configurations favourable for a tail strike. In addition, it was revealed that the AUTO LAND touch down occurred when the aircraft was in a Roll angle of 1 degree to the right and changing to a 3 degree to left abruptly.

3.2.4.2. Once the Pitch angle and Roll angle of the time frame 02:15:36UTC marked in the Ground Clearance Diagram in the FCOM PRO-NOR-SOP-21 P 5/12, it is a probable point at which a tail strike is imminent. (Figure 4)

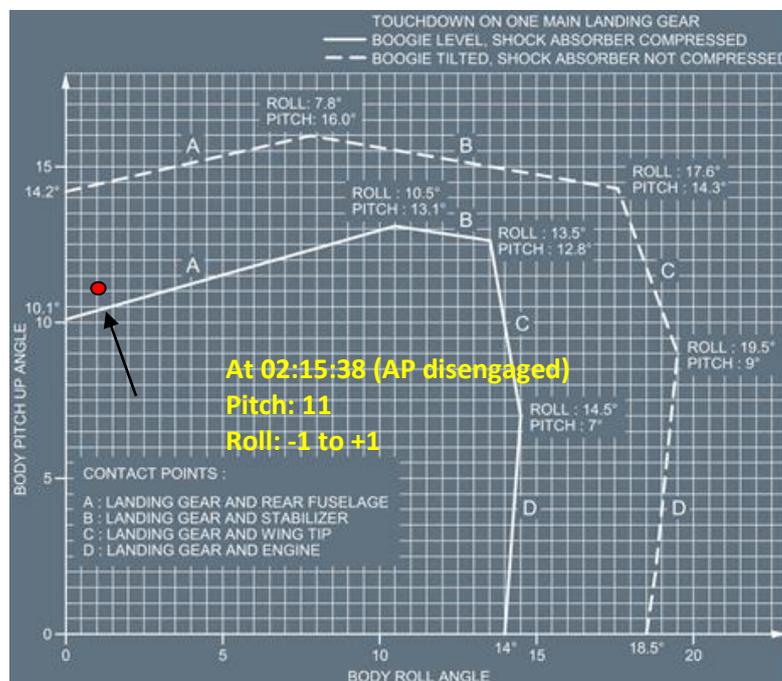
Figure 5 – Ground Clearance Diagram

3.2.4.3. Further after the touch down at 02:15:38UTC time frame, it is noted that the configuration suggests a possibility of (another) tail strike (pitch angle '11'; vertical acceleration "1g"; weight on wheels "on"). Half a second after the touch down, there was a roll side stick input of 11° to the right, which led into a disconnection of auto pilot that occurs at roll inputs greater than 6 degrees. In addition the Roll angle at this time frame was 1 degree to left and changing to a 1 degree to the right.

3.2.4.4. Once the Pitch angle and Roll angle of the two time frame (02:15:38 UTC) marked in the Ground Clearance Diagram in the FCOM PRO-NOR-SOP-21 P 5/12, it is evident that the tail strike is also prominent (Figure 5).

3.2.4.5. Also there is no evidence found to rule out continuation of the tail scraping in between these two time frames.

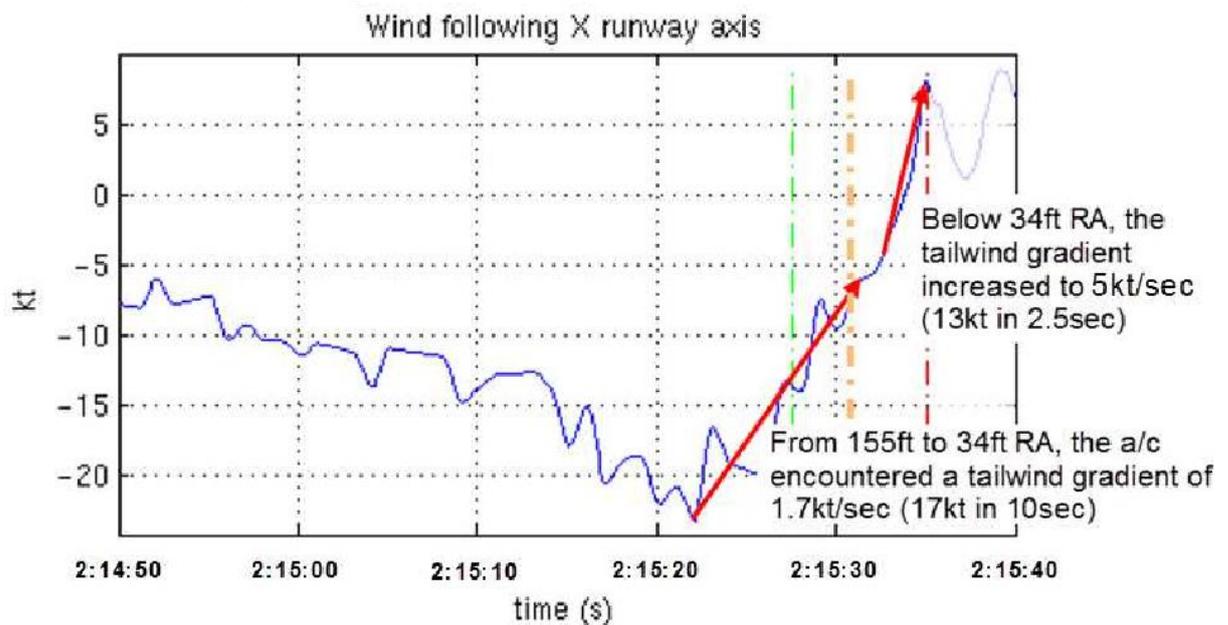
Figure 6- Wind variation along the longitudinal axis (head wind and tail wind)

3.2.6.1. At the crucial height of 40 feet there is evidence of a significant increase in tail wind amounting to 13Knots within 2.5 Seconds causing a substantial drop in the lift of the aircraft (refer diagram below provided by the Manufacturer's report). Analysis of the parameters with the help of DFDR data revealed that facing this adverse wind conditions (windshear) the system design was not able to maintain the speed target.

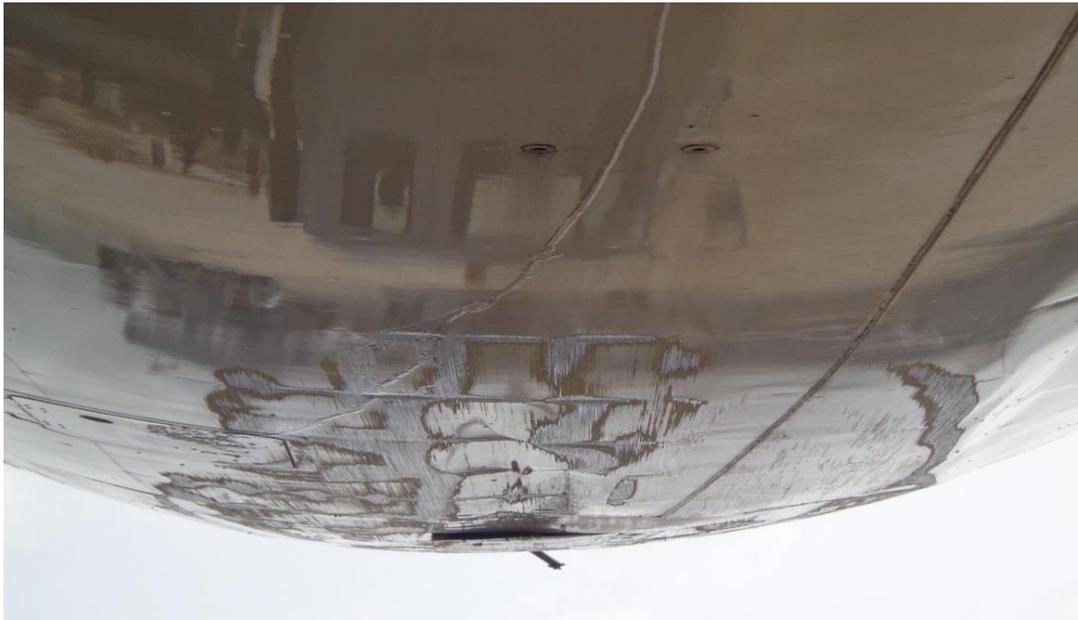
Figure 7 - Aircraft scratch marks (Nose to Tail View)

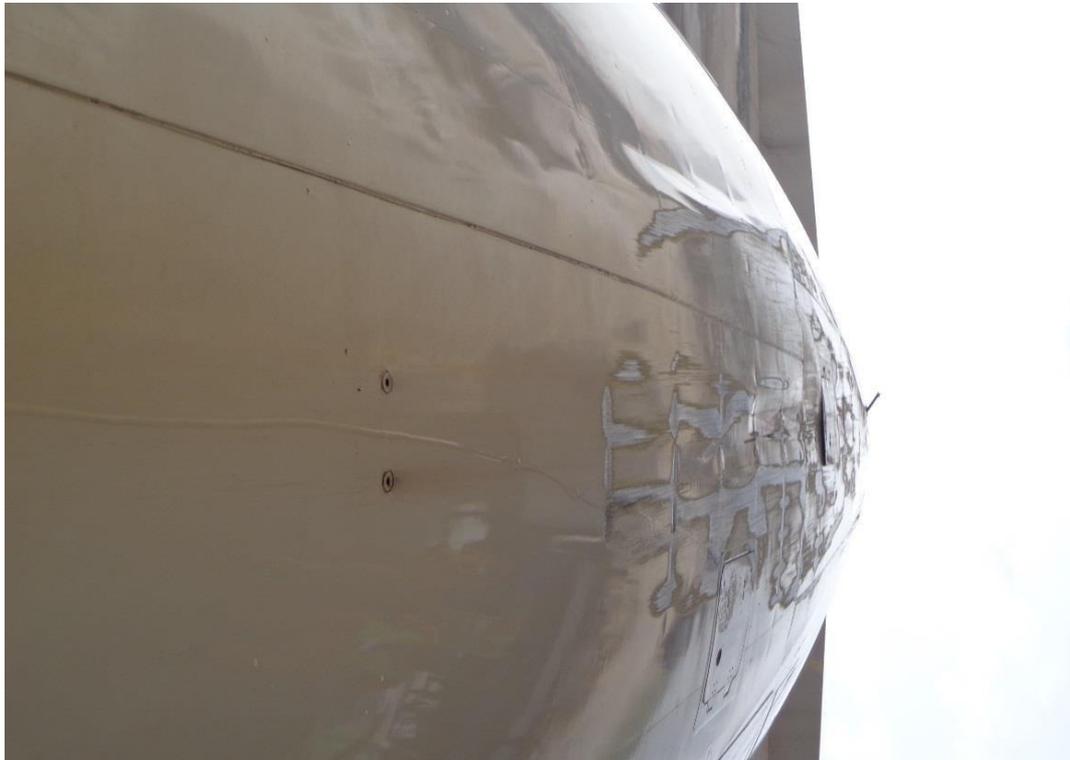
Figure 8 - Aircraft scratch marks (Nose to Tail View)

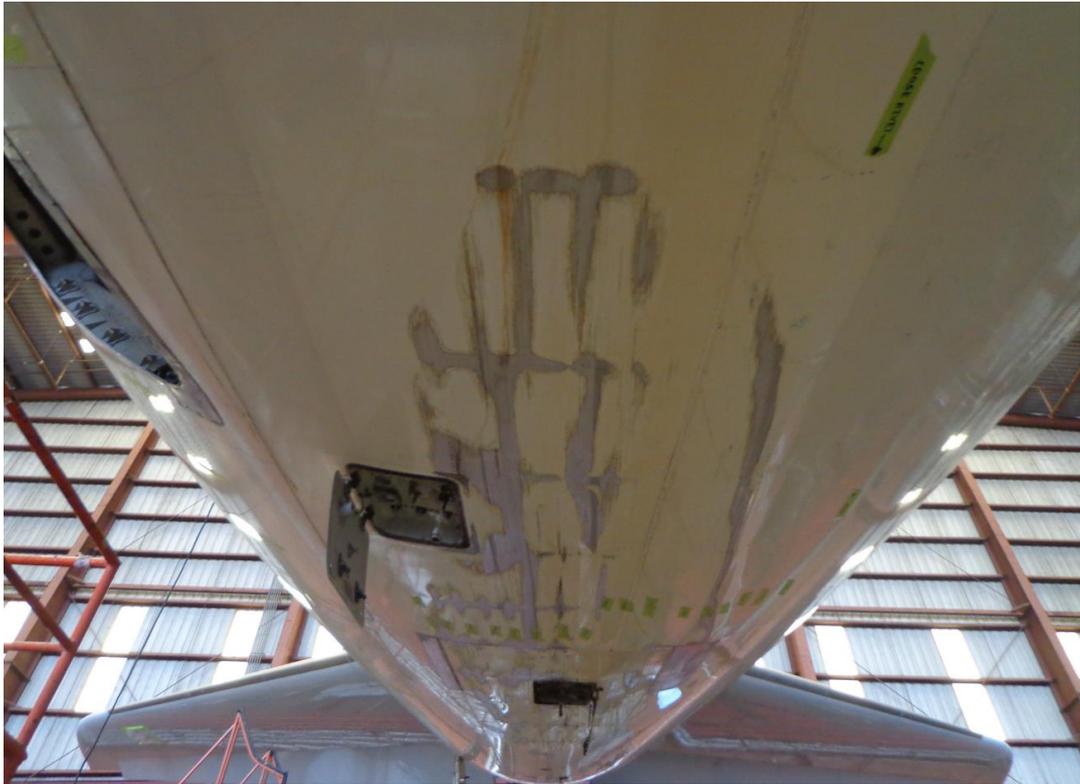
Figure 9 - Aircraft scratch marks

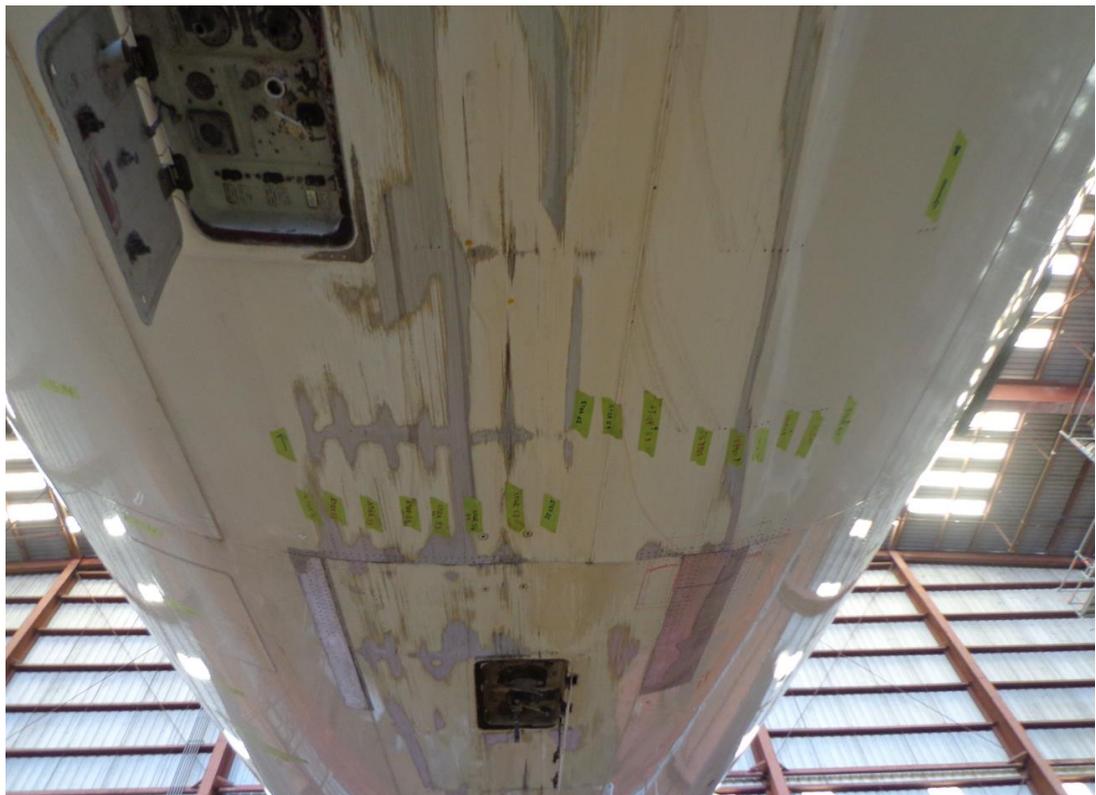
Figure 10 - Aircraft scratch marks
