RE-OPENED ACCIDENT INVESTIGATION REPORT OF LION AIR FLIGHT LN602, EW 46465

Civil Aviation Authority of Sri Lanka

ACCIDENT INVESTIGATION REPORT OF LION AIR FLIGHT LN602, EW 46465

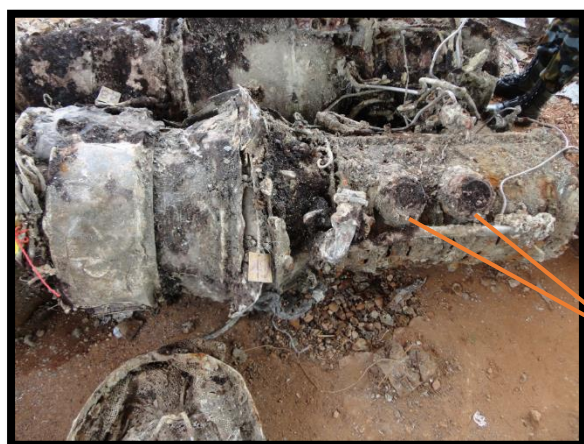
Fig 1

Engine: The wreckage of the engine recovered was badly damaged. Part/ serial numbers were not visible. The accessory gear box area was not intact with the engine. The propeller shaft was available and connected to the hub. A comparison of the wreckage (Fig 1) with a picture of an actual engine (Fig 2) is made below. With the external appearance and the size it is considered as a fair match to an engine type 'AI 24', fitted to AN 24 aircraft.

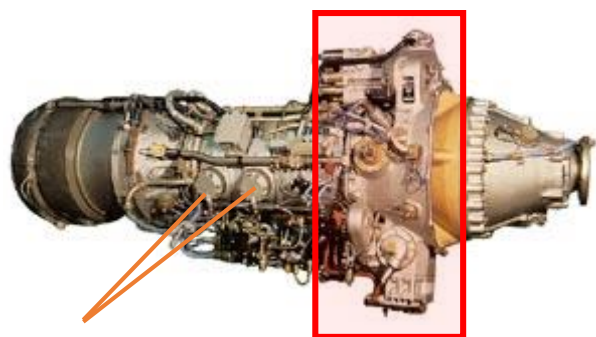
Fig 2

Bleed valves

Missing part of the engine wreckage

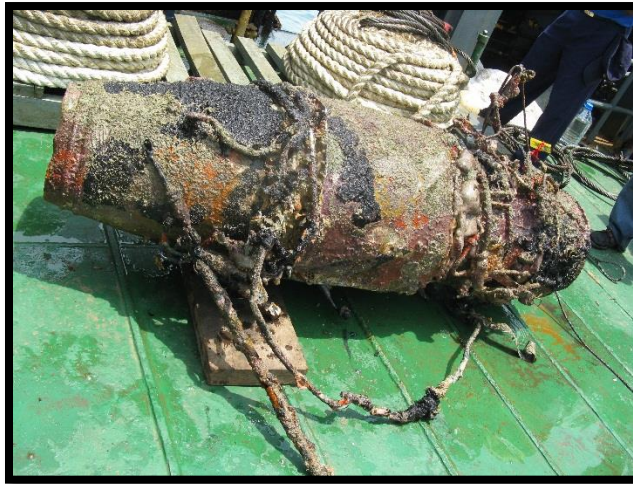
Fig 3

APU is the power generating unit of an aircraft which generate electrical power, as an alternative power source in addition to the main power sources coupled to the engine. The APU that was found was a single piece. (Fig 3) After the cleaning process, several numbers were found in multiple locations in the APU housing (Fig 4). These numbers were communicated to Antonov Design Bureau, Ukraine, and State of Registry, Belarus but a response has not been received at the time of writing of the report. Fig 5 & 6 are extracts from AN 24 Technical Guidance Manual.

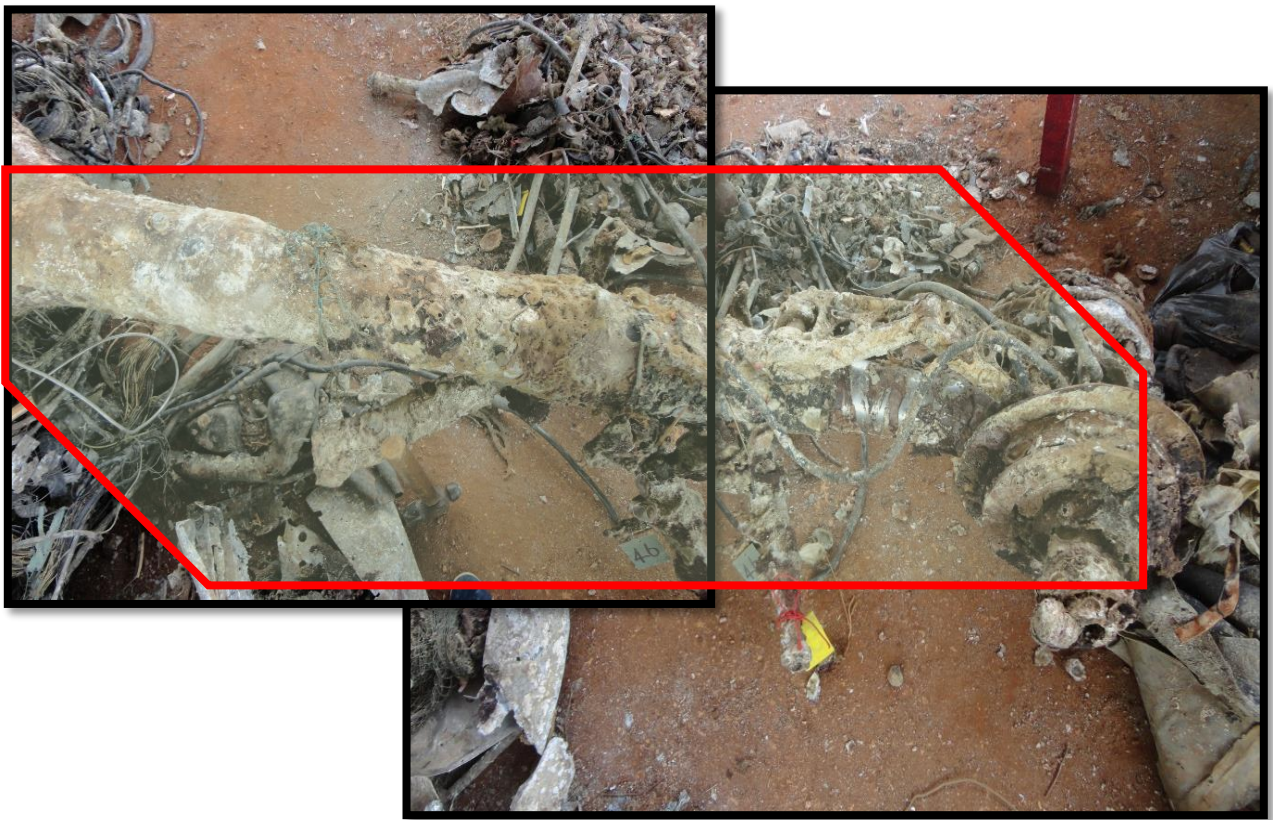
Fig 7

The MLG which was recovered was found in highly deteriorated state without the wheel (Fig 7). The complete strut was intact from yoke to axel (Fig 8) and no other damages observed other than metal fraying due to prolong dunk in the sea water. Break units were attached to axels. No part/serial numbers were found even after subsequent cleaning enabling investigators to establish facts on the identity of debris.

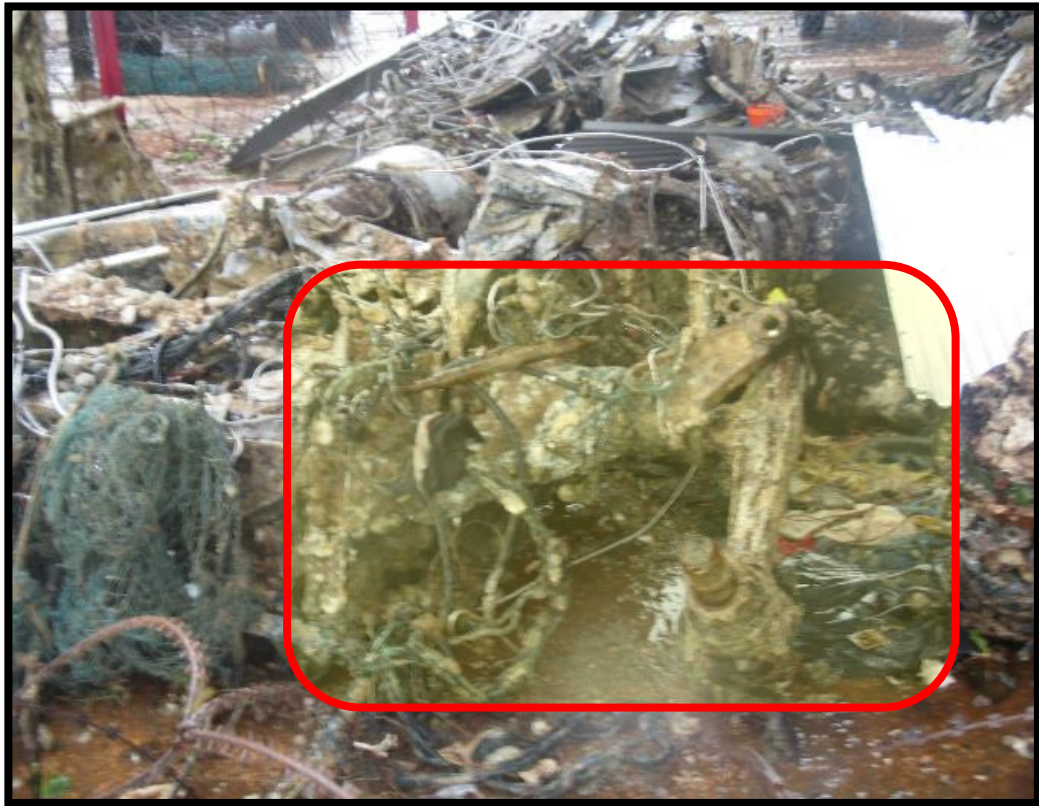
Fig 9

Nose Landing Gear (NLG): The nose strut which was recovered was attached to a part of the airframe (Fig 9). The location is marked in the side elevation diagram of the Aircraft (Fig 15). There were no Part/ Serial numbers found.

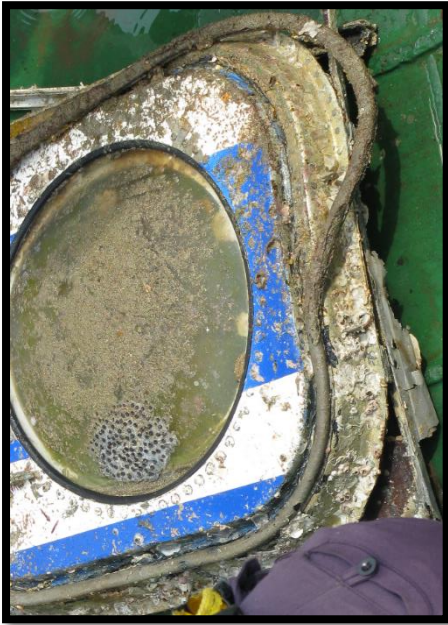
Fig 11

A part resembling an emergency exit of an AN 24 aircraft has been recovered. The painting found on this part is somewhat similar to external appearance of aircraft operated by Lion Air. (Fig 11 & 12). A placard containing the opening instructions of the emergency exit was found in the wreckage (Fig 13).

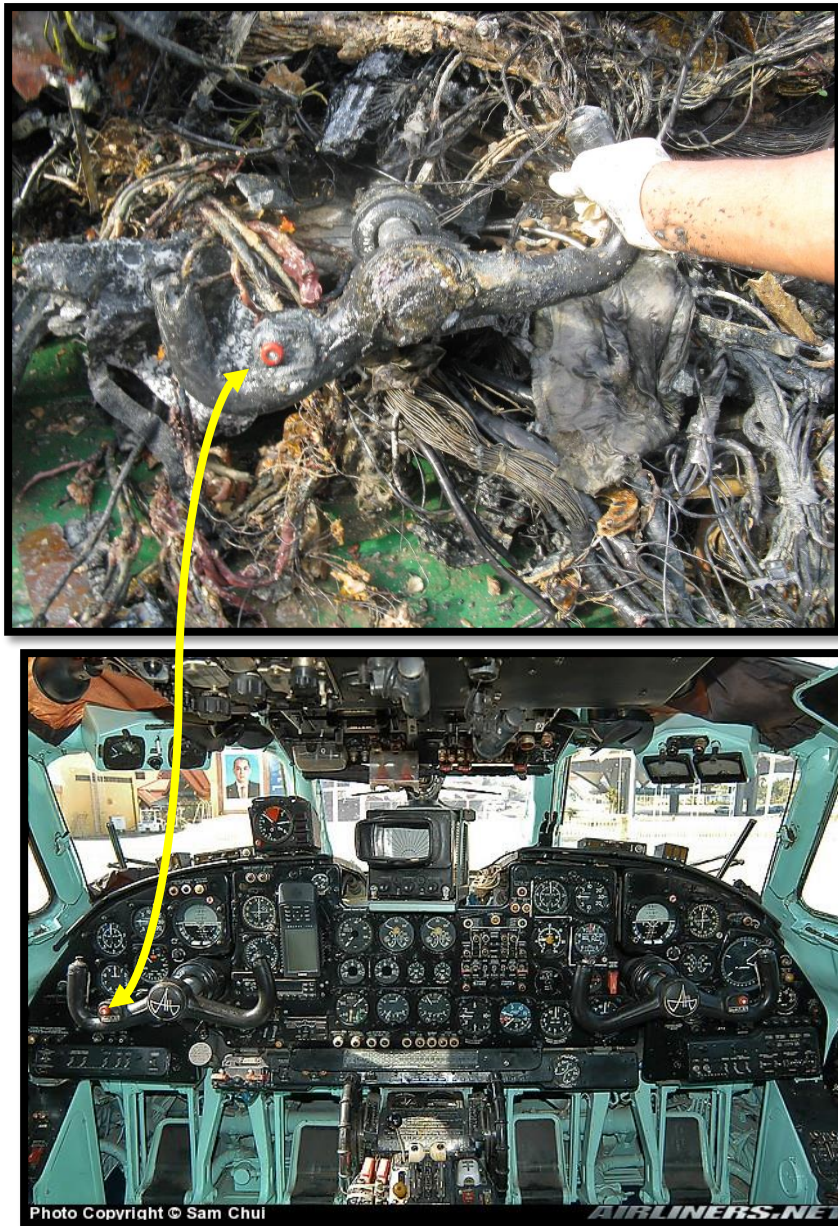
Fig 14

Control Column: Appearance and size matches to that of an AN-24 aircraft left side control column since the red button that is found in the part which was recovered is located on the left hand side of the control column. (Port) (Fig 14)

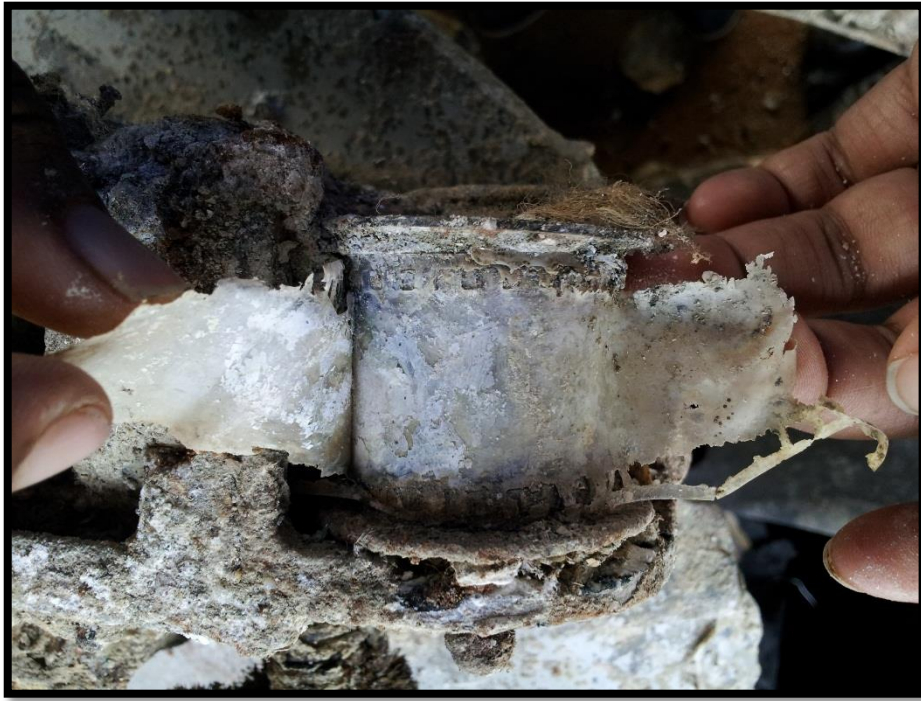
Fig 16

DATA Recorder: No evidence of debris was found to be that of CVR or FDR. But a highly corroded and damaged debris which has been confirmed by the manufacturer as the Auxiliary data recorder.
