FINAL REPORT

**INCIDENT OF SRILANKAN AIRLINES
FLIGHT UL121 AIRBUS A330, 4R-ALC
ON 13TH OCTOBER 2008
AT CHENNAI INTERNATIONAL AIRPORT
INDIA**

**AIRCRAFT INCIDENT REPORT****SYNOPSIS:**

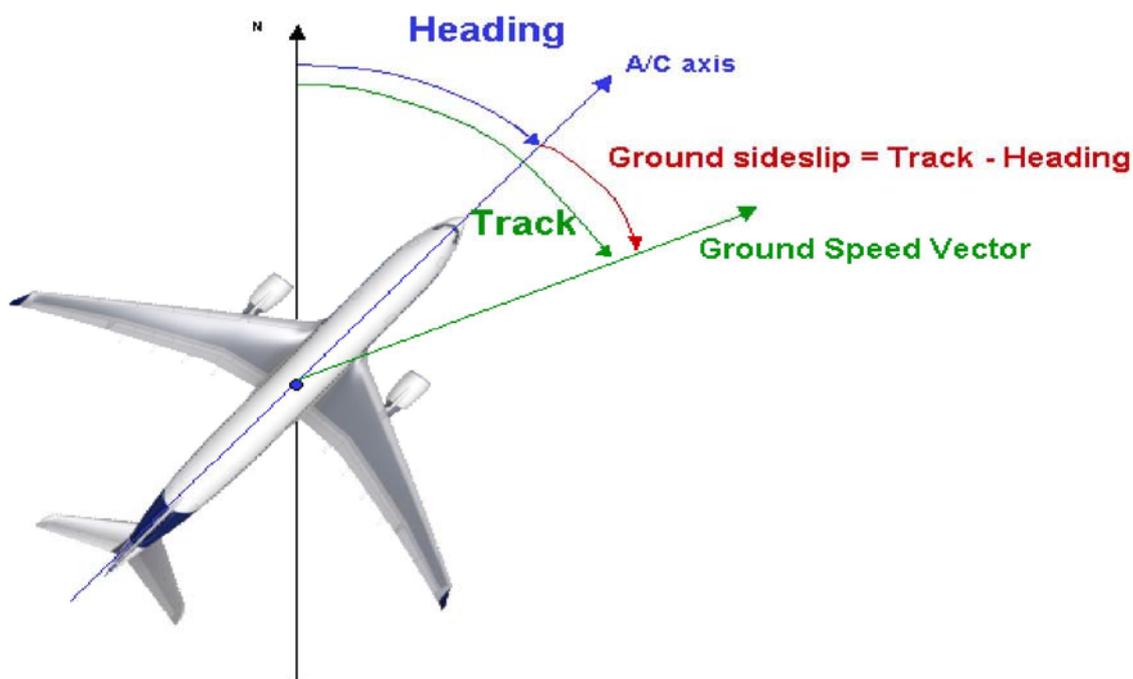
- Let the aircraft rolled to the left leading to an increase of aircraft deviation to the left of the runway axis
 - Performed a right ruder pedal leading to an aircraft nose movement to the right, which created an aircraft sideslip. As a consequence, subject action corrected the aircraft heading but not the aircraft track => Aircraft trajectory was not centered on the runway centerline at time of touchdown

- ◆ After touchdown, aircraft slid □ subject sliding is due to the difference between the track and the heading at time of touchdown associated with a wet runway.
