## FINAL REPORT

**Aircraft Incident of Sakurai Aviation Academy,  
Piper PA 38-112 Tomahawk, bearing registration no 4R-ASJ, emergency landing  
at Payagala Beach, Kaluthara, Sri Lanka on 22<sup>nd</sup> December 2021**

Released by the Civil Aviation Authority of Sri Lanka

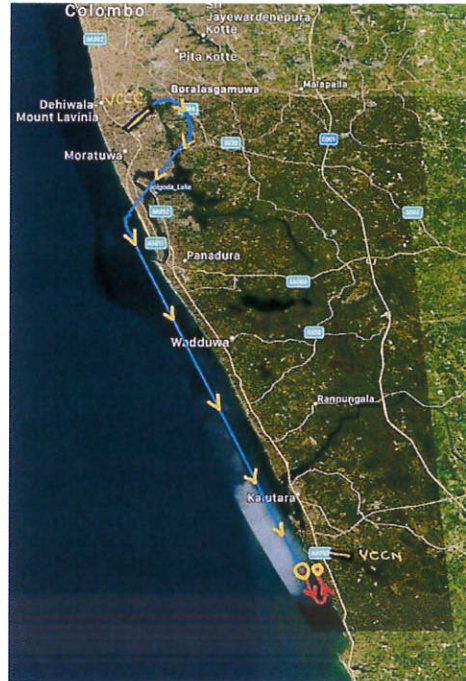
Figure 01: Flight Path

The other occupant had informed the ATC Tower that they were unable to make it to the runway. Subsequently, the PIC had carried out the emergency landing at Payagala beach approx. at 1332hrs (LT).

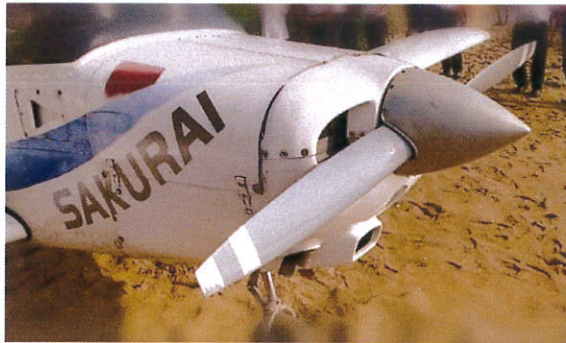
Figure 03: 4R-ASJ, Propeller front view

There was no extensive damage to the aircraft, except the damage on the aircraft left main wheel assembly. As the left main wheel had hit a reef during landing, it was found with a big hole on the outer side wall of the tyre and the wheel hub was found with an impact damage.

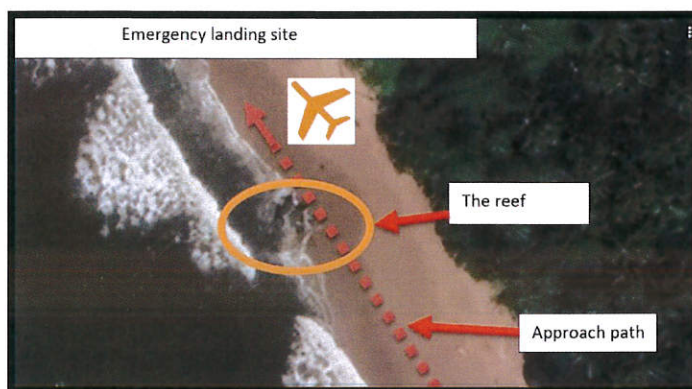
Figure 07: Landing area at Payagala Beach

The aircraft had carried out an emergency landing at the Payagala Beach located in Kaluthara District, in south west coastal line of Sri Lanka, which is a sandy, soggy surface with a slight sloping angle.

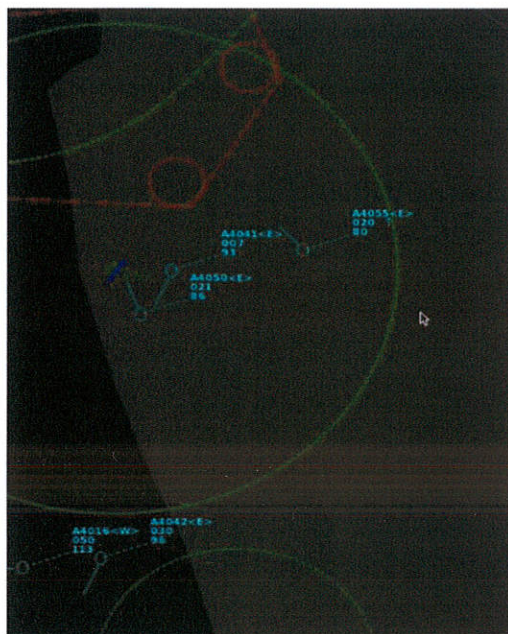
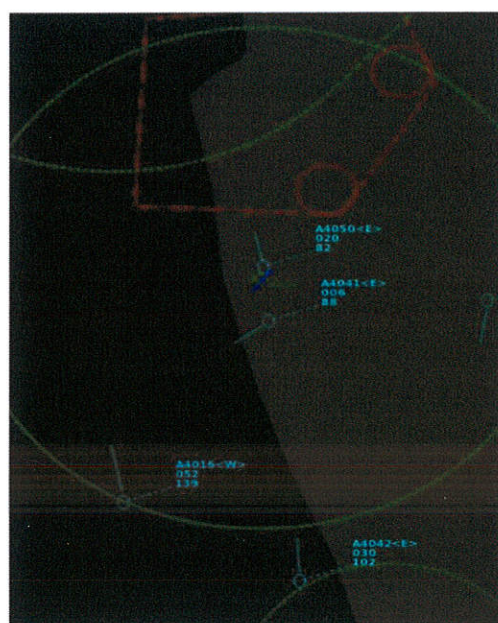
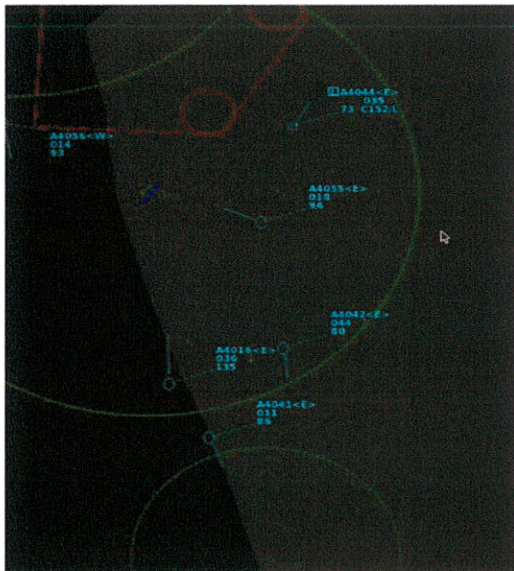
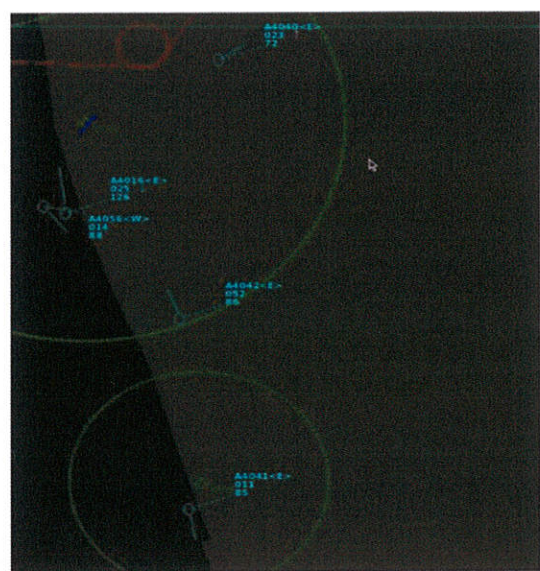
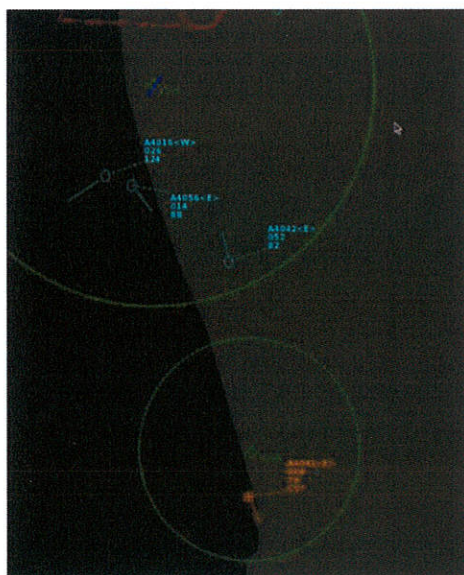
Figure 08: five Radar Images of the flight

As an useful investigation technique, radar images were superimposed with the Radio calls recorded with VCCC and VCCN. The flight path was simulated and found the flight time, directions and the speeds were tallying as per the statements provided by the PIC and the other occupant.

01-Climbing off from Runway 04 of VCCC at 700 feet and 93 Kts, joining the right downwind at the end of the crosswind.

02. Climbing at a speed of 88 Kts at 600 feet in right downwind area south of VCCC.

03. Cruising along the coast line towards south of VCCC at a height of 1100 ft and at a speed of 86 Kts.

04. Encountering the power loss passing VCCN at the height 1100 feet and speed of 85 Kts.

05. The last blip of the 4R-ASJ indicating in red colour at 700 feet and the speed of 78 Kts south west of VCCN.

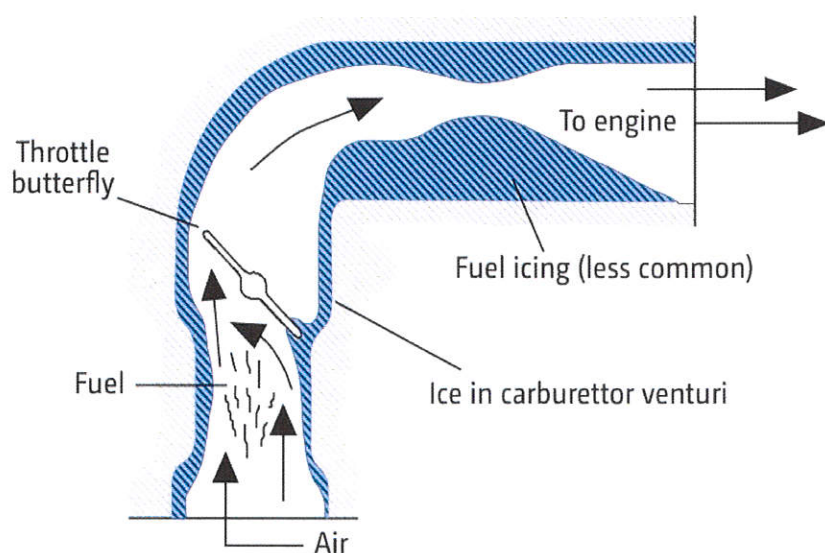
Carburetor icing occurs as a result of vaporization of fuel and a reduction in pressure as the fuel & air mixture passes through the venturi in the carburetor. These effects cause a drop in the temperature which, if it falls below the dew or freezing point of water, will result in ice forming on the sidewalls and the butterfly valve in the carburetor. As the ice builds up, it gradually blocks the venturi and alters the fuel / air balance which causes the engine to run roughly and lose power.

Carb icing is not restricted to cold weather. It could occur even on warm days if humidity is high, especially at low power settings.

Figure 13: The formation of carburetor ice may reduce or block fuel – air - flow to the engine

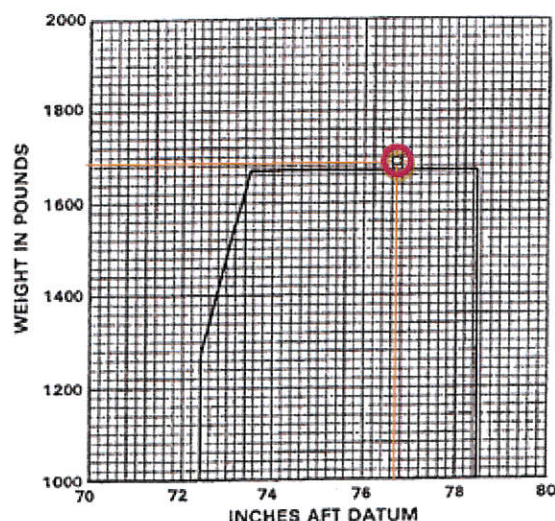
**Centre of gravity limits**

As per the weight and balance graph, loaded moment remained within the given limit of Centre of Gravity (CG) by the Manufacturer. However, it was observed that the aircraft was overloaded since the total weight exceeds the Maximum Take-Off Weight (MTOW) by 41 Lbs. (Refer Appendix: 08)
