FINAL REPORT

**Aircraft Accident of Sakurai Aviation Limited, Cessna 172L Skyhawk
bearing registration mark 4R-GAF crash-landed
at Kimbulapitiya, Negombo, Sri Lanka on 27th Dec 2021**

Released by the Civil Aviation Authority of Sri Lanka

Issued on: 13th July 2023

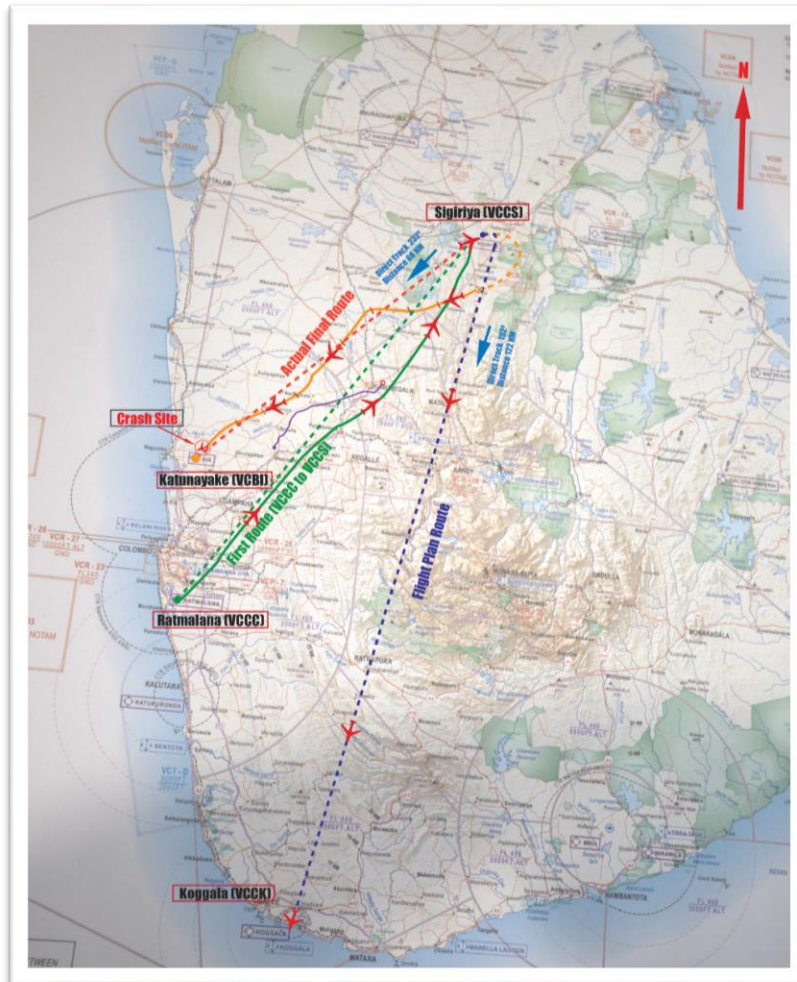
Figure 01: Actual flight path & planned flight path

As per the PIC, the aircraft had encountered an engine RPM fluctuation and subsequent engine failure. Although the flight plan destination was to VCCK, the aircraft had approached runway 22 at VCBI for an emergency landing. While approaching VCBI, the PIC had declared “MAYDAY” and crash landed in a paddy field at Paththayam Watta, Kimbulapitiya, Negombo at approx. 1352hrs (LT).

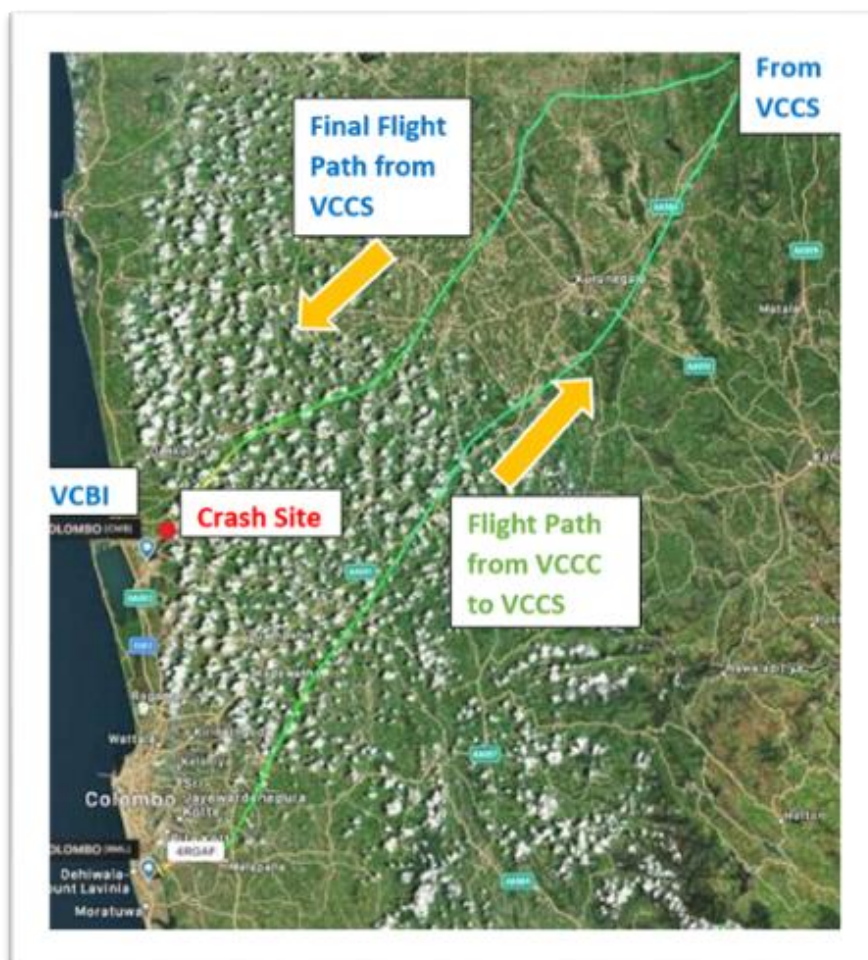
Figure 02: Flight Path (source: Radar 24)

The PIC stated that during descending close to 5000ft the aircraft engine was getting a bit rough and then he had observed the engine rough running with the RPM fluctuation while descending further from 5000ft to 3500ft en route from VCCS (Approximately 1339hrs, the area west of Kurunegala, Sri Lanka - Please refer *Figure 02: Flight Path -source: Radar 24 and Figure 16*).

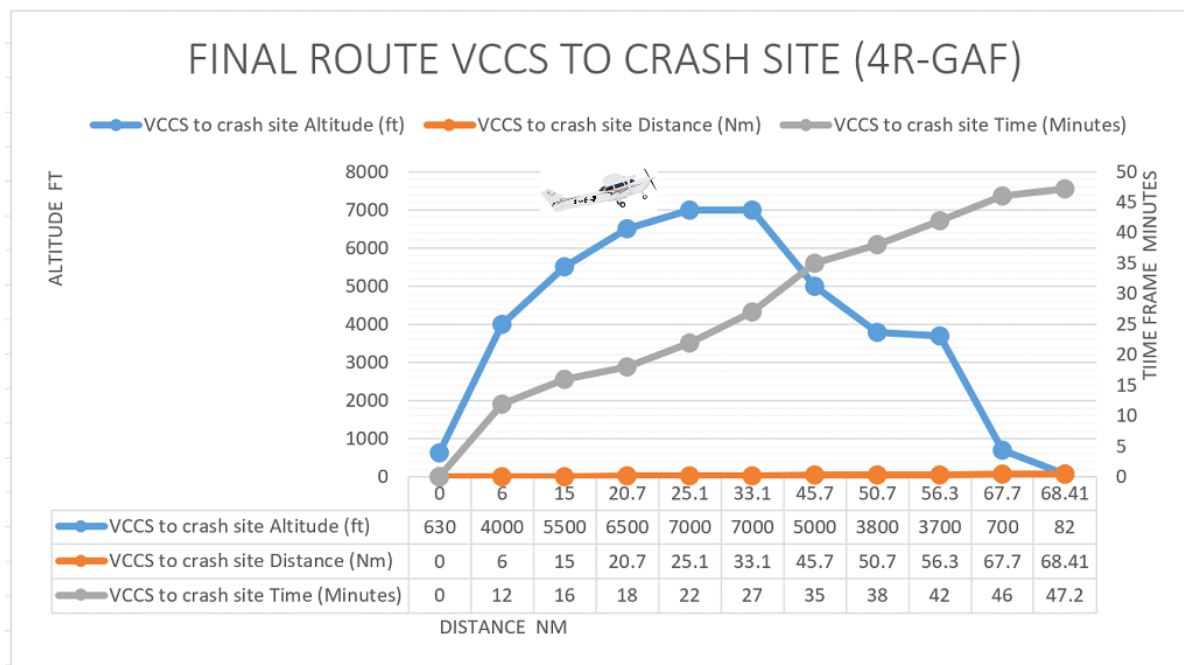
Figure 03: Final route from VCCS to the crash site

- At approx. 1304 (LT) hrs, 4R-GAF had departed VCCS with a total of four on board to proceed to VCCK. During en route to VCCK, the PIC had reported a technical problem to the Colombo Approach Control Centre while descending from 5000ft to 3500 ft. Subsequently, he had reported a partial engine failure at approx. 1341hrs (LT). The PIC had informed his intention to land at VCBI or else to carry out an emergency landing at a suitable place. The Controller at Colombo Approach Control Centre had advised the availability of both runways for landing at VCBI. The PIC had accepted runway 22 and informed that MAYDAY will be declared if necessary.

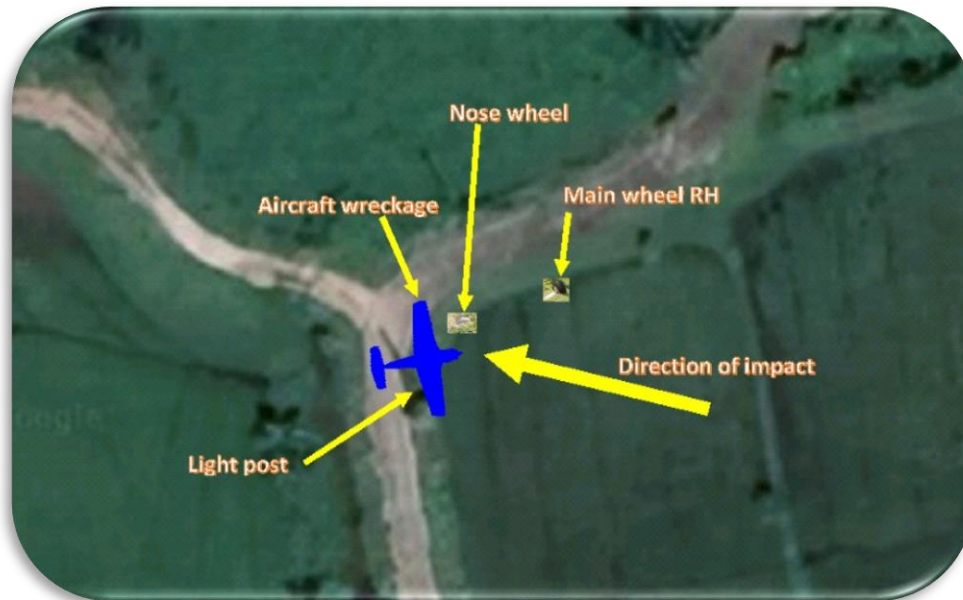
Figure 08: Landed area Paththayam Watta at Kimbulapitiya

The aircraft had crash landed on a paddy field. The nose wheel and right-hand main wheel had been separated and fallen at the crash site at distances from 13m and 38m from the aircraft. A Prominent ground marks were visible after landing in the rice paddy.

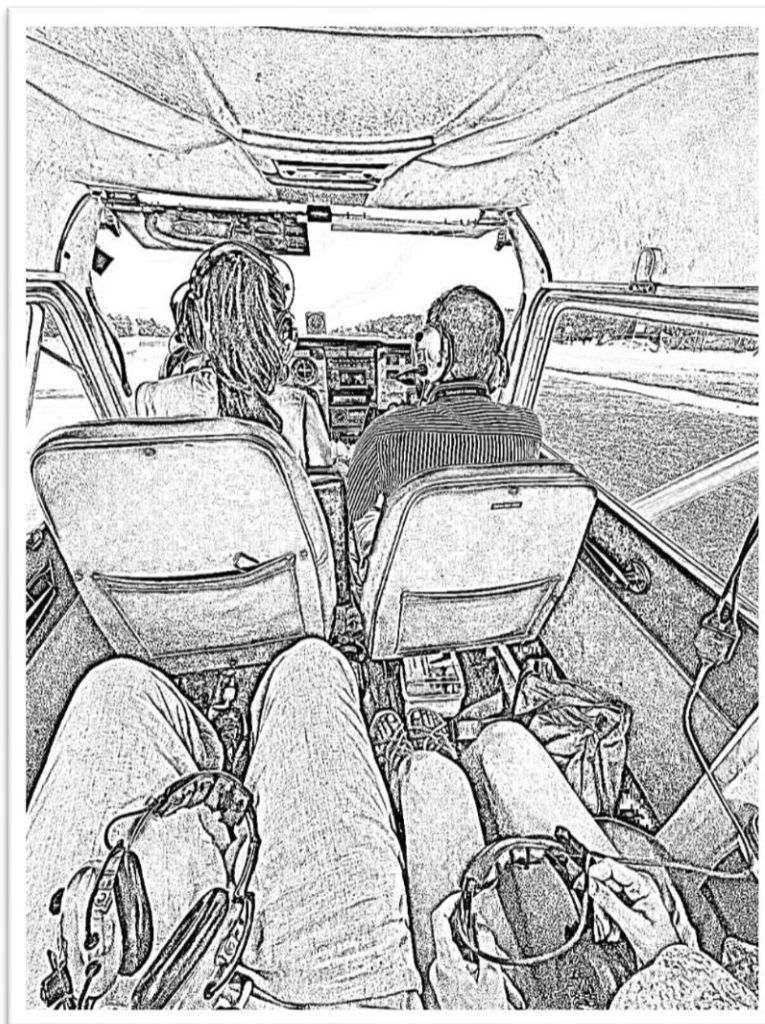
Figure 10: Seating View

With respect to the seating arrangements, the other occupant was seated in the L/H control seat whereas the male passenger was seated behind that seat. The female passenger who was injured was seated behind the R/H control seat which was occupied by the PIC.

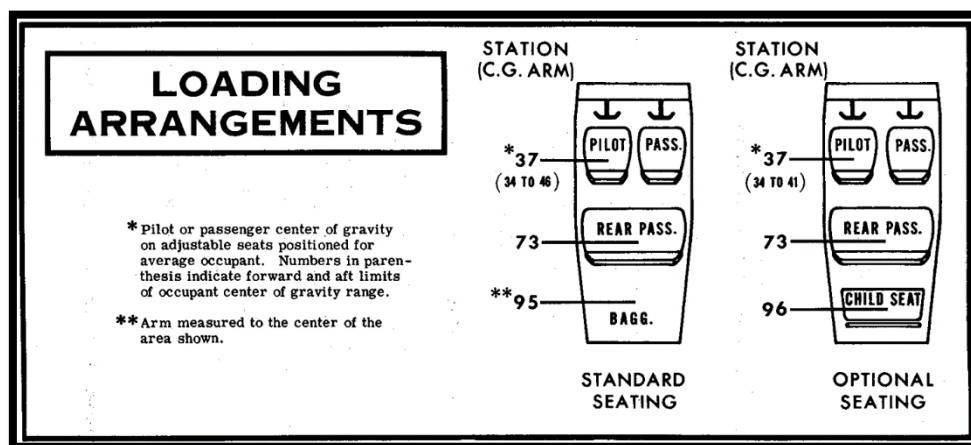
Figure 15: Loading Arrangement given in the Owner's Manual

According to the evidence, the PIC had occupied the right-hand seat and the other occupant had occupied the left-hand seat from the sector commenced from VCCS. Pursuant to the Section on "weigh & Balance" given in the Owner's Manual found on board requires the PIC to be occupied in the left-hand seat as the aircraft being a single pilot-operated aircraft.

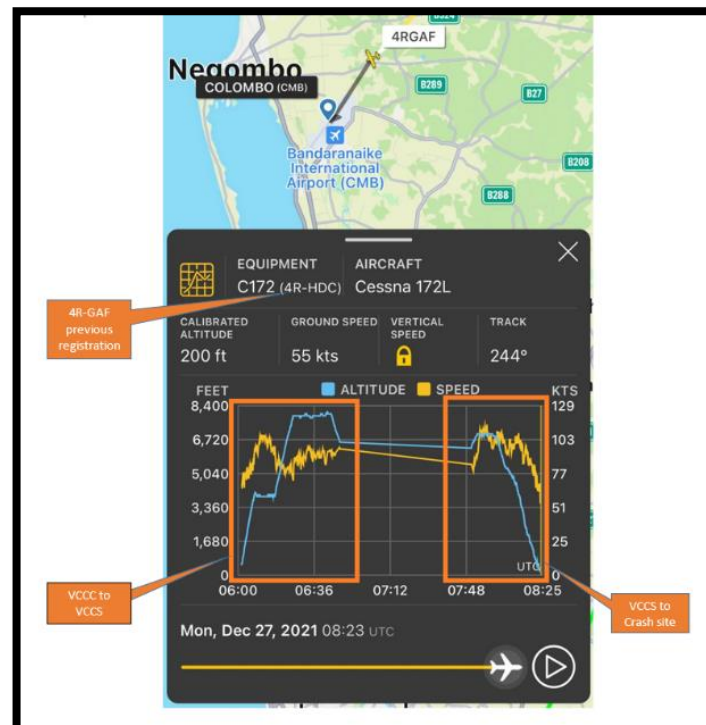
Figure 16: Altitude vs Speed chart (source: Radar 24)

It was probable that the technical issue of the aircraft had started 35 minutes after take-off from VCCS.

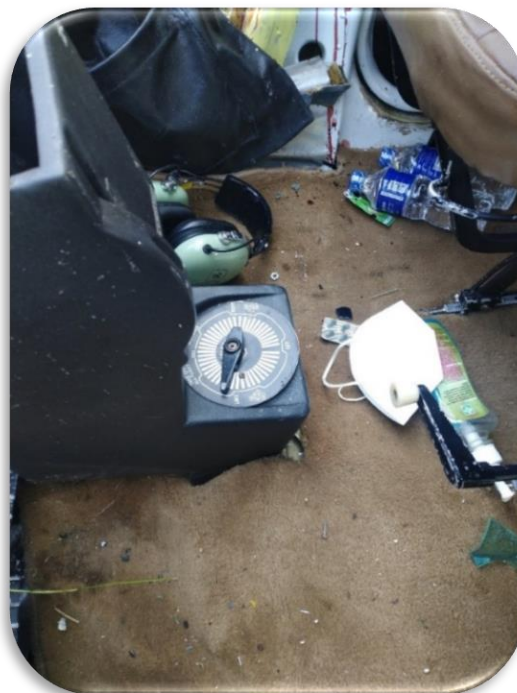
Figure 17: Fuel selector valve

According to the PIC, he had placed the fuel selector valve in the "BOTH ON" position when departing VCCS and it remained in that position until the accident. When the CAASL team arrived at the crash site, the fuel selector valve had been set to the "LEFT" position. The fuel selector valve in the aircraft is shown in *Figure 17*, below.

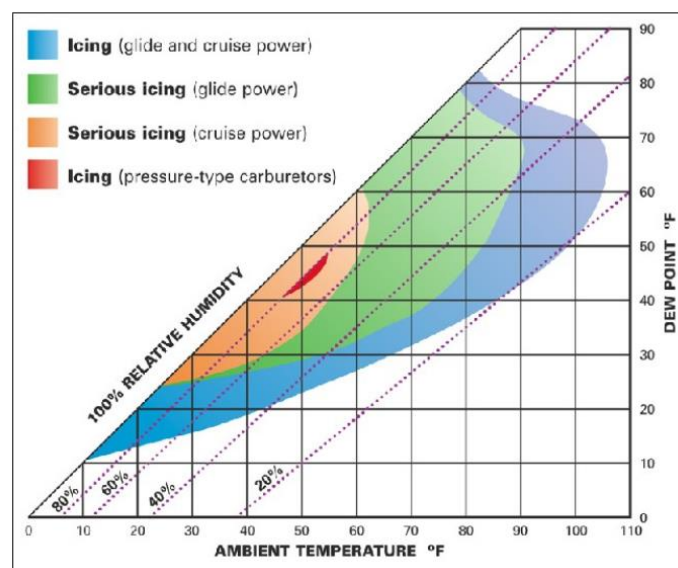
Figure 18: Carburetor icing chart

Carburetor icing doesn't just occur in freezing conditions, it can occur at temperatures well above freezing temperatures when there is visible moisture or high humidity. Icing can occur in the carburetor at temperatures above freezing because the vaporization of fuel, combined with the expansion of air as it flows through the carburetor, (Venturi Effect) causes sudden cooling, sometimes by a significant amount within a fraction of a second. Carburetor ice can be detected by a drop in RPM in fixed-pitch propeller airplanes. Usually, there will be a roughness in engine operation.

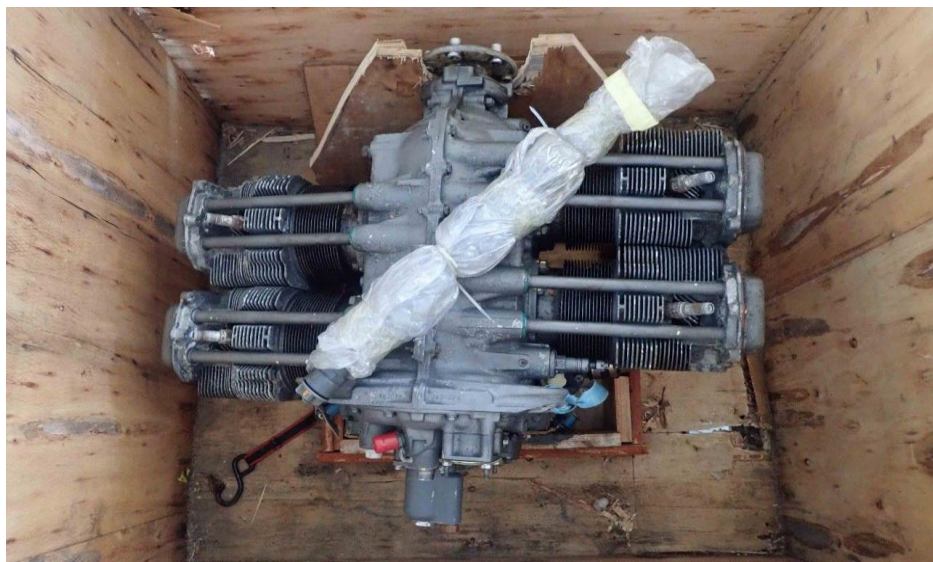
Figure 1 – Engine as-received

The engine arrived in a crate and was removed for examination (figure 1, below). The magnetos and carburetor had already been removed and examined separately.

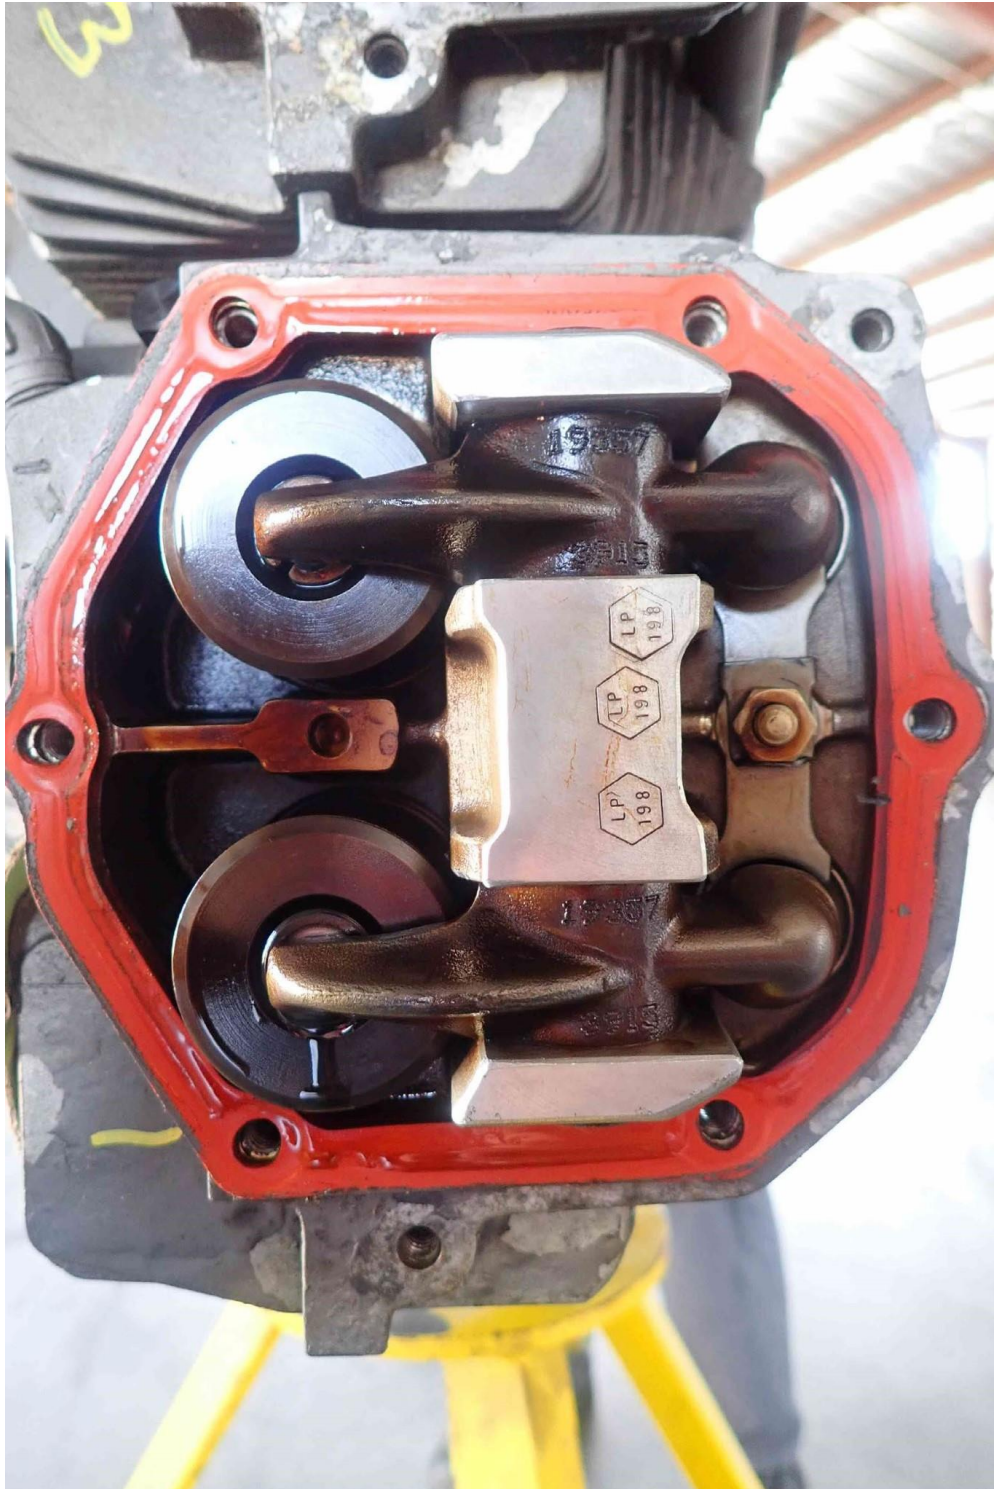
Figure 6 – Number 1 cylinder rocker assembly

The rocker covers were removed and the valve assemblies were intact. The rocker arms and springs were wet with oil and did not show evidence of seizure or excessive heat. The springs were intact, and all keepers were in place at the valve stems (figure 6).

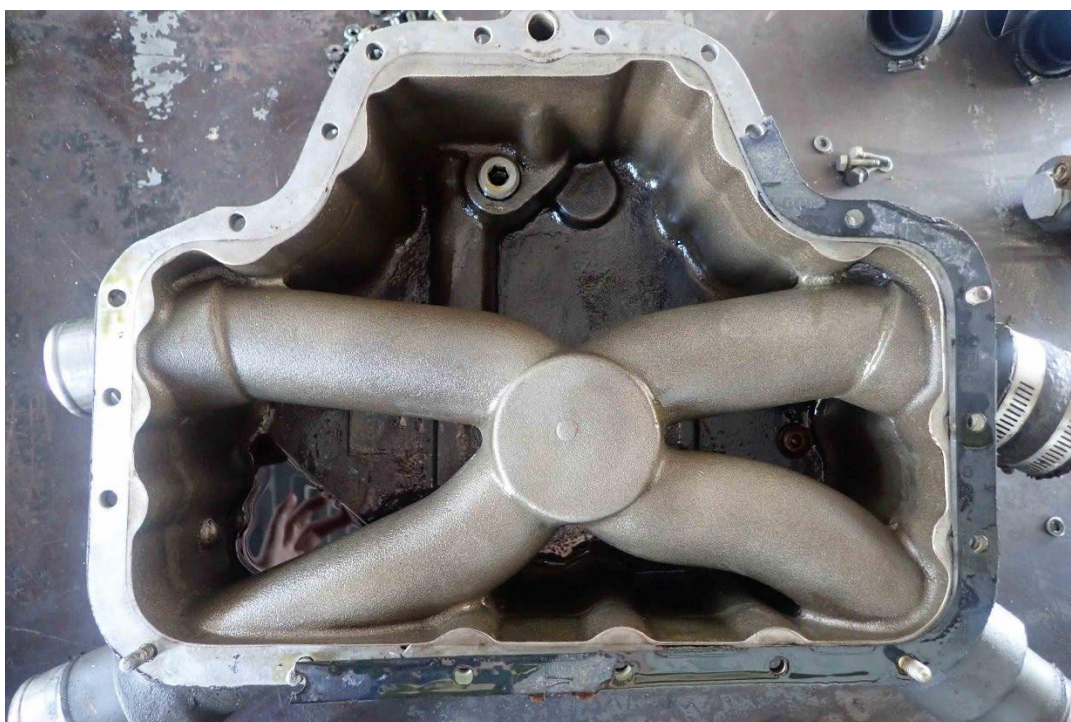
Figure 8 – Oil sump

The oil sump (figure 8) and accessory case (figure 9) were removed and appeared intact. All accessory gears were clean, and coated in oil (figure 10, 11). There was no evidence of gear damage, and the crankshaft gear dowl was in place.

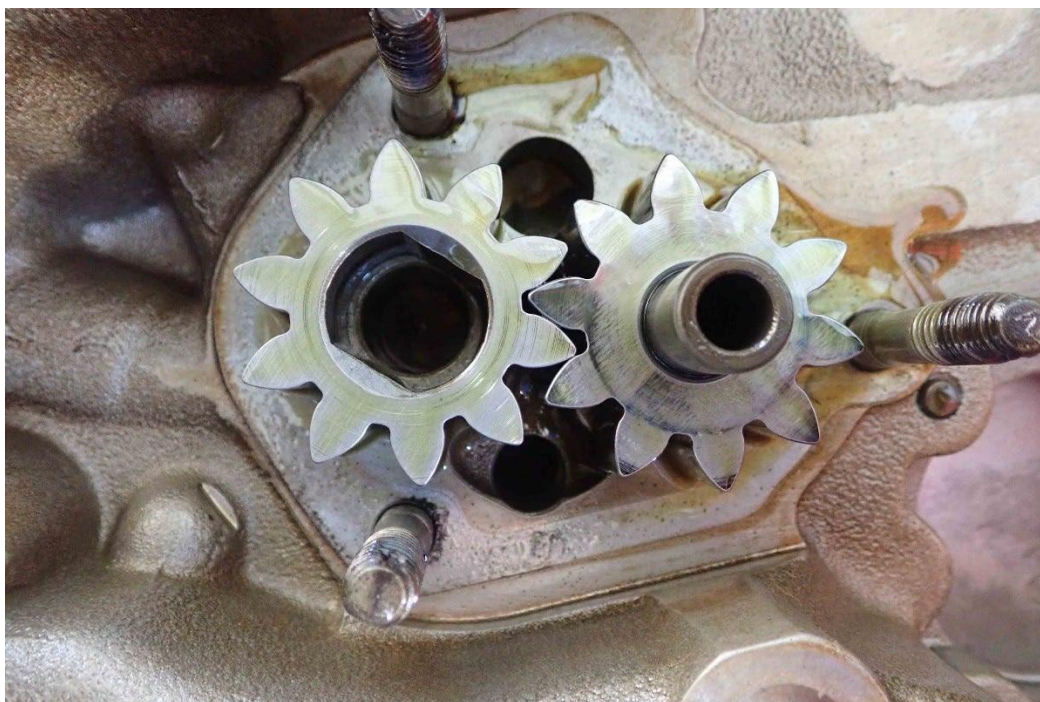
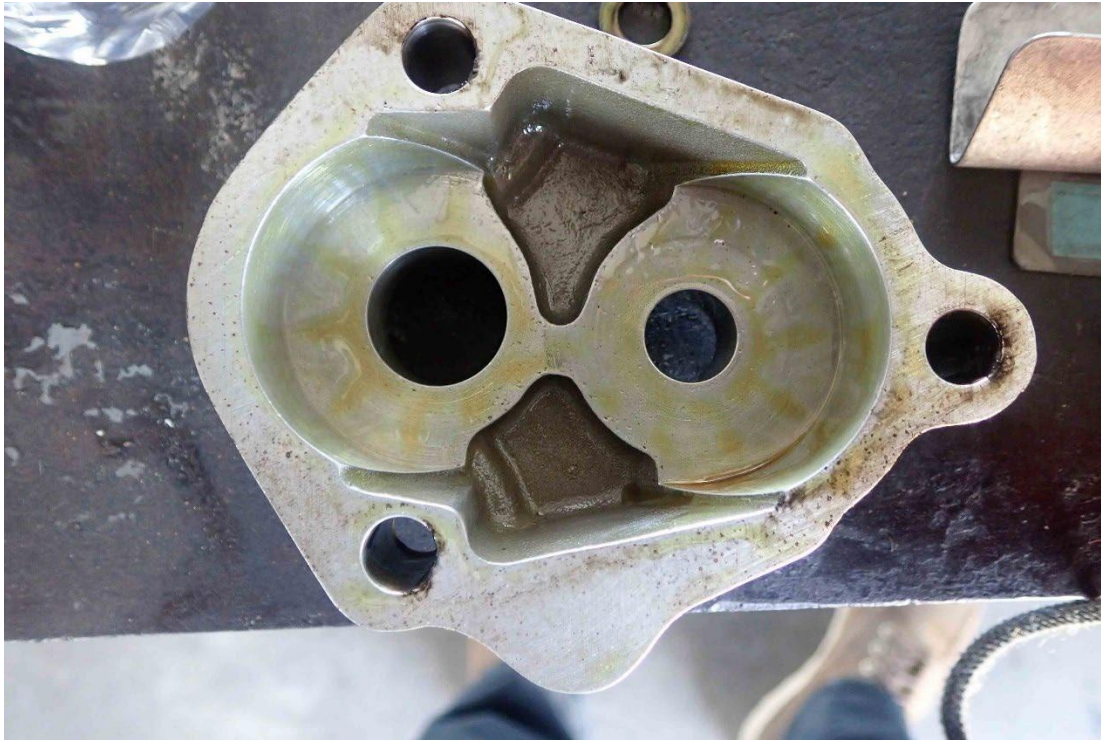
The oil pump gears, and corresponding pump cavity were clean, coated in oil, and did not display any gouges or evidence of distress (figure 12,13).

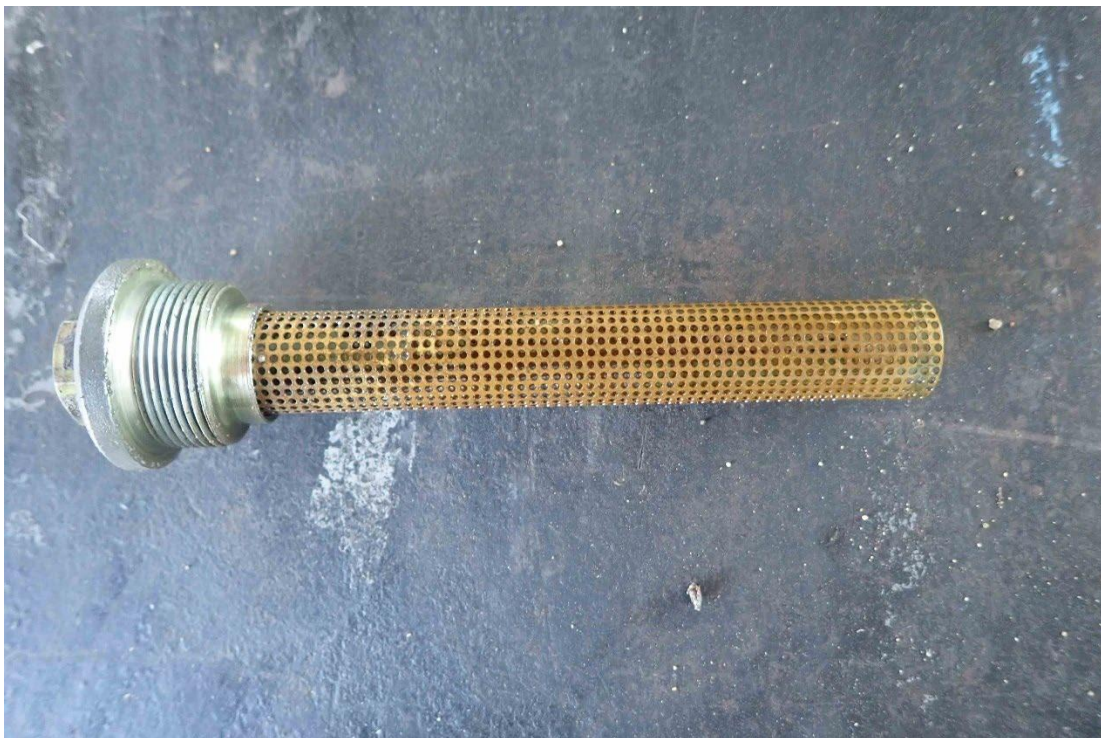
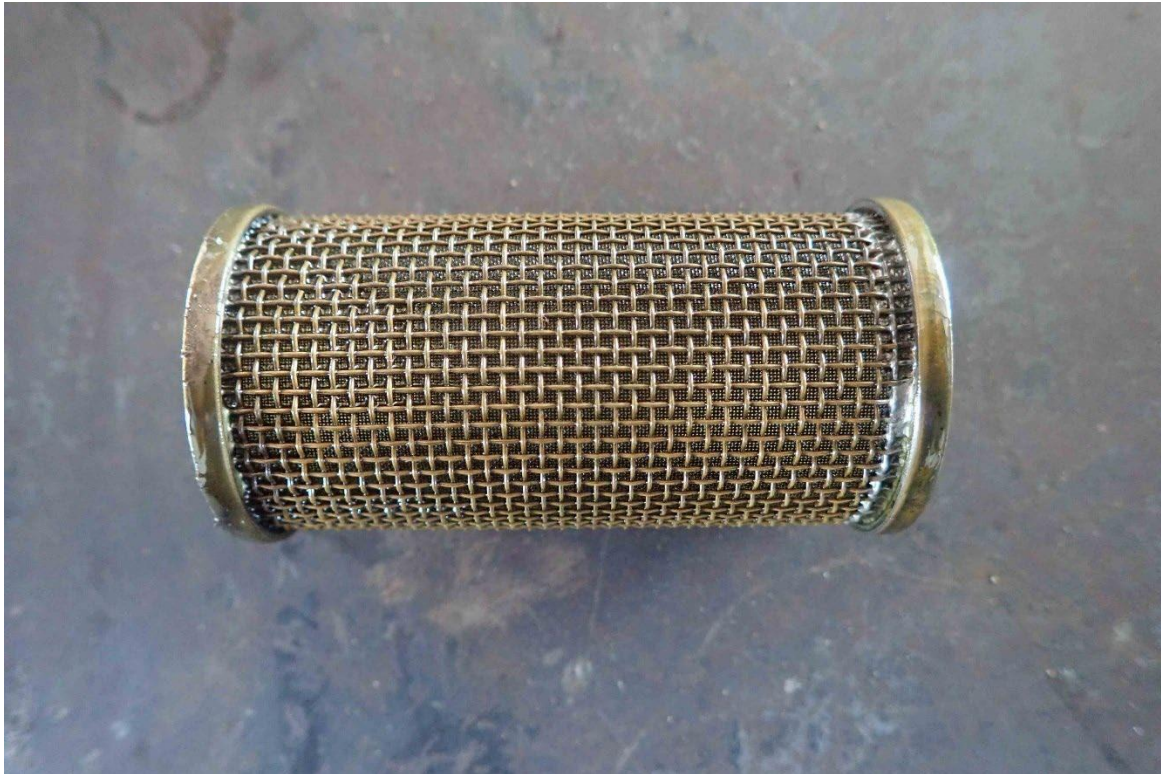
Both the oil suction screen and the main oil screen were free of debris (figure 14, 15).

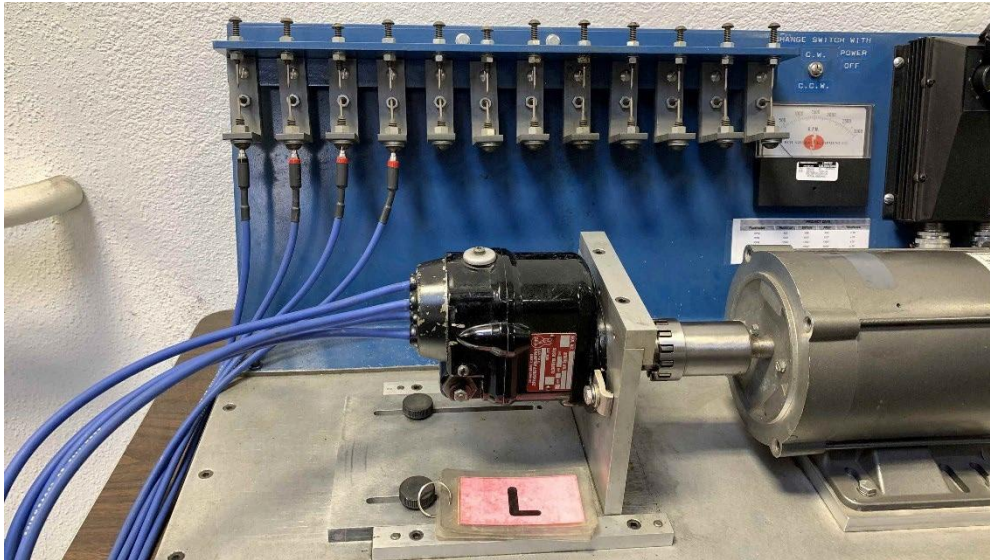
Figure 1 – Left magneto on test stand

The unit was installed in a magneto test stand and operated at speeds from 500 to 2,500 rpm. All output leads produced a spark in sequential order, with no indication of hesitation or misfire (photo 1).

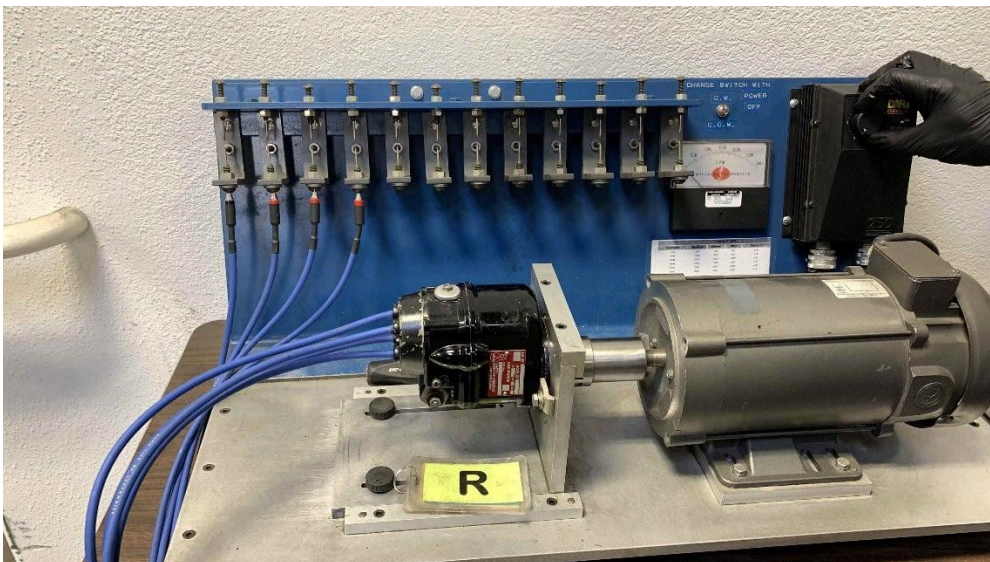
Figure 2 - Right magneto on test stand

The unit was installed in a magneto test stand and operated at speeds from 500 to 2,500 rpm. The magneto did not produce a spark at any lead at all speeds (photo 2).

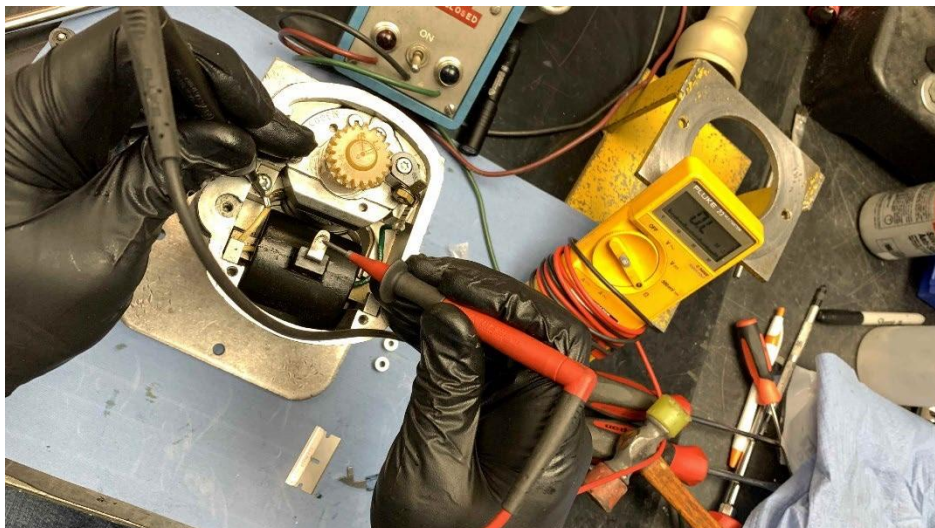
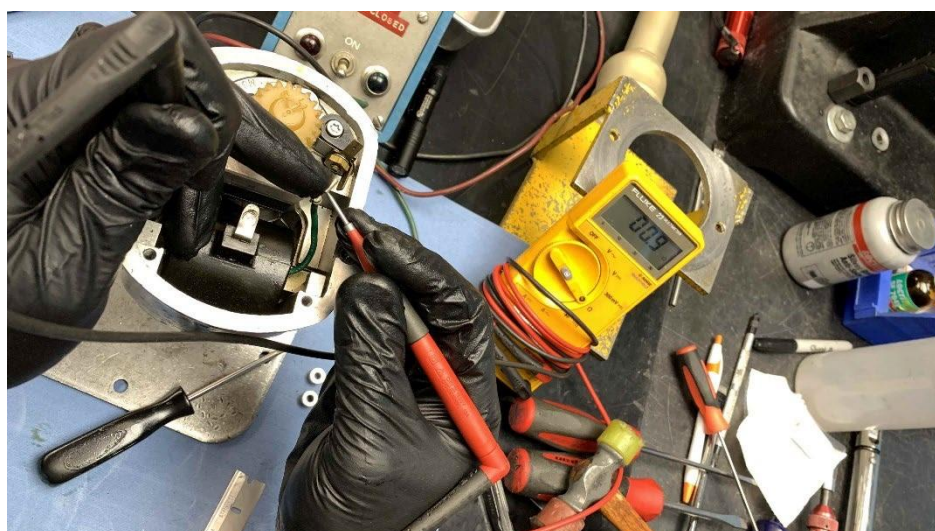
The coil was tested in place with an ohmmeter, revealing an open circuit in the secondary winding, rather than the standard resistance of between 13 K ohms to 20.5 K ohms (photo3). The primary winding measured 0.9 ohms (nominal between 0.5 and 1.2 ohms), (photo4).

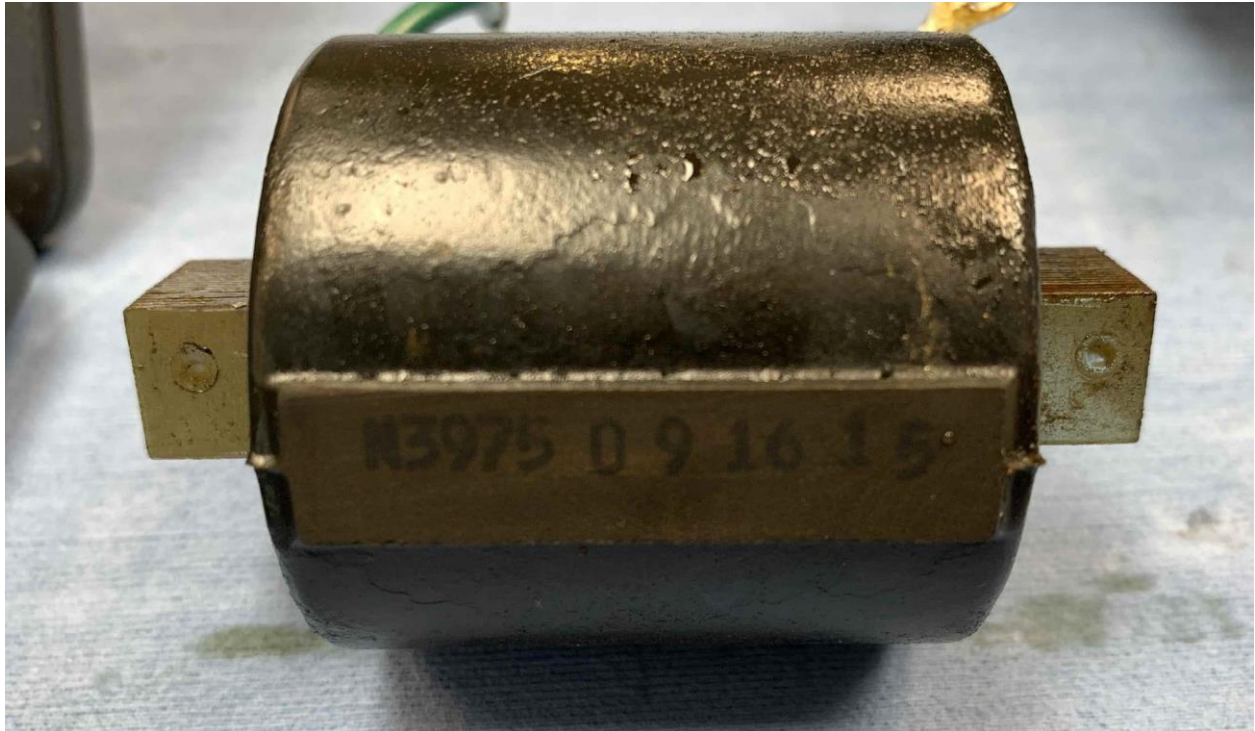
Figure 5 – Coil with data code

The coil date code was from 2015, indicating that it was likely the original coil (photo 5).

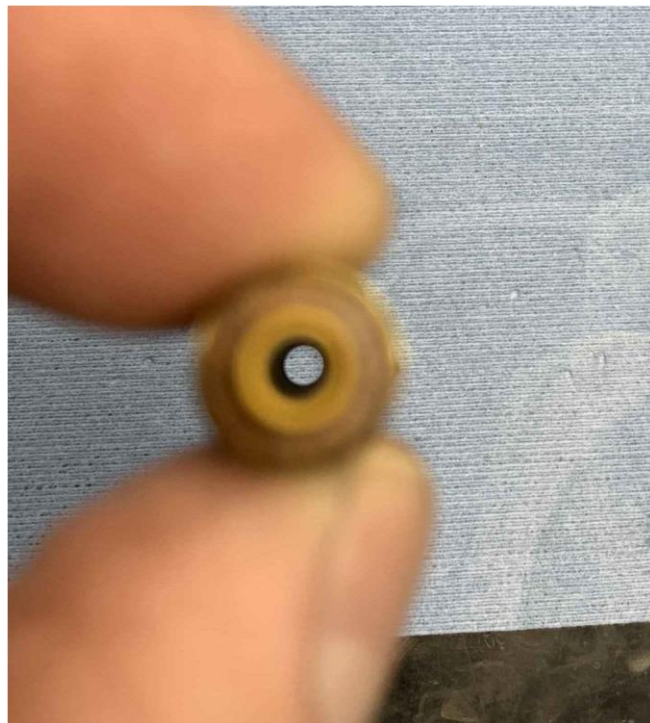
Figure 6 – Main jet passage

A strong smell of automobile gasoline was present within the bowl, which was free of debris or containments. The idle and main jets were clear, and the float valve was pliable and undamaged, (photo 6, 7,8). All internal ports and chambers were clear.

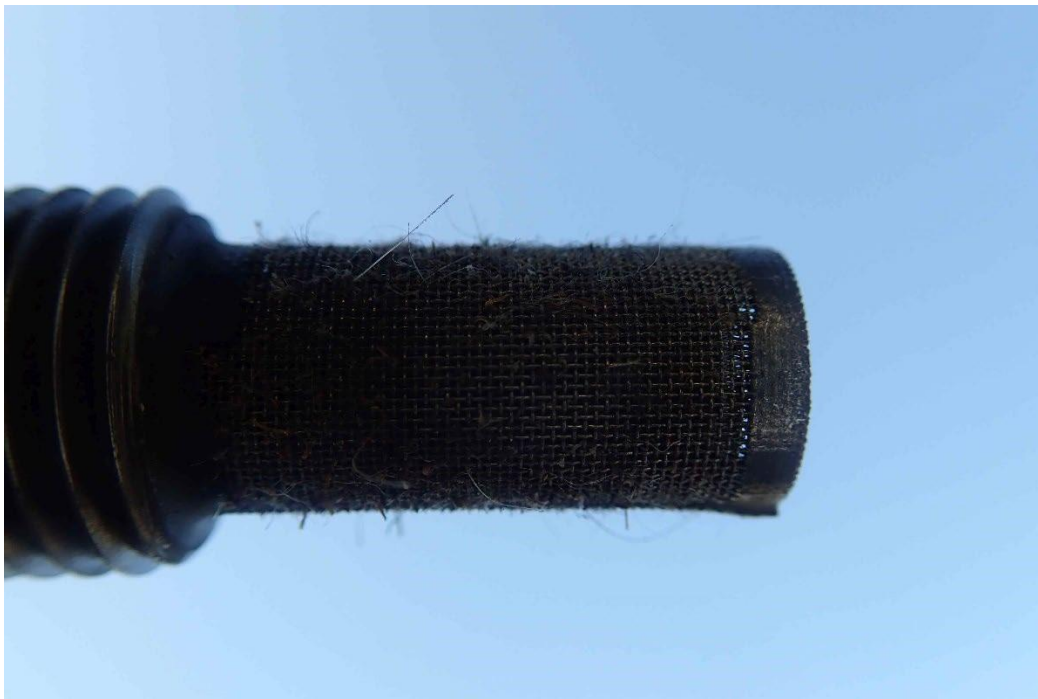
Figure 10 – Fuel inlet strainer

Examination of the magnetos and carburetor was conducted at FAA repair station TZ3R885L in Simi Valley, California on March 14, 2022. Examination revealed that the right magneto was inoperative due to a failed coil (secondary side). No anomalies were noted to the carburetor, except for its fuel inlet strainer, which was almost completely occluded with a fibrous material.

Removal of the fuel inlet strainer revealed that it was almost completely blocked a fibrous lint-like material (photo 10, 11, 12)
