FINAL REPORT

**SriLankan Airlines Flight UL 303,
Airbus Industries A330-343, bearing registration
4R-ALP, Go Around due to
Wind Shear, during final approach to
Bandaranaike International Airport, Katunayake
on 05th July 2023**

Released by the Civil Aviation Authority of Sri Lanka

Issued on: 06th Sept 2023

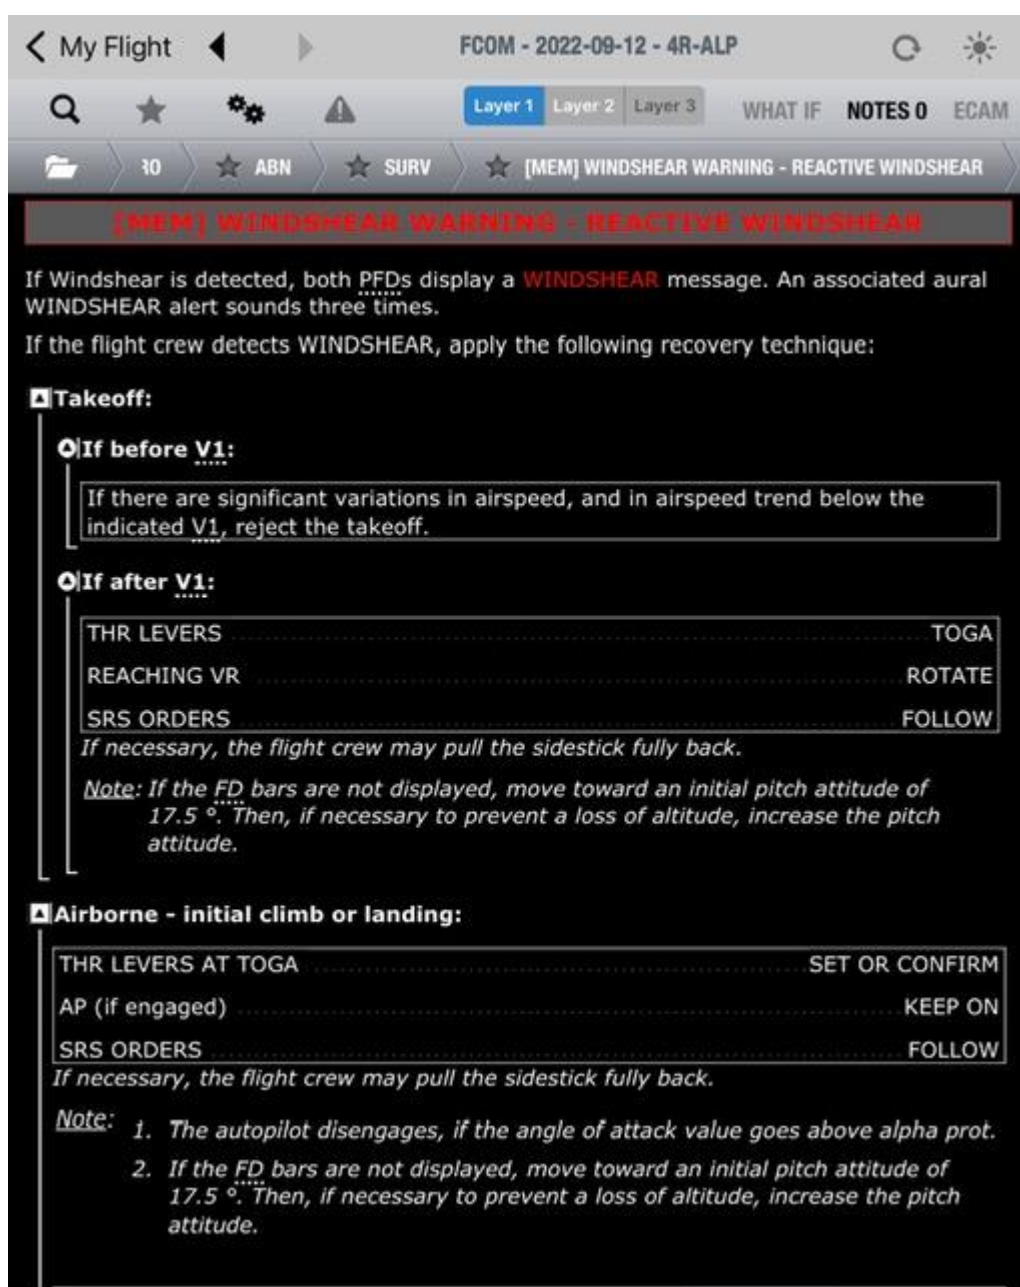
Figure 5: SOP – FCOM A330 for Wind Shear

SriLankan Airlines UL303 A330 aircraft fully configured and fully established on ILS approach for RWY 22 initiated a Go- Around at 1163 ft (RA) on encountering wind shear condition. As per the Standard Operating Procedure (SOP) of FCOM A330 for Go-Around, the flight crew must consider Go-Around if stabilised approach is impossible. In the case of wind shear it is a mandatory requirement for the flight crew to initiate a Go-Around.

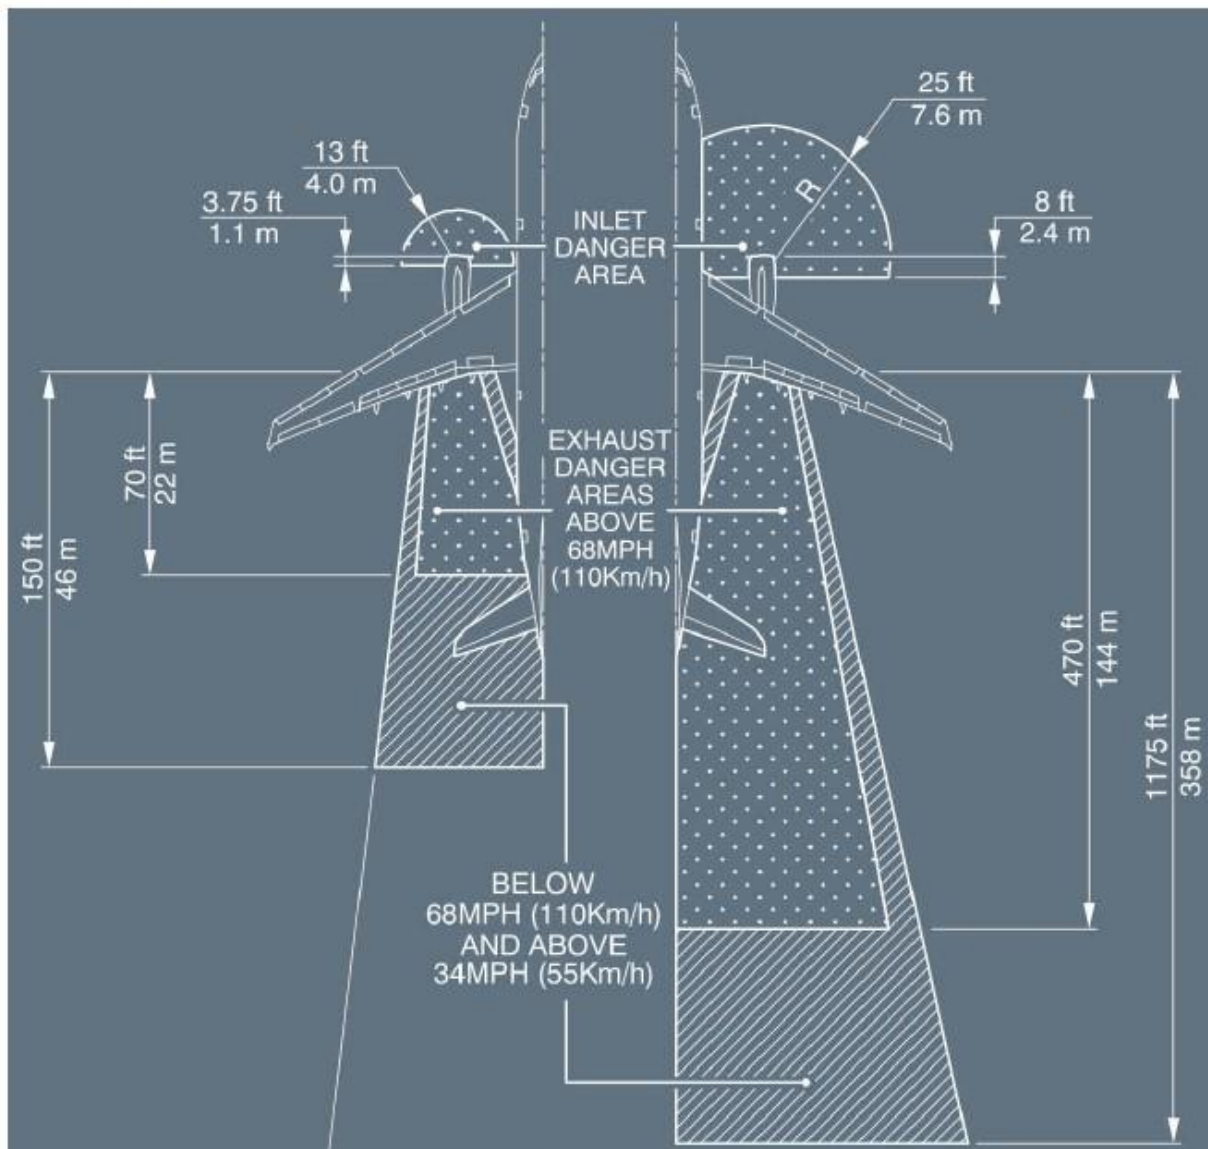
Figure 7: A 330 engine exhaust danger area

According to Airbus documentation on engine exhaust velocities, the distances of above locations of reported damages (above 2,3 and 4) are out of the area where the exhaust velocity is still notable.

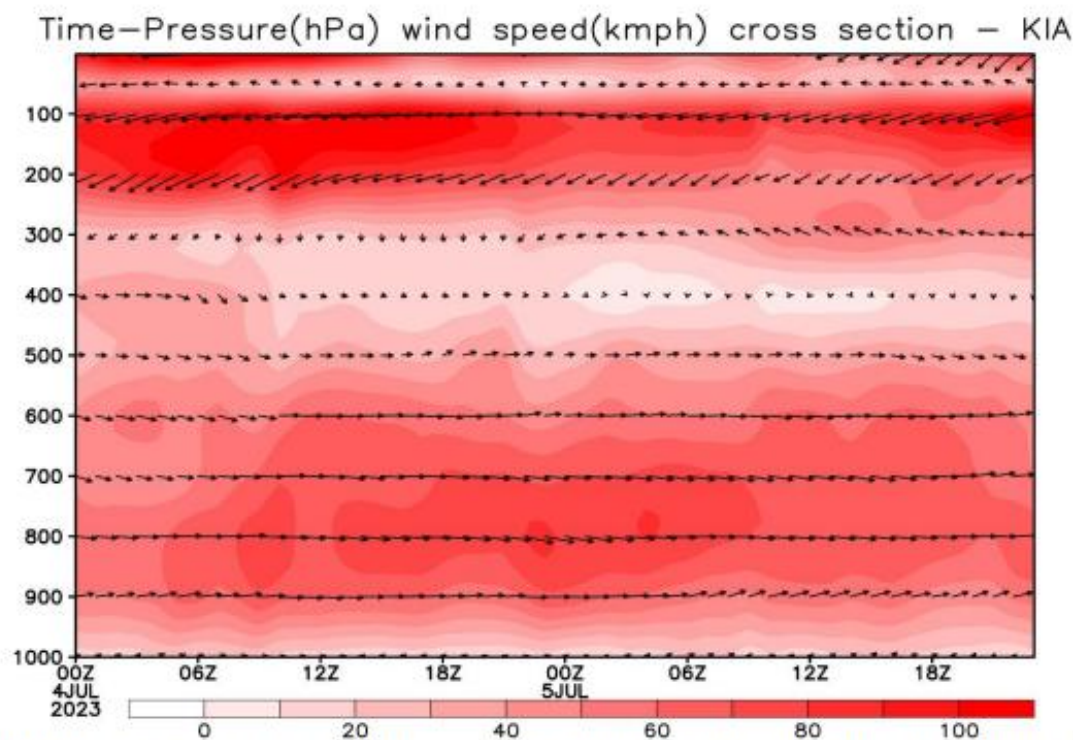
Figure 01: Vertical cross section of wind speed (shaded) and direction (arrows) over BIA during 04th and 05th July 2023; Data: ERA5 hourly reanalysis data from European Centre for Medium-Range Weather Forecasts (ECMWF)

The figure 01 shows vertical cross section of the wind speed and direction over BIA during 04th and 5th July 2023. It shows a strong wind current at 800hPa level (around 2000m from surface) with maximum wind speed of about (80-90) kmph.

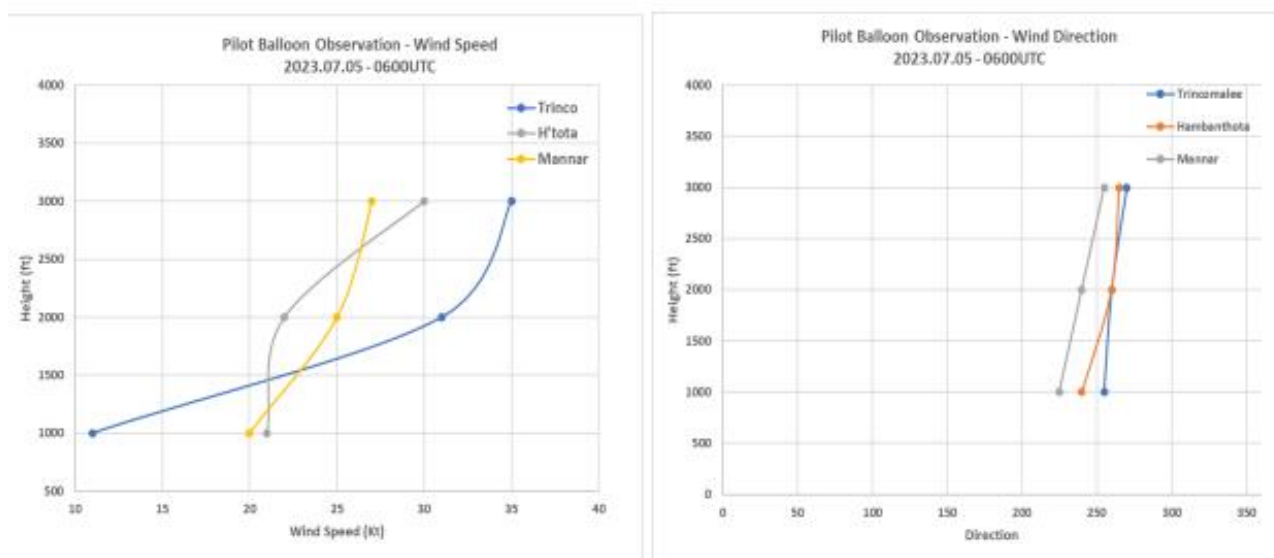
Figure 02: Pilot balloon observation on 05th July 2023 at 0600UTC; Data: Department of Meteorology

It is also observed by the pilot balloon observations of the Department of Meteorology on 04th and 05th July 2023. Figure 02 & 03 illustrate the pilot balloon observations at 0600UTC and 1200UTC on 05th July 2023.

Due to prevalence of low-level clouds during the pilot balloon observation period, data is available only up to 3000 feet at 0600UTC and up to 5000ft at 1200UTC. Pilot balloon observation was not available at Colombo Meteorological Office at 0600UTC. According to the balloon observation on 05th July, there were strong winds about (30-35) knots over Sri Lanka from 3000ft to 5000ft above the surface.

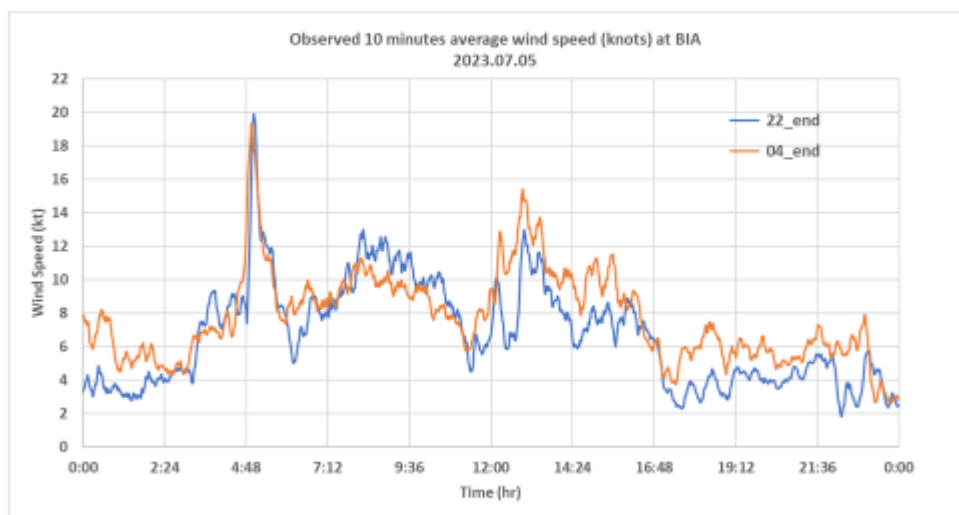
Figure 04: Observed 10 minutes average surface wind speed at BIA on 05th July 2023. Data from BIA

Following graphs illustrate observed 10 minutes average wind speed at runway surface ends (Figure 04) and recorded maximum wind gusts at BIA (Figure 05) on 05th July 2023. This observation data is evidenced that, there were strong gusty winds across the BIA area from 05.00hrs to 06.00hrs and from 12.00hrs to 16.00hrs on 05 July 2023.
