RE-OPENED ACCIDENT INVESTIGATION REPORT OF LION AIR FLIGHT LN602, EW 46465

Civil Aviation Authority of Sri Lanka

ACCIDENT INVESTIGATION REPORT OF LION AIR FLIGHT LN602, EW 46465

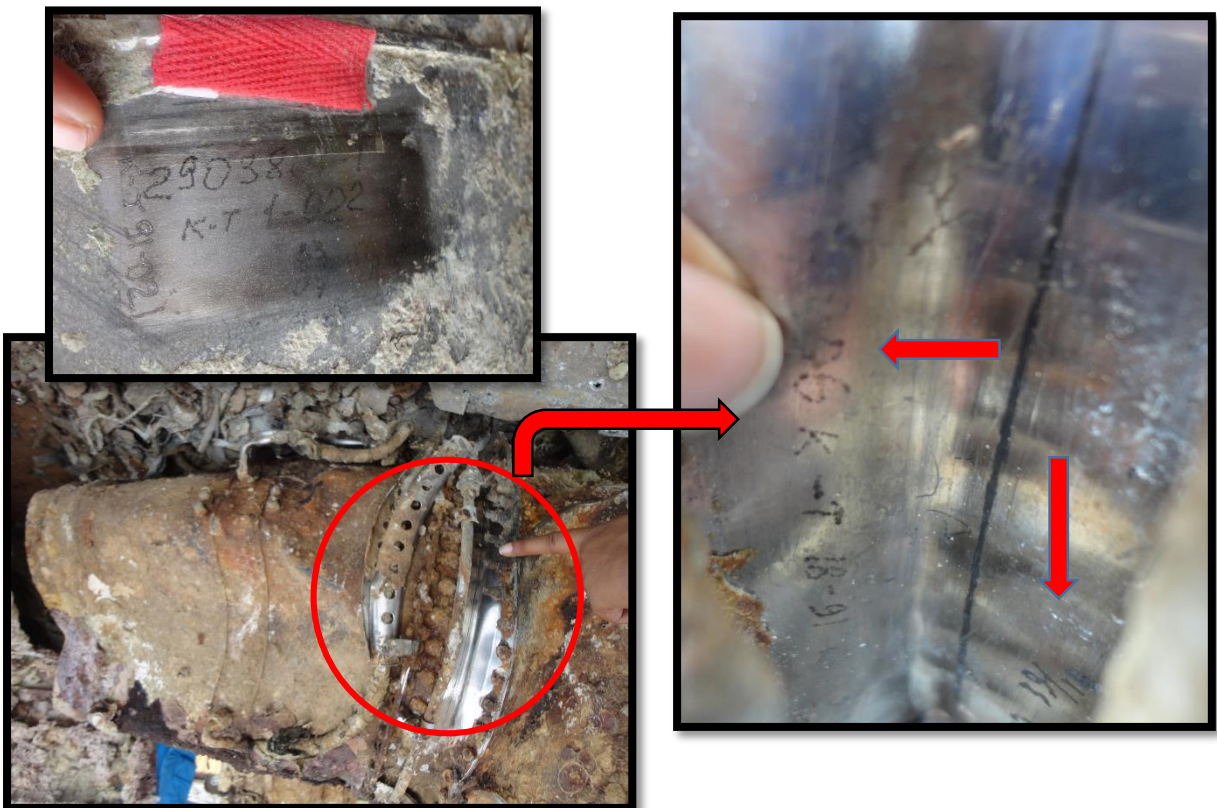
Fig 4

APU is the power generating unit of an aircraft which generate electrical power, as an alternative power source in addition to the main power sources coupled to the engine. The APU that was found was a single piece. (Fig 3) After the cleaning process, several numbers were found in multiple locations in the APU housing (Fig 4). These numbers were communicated to Antonov Design Bureau, Ukraine, and State of Registry, Belarus but a response has not been received at the time of writing of the report. Fig 5 & 6 are extracts from AN 24 Technical Guidance Manual.

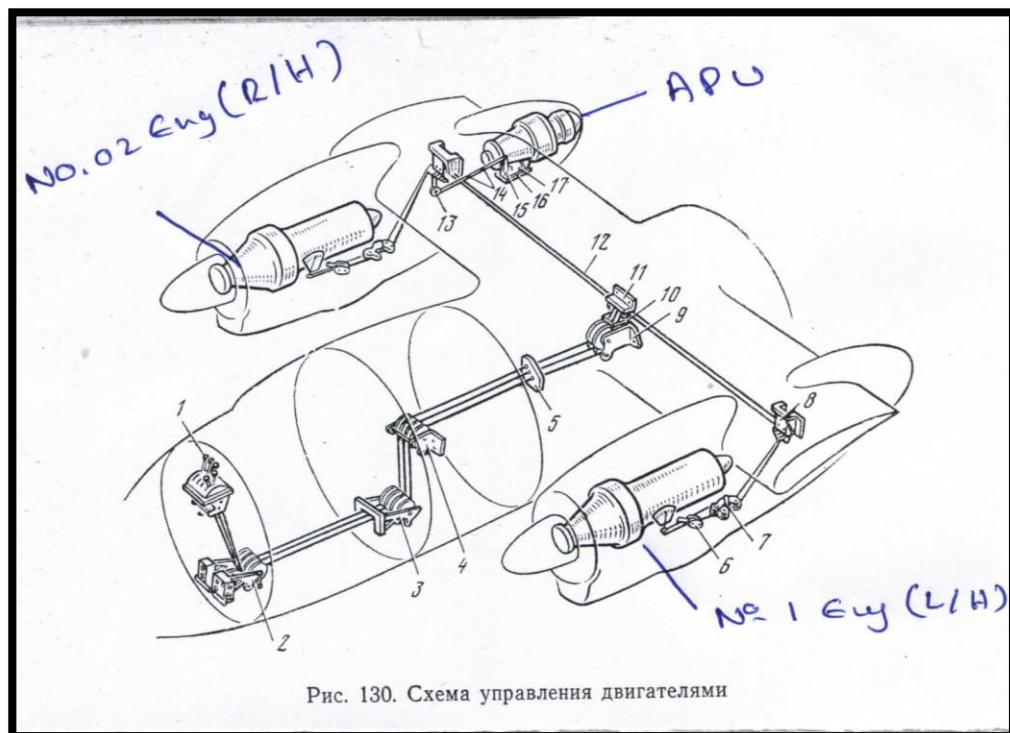
Fig 6

As there is only one APU available in an AN 24 aircraft and as it is located in the right wing engine compartment (fig 6), it is considered very rationale to assume that other parts recovered from close proximity of the site in the sea bed, the engine and the main landing gear recovered are of the same side of the aircraft which is right hand side (Starboard).

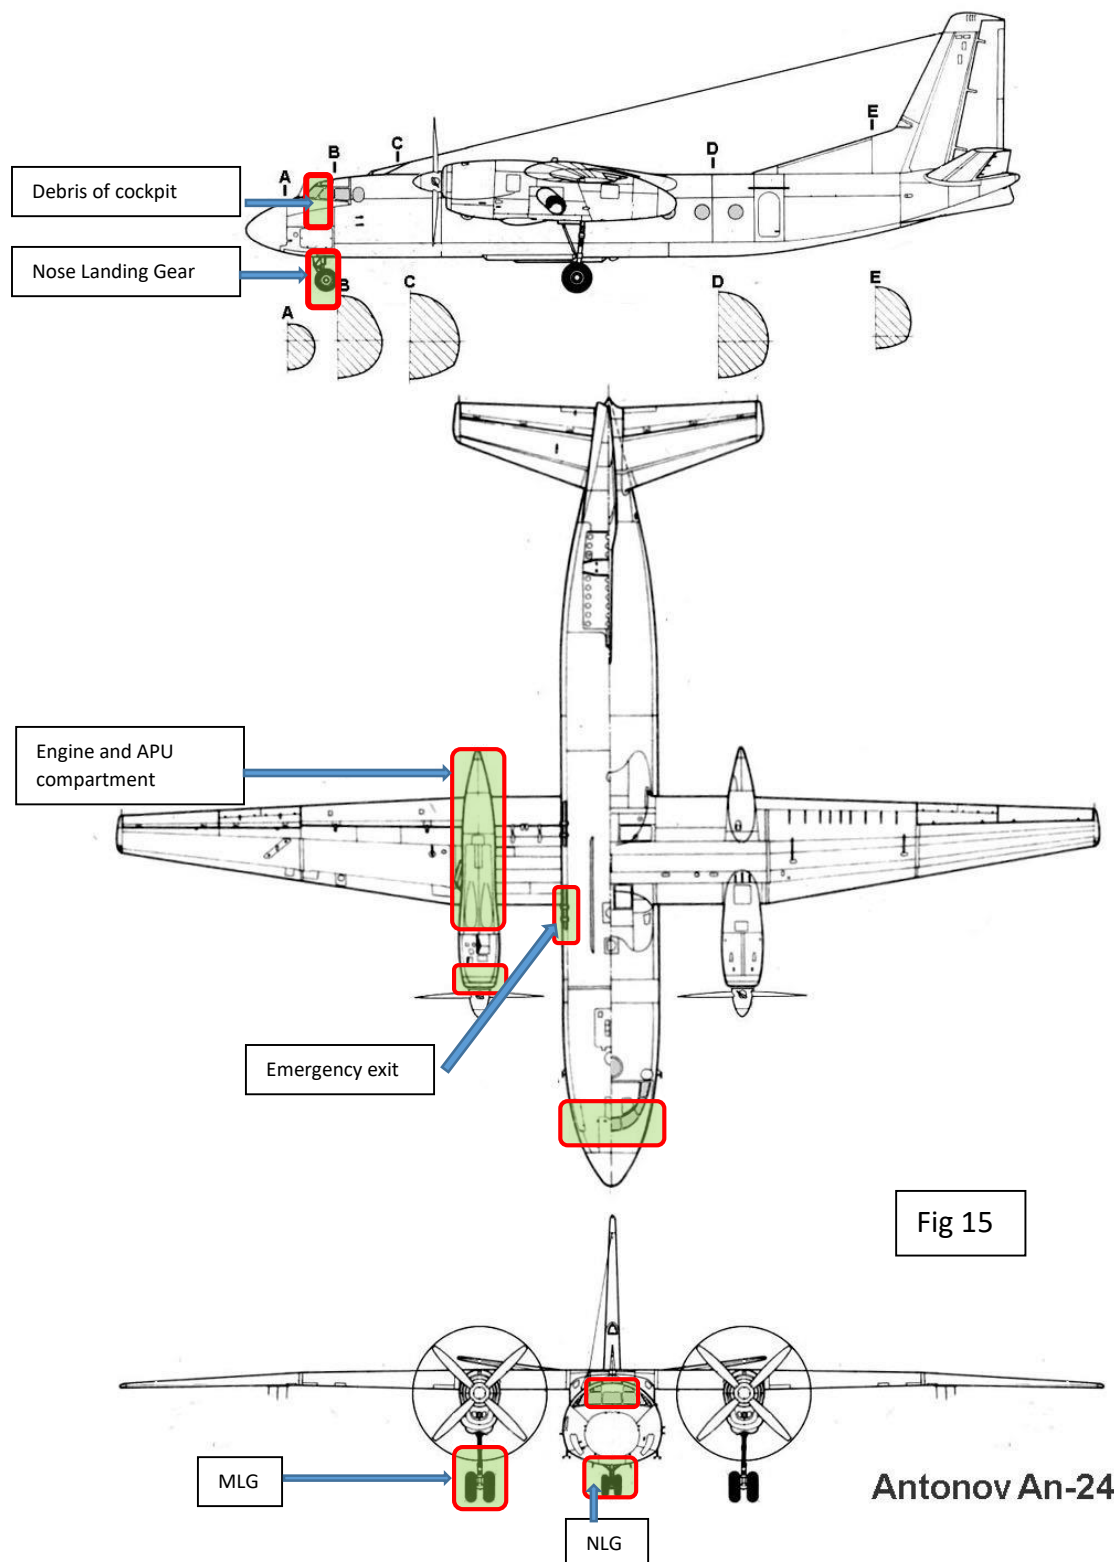
Locations of the suspected main parts recovered from the wreckage:

Nose Landing Gear (NLG): The nose strut which was recovered was attached to a part of the airframe (Fig 9). The location is marked in the side elevation diagram of the Aircraft (Fig 15). There were no Part/ Serial numbers found.
